SERIOUS INCIDENT

Aircraft Type and Registration:	Boeing 737-8AS, EI-GJT	
No & Type of Engines:	2 CFM56-7B26E turbofan engines	
Year of Manufacture:	2018 (Serial no: 44837)	
Date & Time (UTC):	9 October 2018 at 2205 hrs	
Location:	En route from Porto Airport, Portugal to Edinburgh Airport	
Type of Flight:	Commercial Air Transport (Passenger)	
Persons on Board:	Crew - 6	Passengers - 177
Injuries:	Crew - None	Passengers - None
Nature of Damage:	None reported	
Commander's Licence:	Air Transport Pilot's Licence	
Commander's Age:	61 years	
Commander's Flying Experience:	19,500 hours (of which 350 were on type) Last 90 days - 170 hours Last 28 days - 60 hours	
Information Source:	AAIB Field Investigation

Synopsis

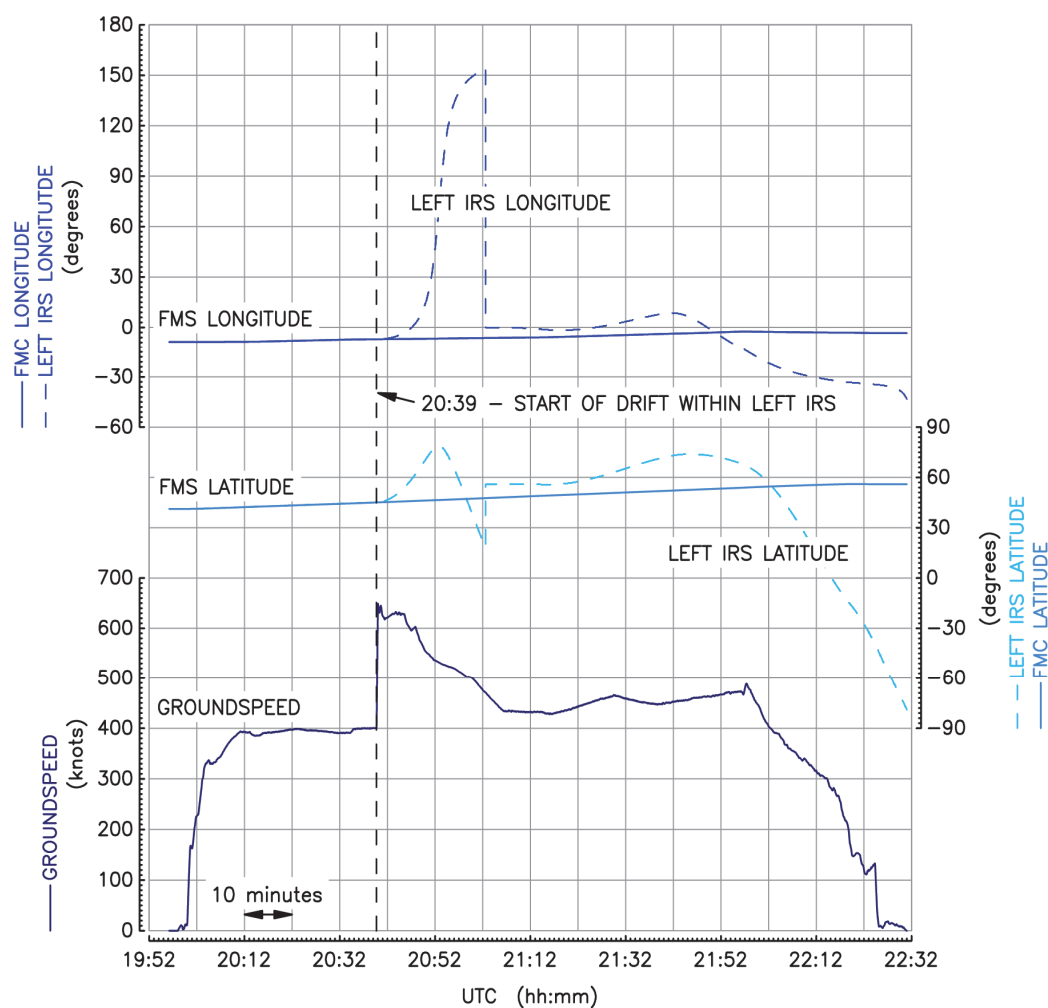
Figure 1 is a plot of the aircraft's latitude and longitude, recorded from the Flight Management Computer (FMC) and the left IRS, together with the groundspeed indicated on the commander's PFD. The figure shows that at 2039 hrs the latitude and longitude in the left IRS began to drift with a corresponding 250 kt jump in the indicated groundspeed.

Left IRS latitude and longitude drift during the flight

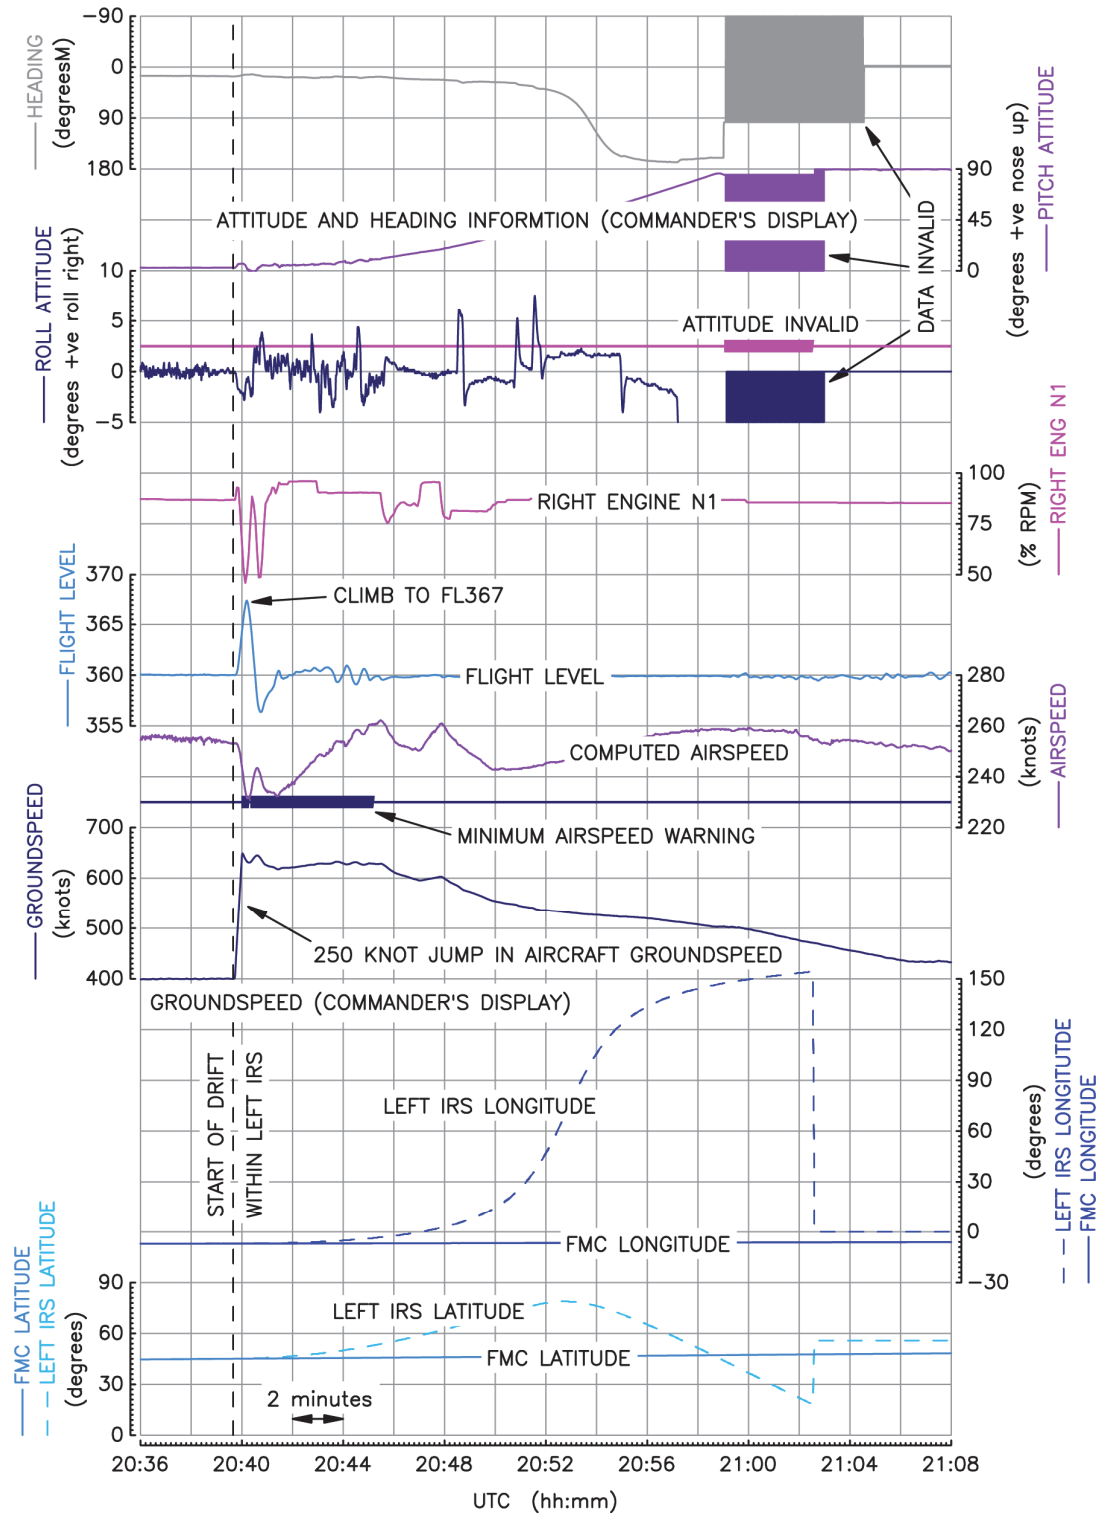
Figure 2 is a closeup of salient parameters recorded on the FDR from when the left IRS started to drift until just after the failed attitude indication was given. Highlighted in the figure shortly after the drift started are the climb to FL367 from FL360, the increase in N_1 to 95%, the pitch up, and the decrease in airspeed from about 250 kt to below 232 kt when a minimum airspeed warning was triggered. The erroneous attitude, heading and groundspeed information presented to the commander are also plotted and show the pitch attitude increasing to 90° and the heading changing by nearly 180° over a period of about 20 minutes, after which the aircraft issued an indication of invalid attitude information.

Salient FDR data during left IRS drift event

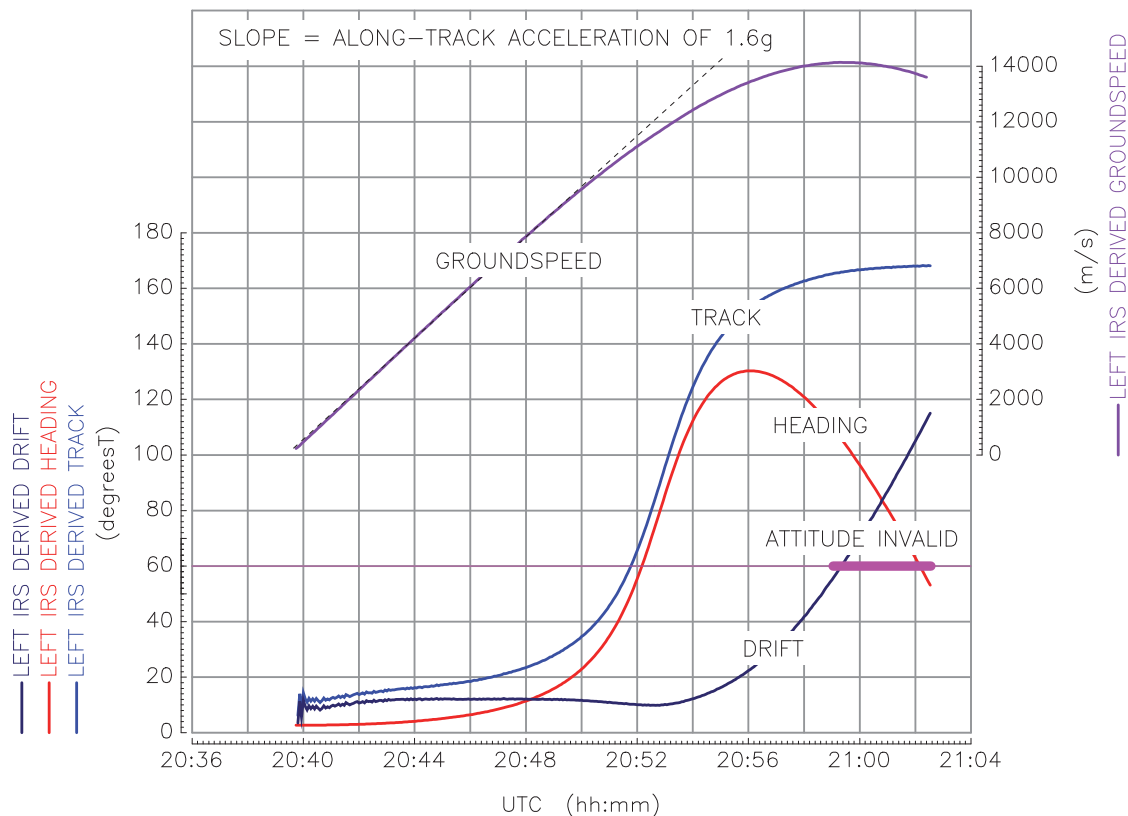
Although only the latitude and longitude from the left IRS were recorded, it was possible to derive the track and groundspeed it would have been generating, as well as an estimate of the aircraft's heading and, hence, the drift the left IRS was experiencing. These derived

parameters are reproduced in Figure 3 and show that the drift in latitude and longitude was initially driven by an along-track acceleration of about 1.6 g. The figure also shows that when the aircraft issued an indication that the attitude information was invalid, the left IRS drift had just reached 60°.

Left IRS derived data based on its recorded latitude and longitude
