**ACCIDENT**

<b>Aircraft Type and Registration:</b>	Boeing 737-8AS, EI-EBW	
<b>No &amp; Type of Engines:</b>	2 CFM International CFM56-7B/3 turbofan engines	
<b>Year of Manufacture:</b>	2009	
<b>Date &amp; Time (UTC):</b>	14 January 2017 at 1645 hrs	
<b>Location:</b>	On descent to Manchester Airport	
<b>Type of Flight:</b>	Commercial Air Transport (Passenger)	
<b>Persons on Board:</b>	Crew - 6	Passengers - 89
<b>Injuries:</b>	Crew - 1 (Serious)	Passengers - None
<b>Nature of Damage:</b>	None reported	
<b>Commander's Licence:</b>	Airline Transport Pilot's Licence	
<b>Commander's Age:</b>	31 years	
<b>Commander's Flying Experience:</b>	4,977 hours (of which 4,833 were on type) Last 90 days - 156 hours Last 28 days - 29 hours	
<b>Information Source:</b>	AAIB Field Investigation

**Synopsis**

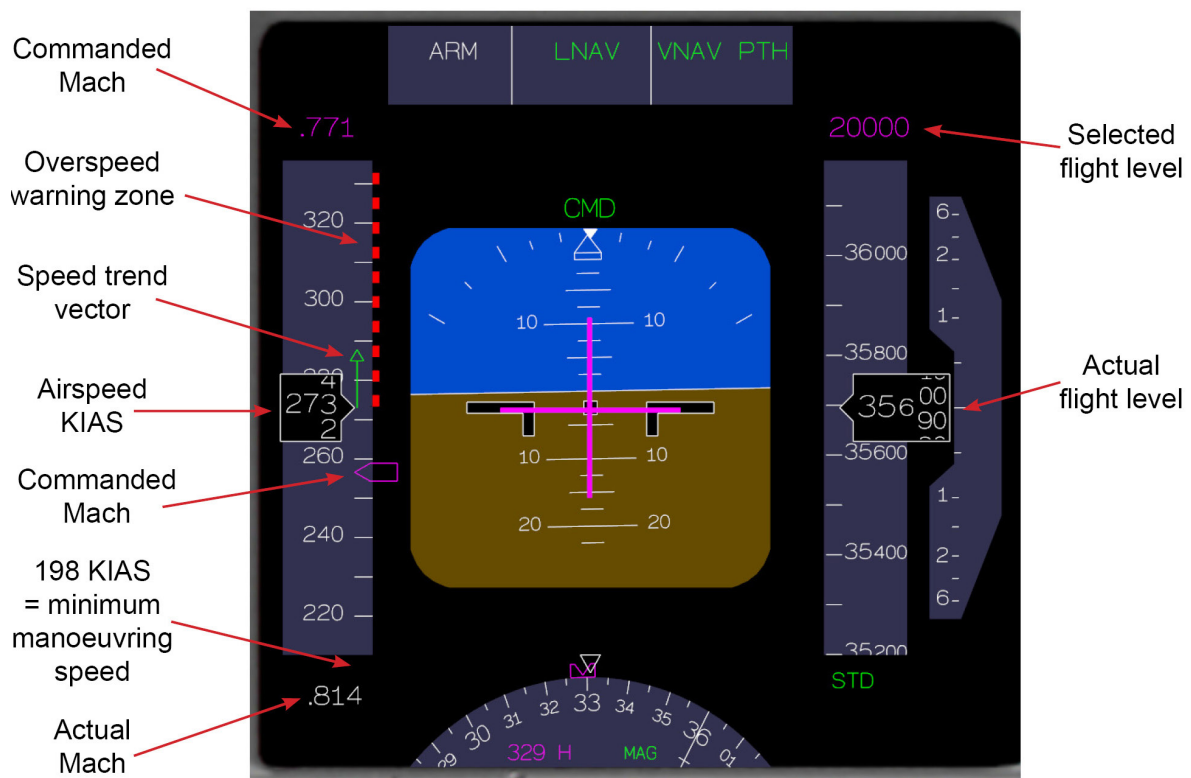
**Figure 1**

Recorded data showed that from FL392 in the descent, the windspeed displayed on the primary flight display (PFD) started to rise gradually. Then, when passing FL367, it increased at a greater rate, rising by 22 kt over 28 s. This corresponded with an increase in the aircraft's speed from 0.78 M to a maximum of 0.818 M, where an overspeed was recorded. The commander recalled that the speed trend vector<sup>7</sup> had simultaneously extended rapidly well into the overspeed warning zone<sup>8</sup> by around a corresponding 15-20 kt.

Example image of a PFD under conditions similar to EI-EBW just prior to autopilot disengagement

The commander stated that he had not noticed the windspeed indication on the PFD increasing. Both pilots reported to the operator that they noted and discussed the ensuing airspeed increase.

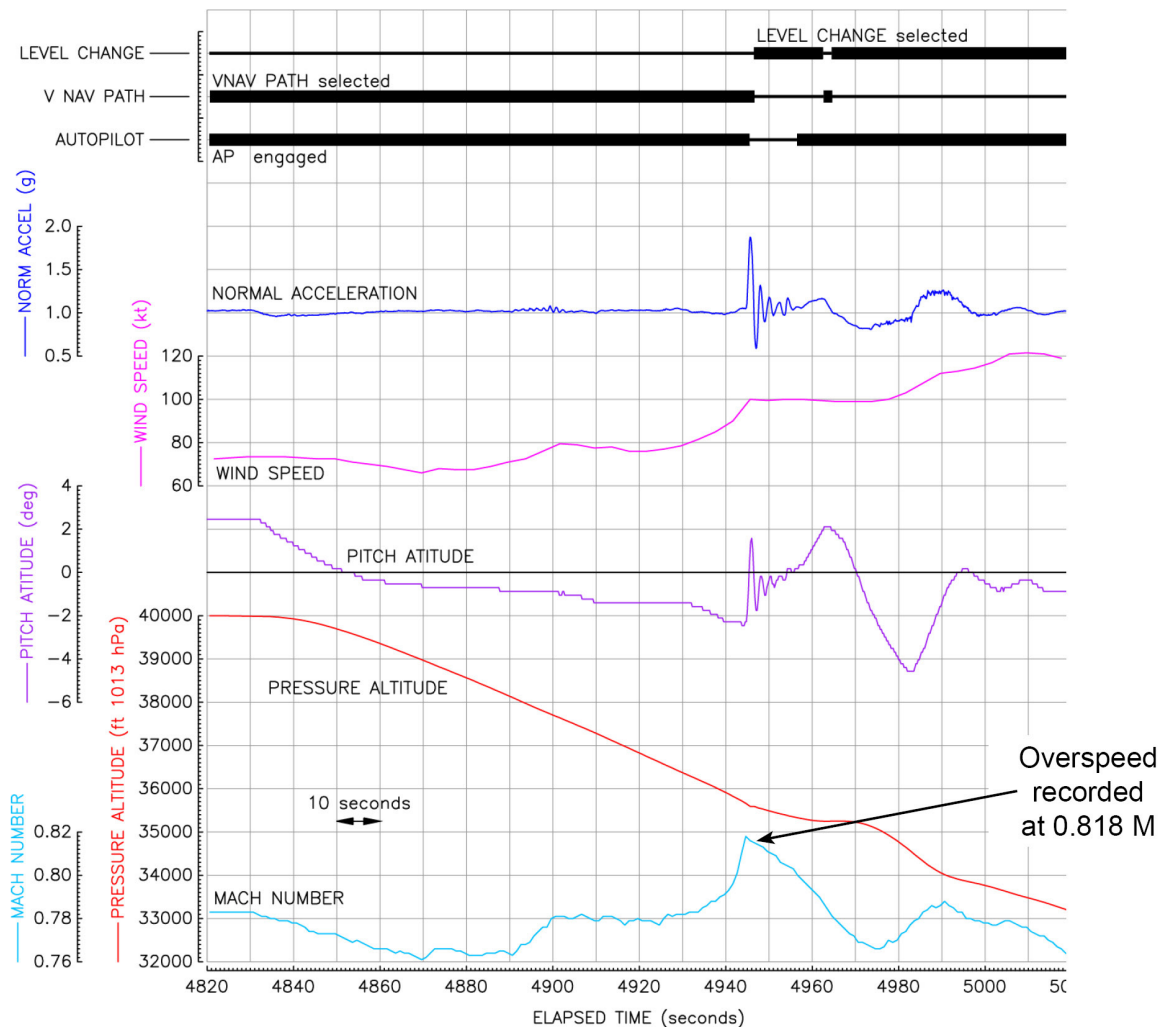
**Figure 2**  
Recorded information

The following parameters were recorded.

There were marked changes in normal acceleration<sup>9</sup> on the aircraft over a short period.

Further analysis of the data by the manufacturer showed that in the one second during which the autopilot became disengaged the force exerted on the control column by the commander changed from -0.51 lbs to +42.76 lbs.

Immediately following autopilot disengagement, the overspeed protection logic caused the vertical flight mode to revert from VNAV PATH to LEVEL CHANGE<sup>10</sup>.

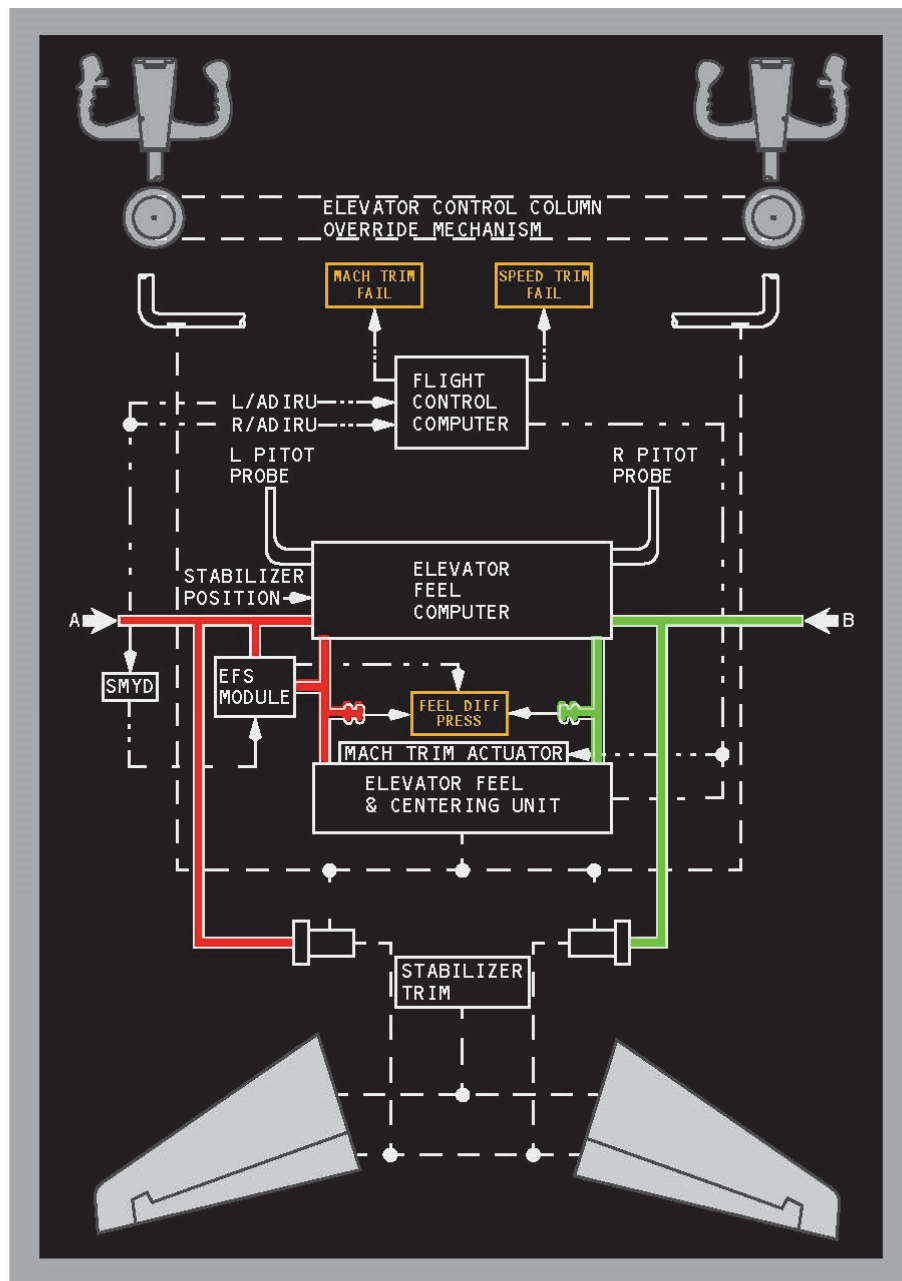
**Figure 3**  
Pitch control system schematic

The feel computer behaves like a centering spring whose stiffness varies with airspeed. It provides a restoring force towards the neutral position of the control column. The autopilot servos are limited to 25 lb of force for single channel operation. Separate force sensors measure pilot column input and the autopilot will disconnect if the force applied by the pilot(s) exceeds 21 lbs.

To have any effect on elevator position with the autopilot engaged, the pilot input force must overcome the sum of the autopilot applied force and the feel computer.

If the autopilot acts to keep the control column in its neutral position, both the autopilot and the feel computer will be resisting any pilot input. In this case, the 21 lb manual input threshold will be reached before the autopilot actuator needs to exert an opposing 25 lb to maintain the column's neutral position, resulting in the autopilot disconnecting before there is any motion transmitted to the elevators.

Parameters relevant to autopilot disconnection for this accident were recorded. The sample rate was such that the timing of disconnection could be determined within a window of 0.3 s. The column force exerted by the commander rose above the autopilot disconnect threshold of 21 lb during such an interval of 0.3 s. Accordingly, it was not possible to determine whether autopilot disengagement was caused by force override or by the commander's use of the autopilot disengage button.
