**ACCIDENT**

| <b>Aircraft Type and Registration:</b> | Boeing 737-8AS, EI-GDZ | |
| <b>Location:</b> | London Stansted Airport | |

**Synopsis**

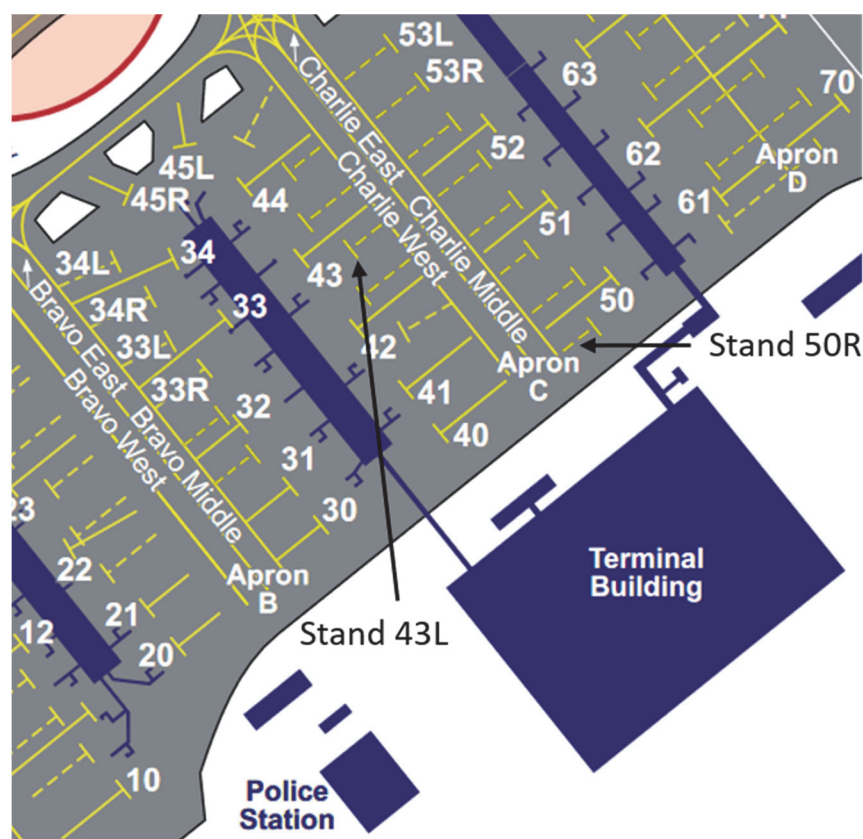
**Figure 1**

The aircraft was parked on stand C43L with the headset operator on the right side of the aircraft, in communication with the flight deck and the tug driver in his driving position. The weather was described as poor visibility with strong winds and heavy rain causing standing water, reflecting the airport lights and making the ground markings difficult to see. The intended stands and taxi lines are shown at Figure 1.

Parking stands and taxi lines with 50R being closest to the blast fence.

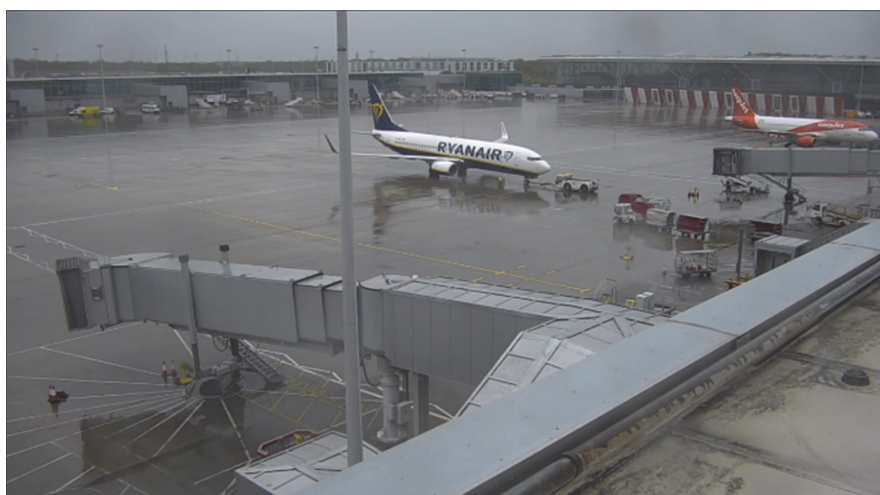
**Figure 2**

Initial pushback from the Stand 43L

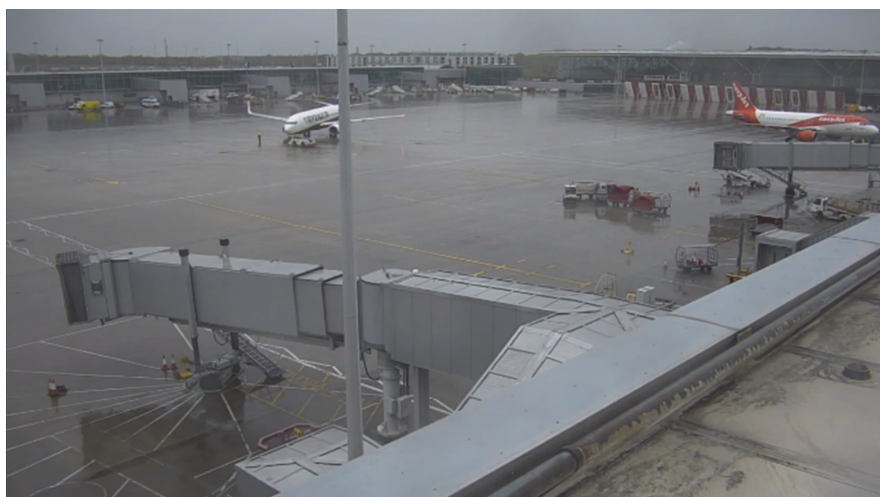
**Figure 3**

The aircraft approaching the taxi line with the headset person on the right side of the aircraft

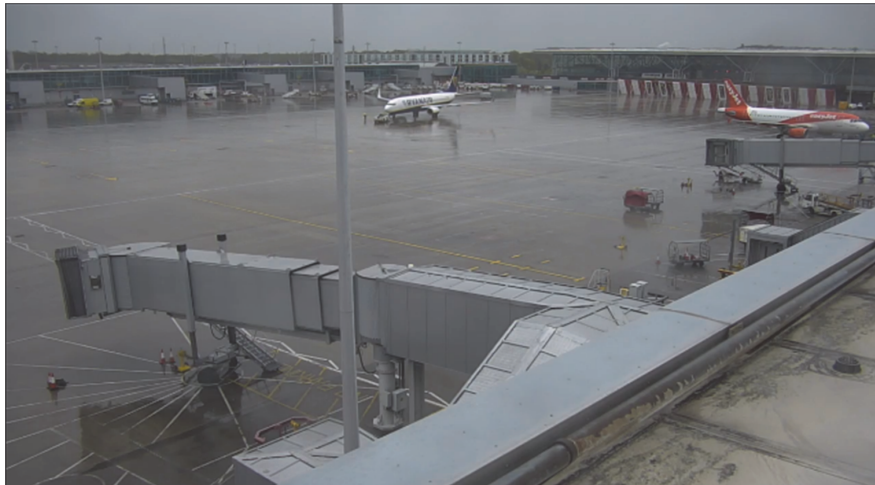
**Figure 4**

The aircraft established on the taxi line

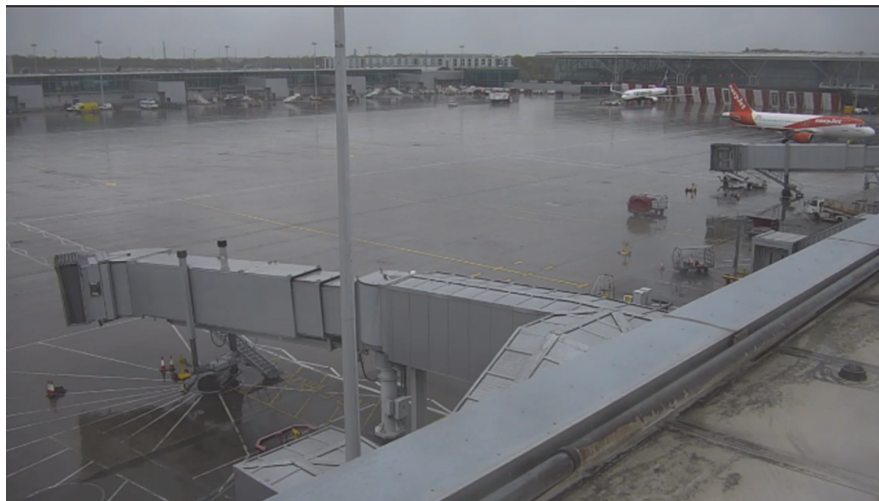
**Figure 5**

Closed-circuit Television (CCTV) of the event showed that the aircraft was pushed back but moved slightly from side to side as the tug driver attempted to locate and follow the taxi line. When the tail of the aircraft contacted the blast fence, the tug stopped and then reversed a short distance before becoming stationary. The images in Figures 2 to 6 were taken from the CCTV recording.

The aircraft contacting the blast fence

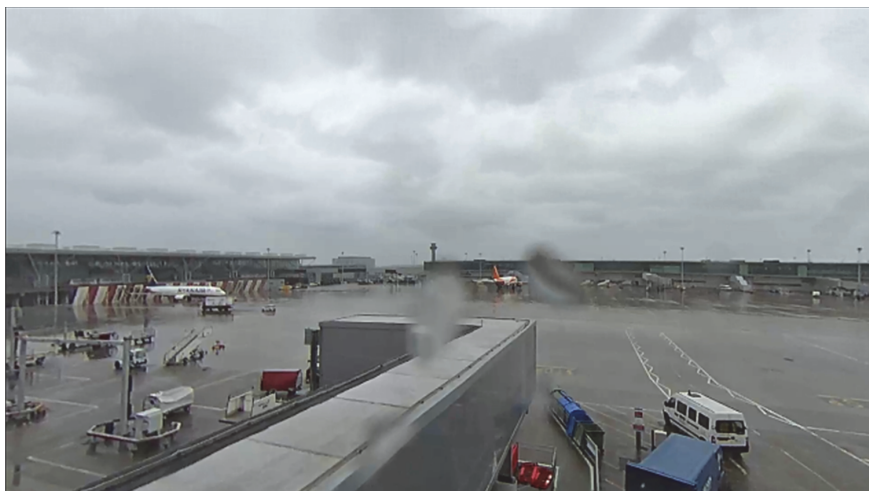
**Figure 6**

The aircraft contacting the blast fence from a different camera angle
