## INCIDENT

<b>Aircraft Type and Registration:</b>	ATR42-300, EI-SLD	
<b>No &amp; Type of Engines:</b>	2 Pratt and Whitney PW120 turboprop engines	
<b>Year of Manufacture:</b>	1985	
<b>Date &amp; Time (UTC):</b>	18 January 2007 at 2225 hrs	
<b>Location:</b>	London Stansted Airport	
<b>Type of Flight:</b>	Commercial Air Transport (Cargo)	
<b>Persons on Board:</b>	Crew - 2	Passengers - None
<b>Injuries:</b>	Crew - None	Passengers N/A
<b>Nature of Damage:</b>	None	
<b>Commander's Licence:</b>	Airline Transport Pilot's Licence	
<b>Commander's Age:</b>	41 years	
<b>Commander's Flying Experience:</b>	2,732 hours (of which 2,144 were on type) Last 90 days - 147 hours Last 28 days - 35 hours	
<b>Information Source:</b>	AAIB Field Investigation

## Synopsis

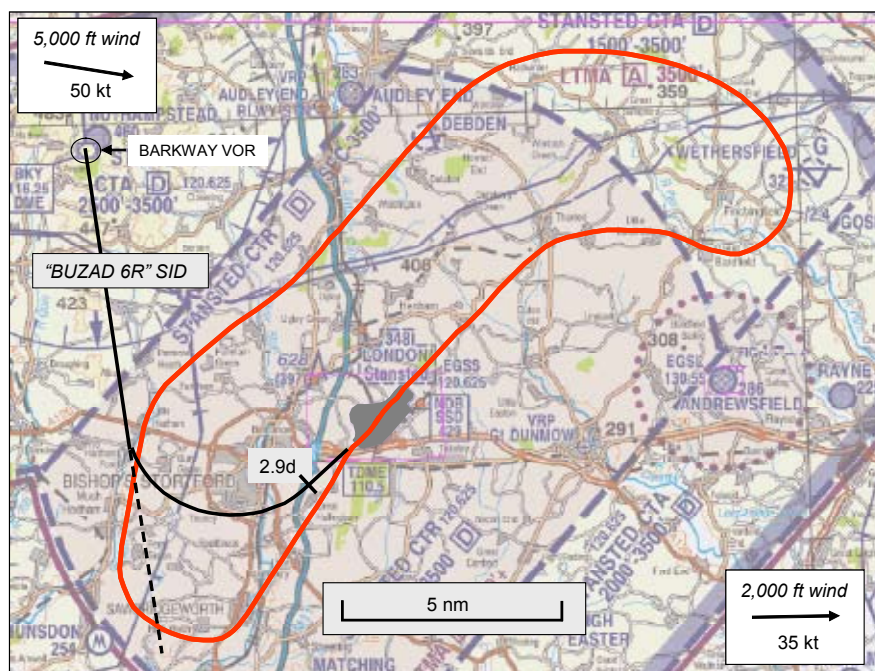
The aircraft took off from Stansted's Runway 23, with a reported wind from 240° at 14 kt. Almost immediately after becoming airborne, the crew experienced a yawing motion, which developed into a motion described later by them as being similar to a Dutch roll. In accordance with standard flight procedures, the co-pilot attempted to engage the yaw damper after takeoff but it would not engage. The commander told the co-pilot she was having difficulty controlling the aircraft. The aircraft climbed to 3,000 ft above mean sea level (amsl) and maintained approximately the runway heading. When the aircraft was seen by Air Traffic Control (ATC) to be deviating from the cleared 'BUZAD 6R' Standard Instrument Departure (SID), the controller instructed the crew to turn right. The co-pilot informed the controller of the control difficulties and requested radar vectors for an immediate return to the airport. Figure 1 shows the aircraft's ground track, based on recorded radar data.

Aircraft ground track, SID and wind data

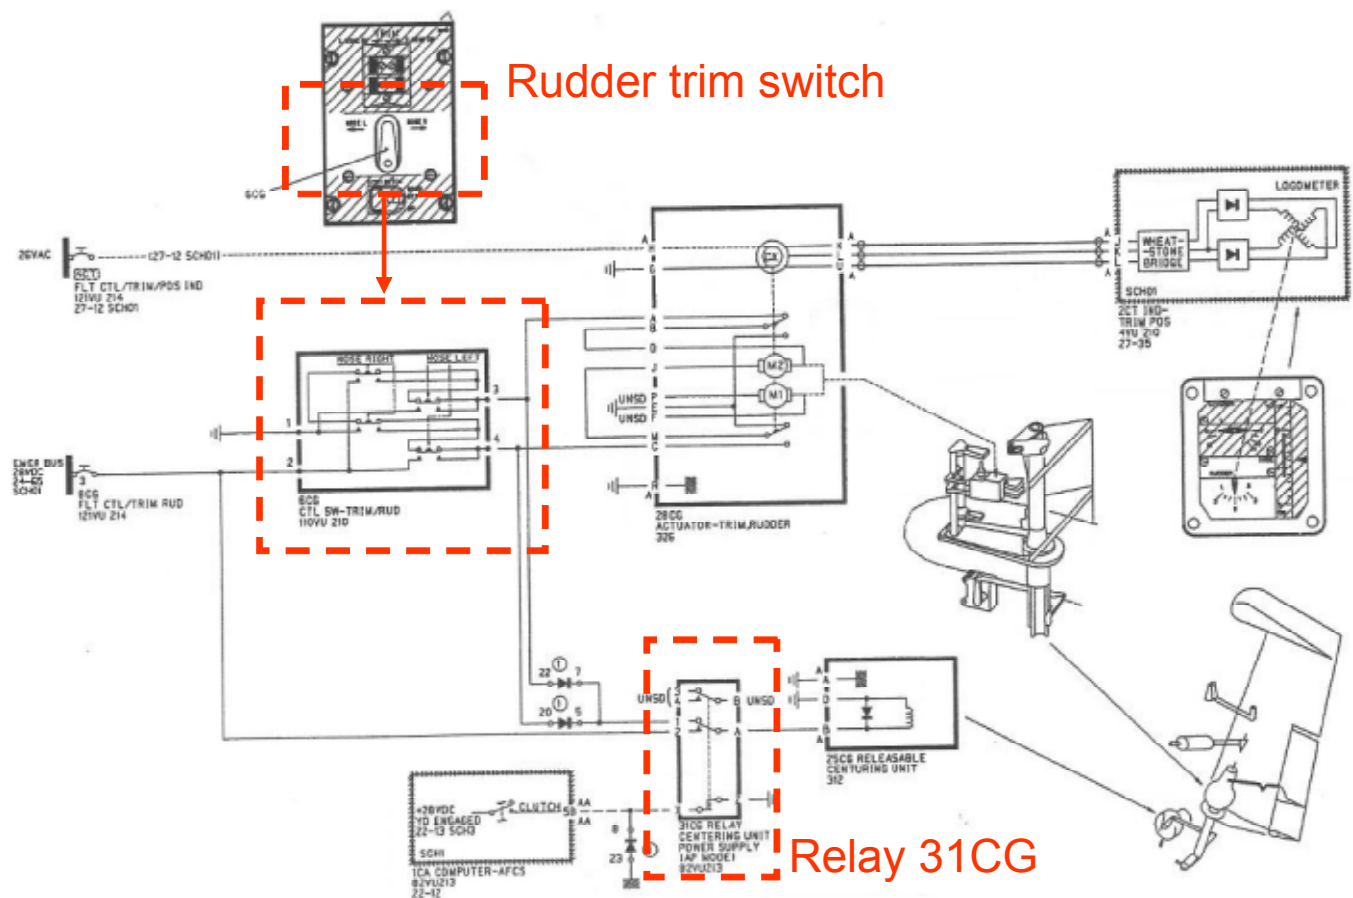
**Figure 4**  
Yaw control schematic

The 31CG relay was tested and found to be satisfactory. It can be seen in Figure 4 that three of the contact pins are unused. The active ones were noted to be blackened as a result of electrical arcing in service but this was stated to be a normal phenomenon and had not resulted in erosion of the contacts.

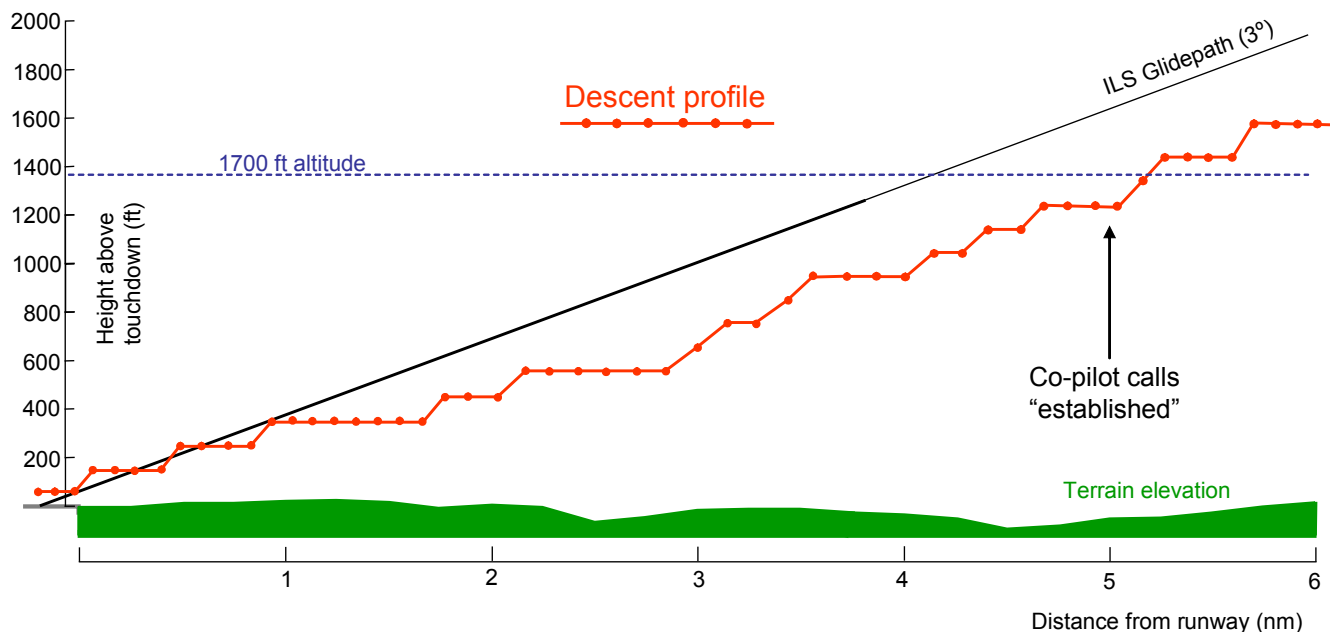
**Figure 5**  
Final approach

the controller cleared the crew to descend on the ILS. However, the aircraft descended below 1,700 ft before reaching the glideslope and was about 300 ft to 400 ft below it at 4 nm. At about 3.5 nm from touchdown the aircraft started to deviate further below the glideslope until it levelled at about 500 ft above airfield level (aal). It then descended further to about 300 ft aal which it maintained until intercepting the normal approach path at about 1 nm from touchdown.

At about 2 nm from touchdown there was a significant speed reduction below about 160 kt which, from the pilots’ reports, would be coincident with the selection of flap 15. Wind reports from ATC showed a fairly steady surface wind from 240° at 16 to 18 kt. After landing, ATC asked if the crew were able to vacate the runway normally. The co-pilot replied “AFFIRM, FULL CONTROL ON THE GROUND”.

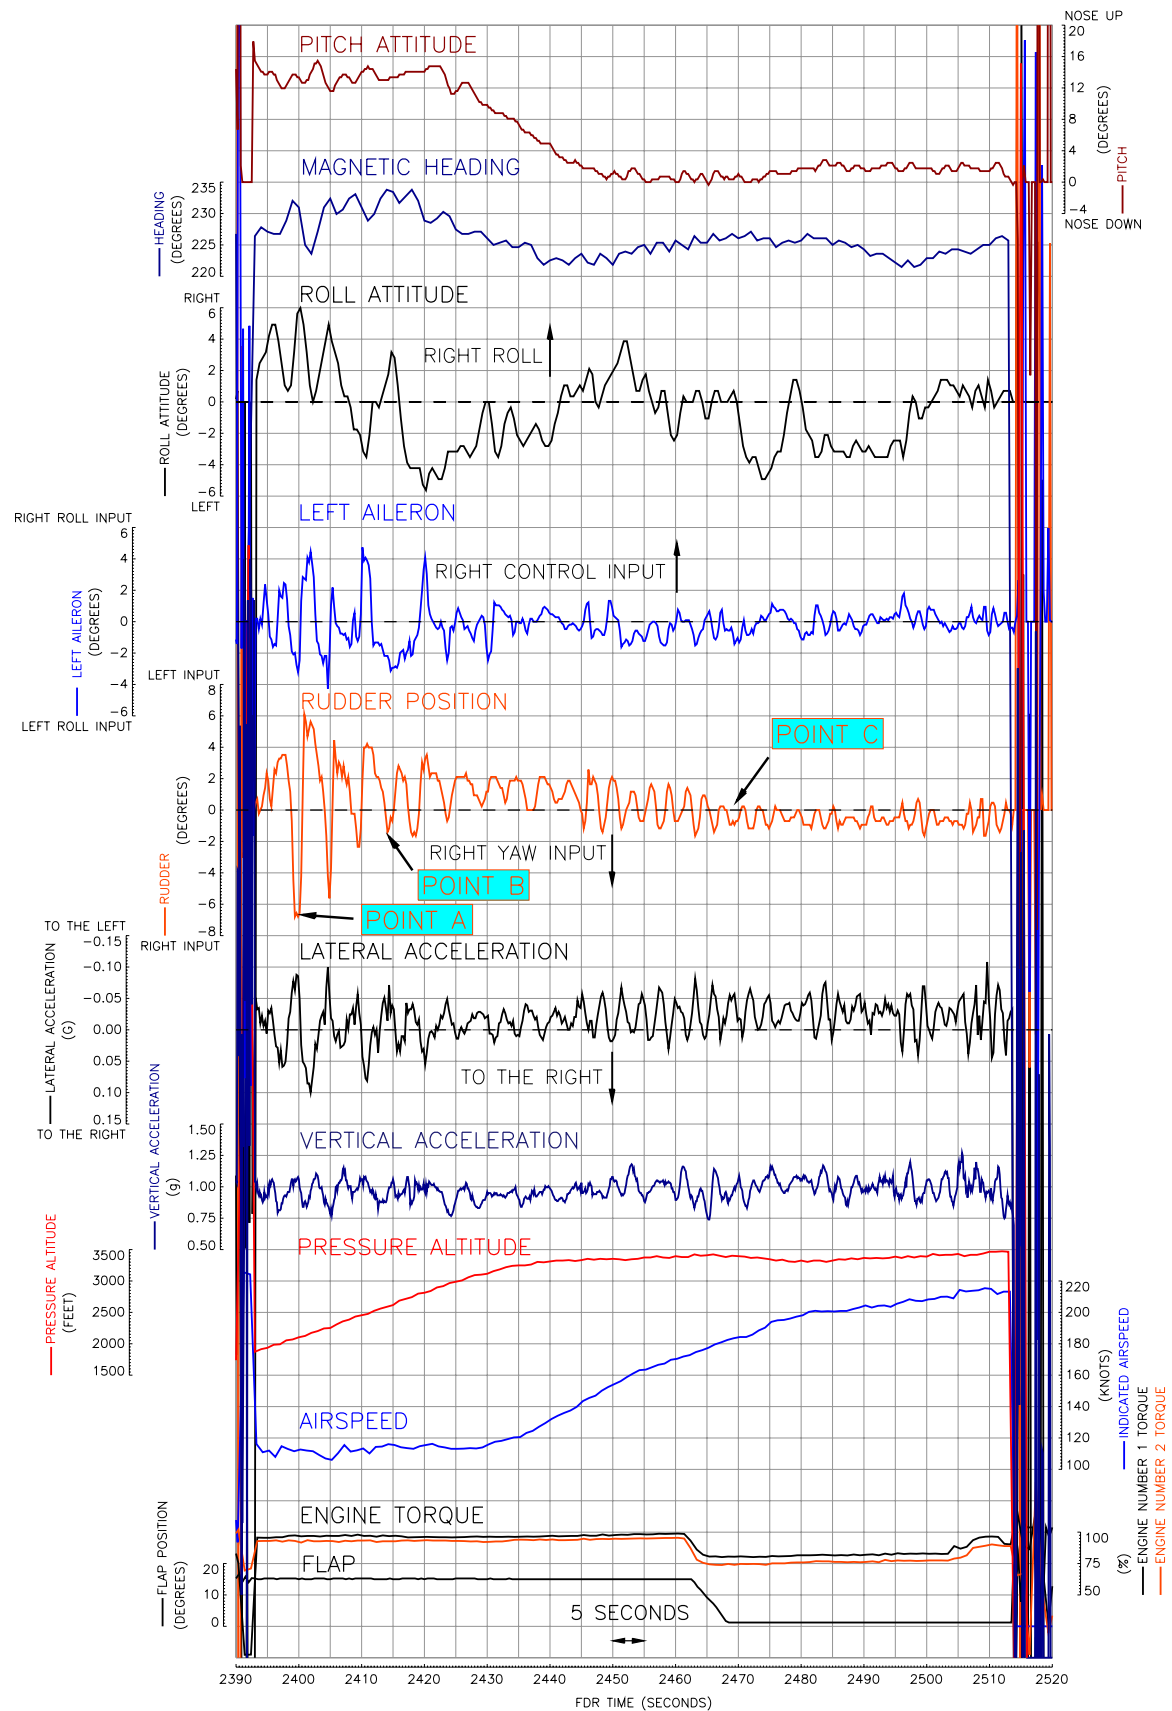
Figure 6

The next three oscillations shared similar characteristics of rudder motion and lateral control input. On each occasion the rudder moved rapidly from its right deflected position to the left (maximum travel was nearly 13°), in one second or less, accompanied by an opposite roll control input over the same duration. The rudder then returned to the right at a slightly lower rate, with a similarly slower roll input. The period of these oscillations was between 4.3 and 5 seconds.

The applied lateral control input did not always appear to be in response to aircraft rolling motion, particularly during the most significant recorded oscillations. From Point A, the rapid reversal of roll input to the right was initiated when the aircraft was both banked slightly to the right and rolling to the right, a situation repeated during the next oscillation. The initial right bank coincided with the correction back to the runway centreline, after the aircraft drifted left just after lift off. The subsequent left bank resulted in the aircraft stabilising about a mean heading of 225°, which was also the runway heading, and consistent with the ground track seen on radar.

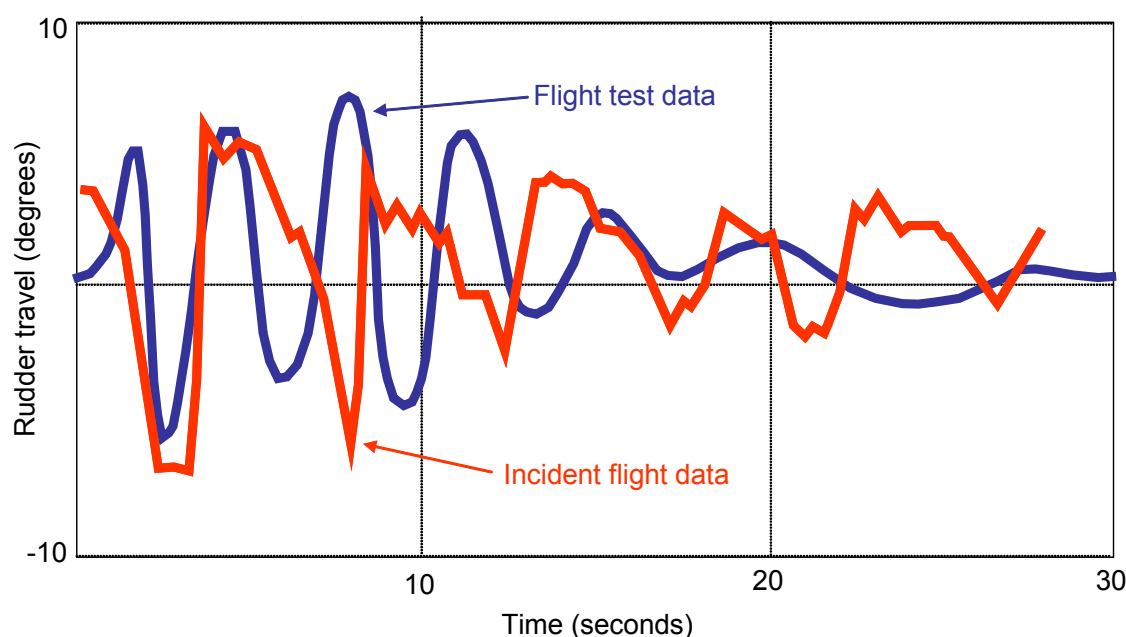
**Figure 7**

Incident FDR plot overlaid on flight test Dutch roll data

Although the observed motion bore some similarities to a Dutch roll, it was not the same. In particular, the uneven and high rates of rudder travel were not natural motions, and the frequency was different. Although coarse use of roll control (involving activation of wing spoilers) would induce yaw, it was considered that the only way in which the rudder could move in the way it did was through the direct assistance of the spring tab, ie by pilot application. It was stressed that the rudder damper also operates during flight, so always acts to limit the rate of rudder travel.
