SERIOUS INCIDENT

Aircraft Type and Registration:	1) Boeing 737-800, EI-FJW 2) Airbus A320-214, OE-IVC
No & Type of Engines:	1) 2 CFM56-7B26E turbofan engines 2) 2 CFM56-5B4/3 turbofan engines
Year of Manufacture:	1) 2016 2) 2016
Date & Time (UTC):	13 August 2018 at 0948 hrs
Location:	Runway 06 at Edinburgh Airport
Type of Flight:	1) Commercial Air Transport (Passenger) 2) Commercial Air Transport (Passenger)
Persons on Board:	1) Crew - 7 Passengers - 159 2) Crew - 6 Passengers - 180
Injuries:	1) Crew - None Passengers - None 2) Crew - None Passengers - None
Nature of Damage:	1) None 2) None
Commander's Licence:	1) Airline Transport Pilots Licence 2) Airline Transport Pilots Licence
Commander's Age:	1) 42 years 2) 37 years
Commander's Flying Experience:	1) 6,800 hours (of which 6,650 were on type) Last 90 days - 160 hours Last 28 days - 30 hours 2) 10,000 hours (of which 9,000 were on type) Last 90 days - 200 hours Last 28 days - 70 hours

Synopsis

A landing Boeing 737 closed to within 875 m of a departing Airbus A320 when landing at Edinburgh Airport. The airport air traffic control service provider defined this as a runway incursion as the 737 was over the runway surface when th

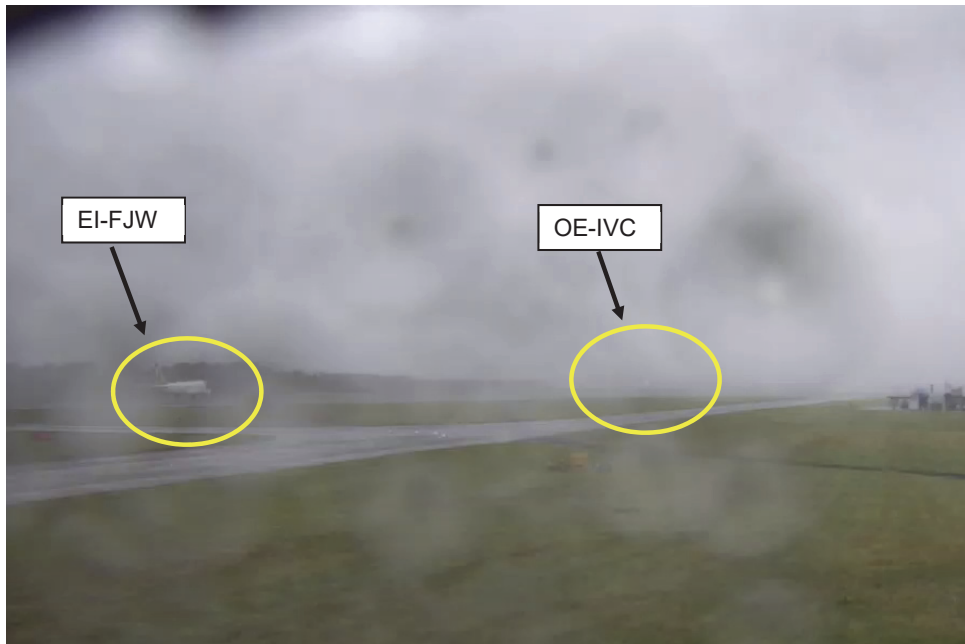
As EI-FJW was over the runway at the same time as OE-IVC was completing its takeoff roll, the event was classed as a runway incursion by the air navigation service provider (ANSP). At the closest point of approach, the two aircraft were separated by approximately 875 m, with OE-IVC being at 60 ft aal when EI-FJW touched down. Figure 2 shows a CCTV view looking down the runway which, although partially obscured by rain on the camera, shows both EI-FJW and OE-IVC visible in the frame.

CCTV showing both aircraft over the runway

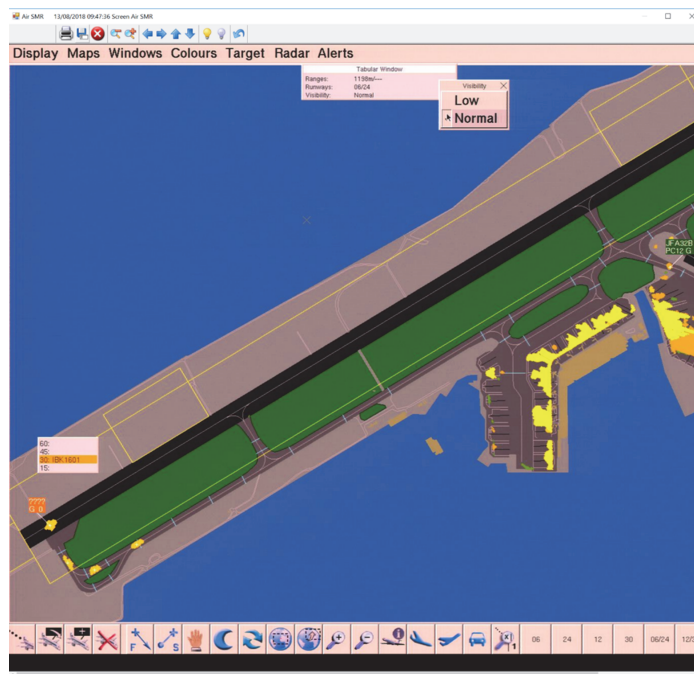
Figure 5

An active Stage 1 RIMCAS alert at EDI

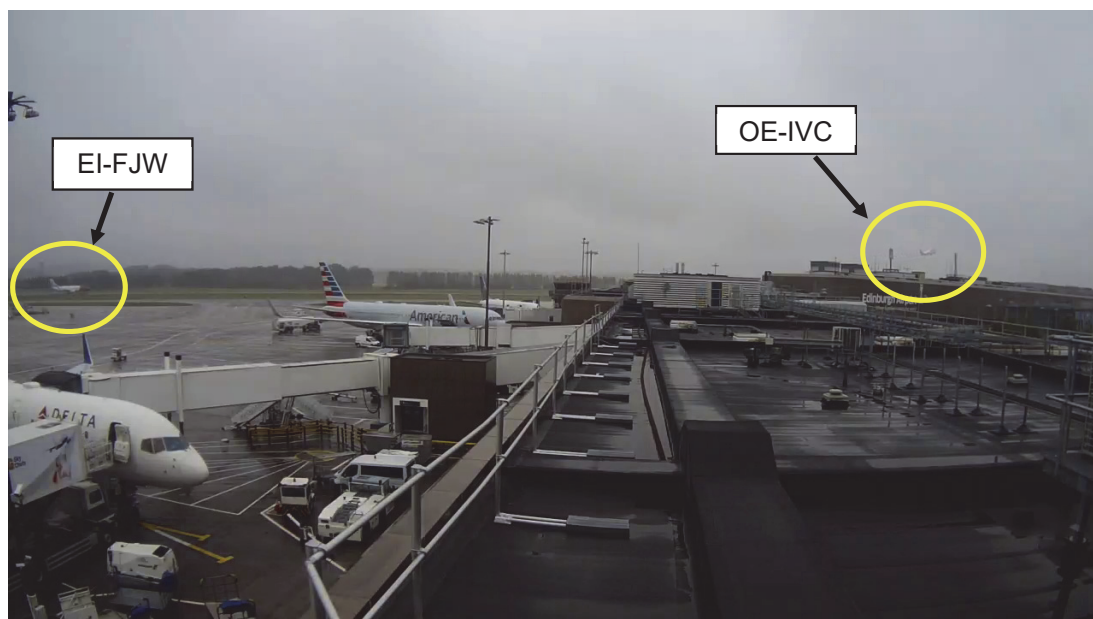
Figure 6

CCTV screenshot of the event showing both aircraft

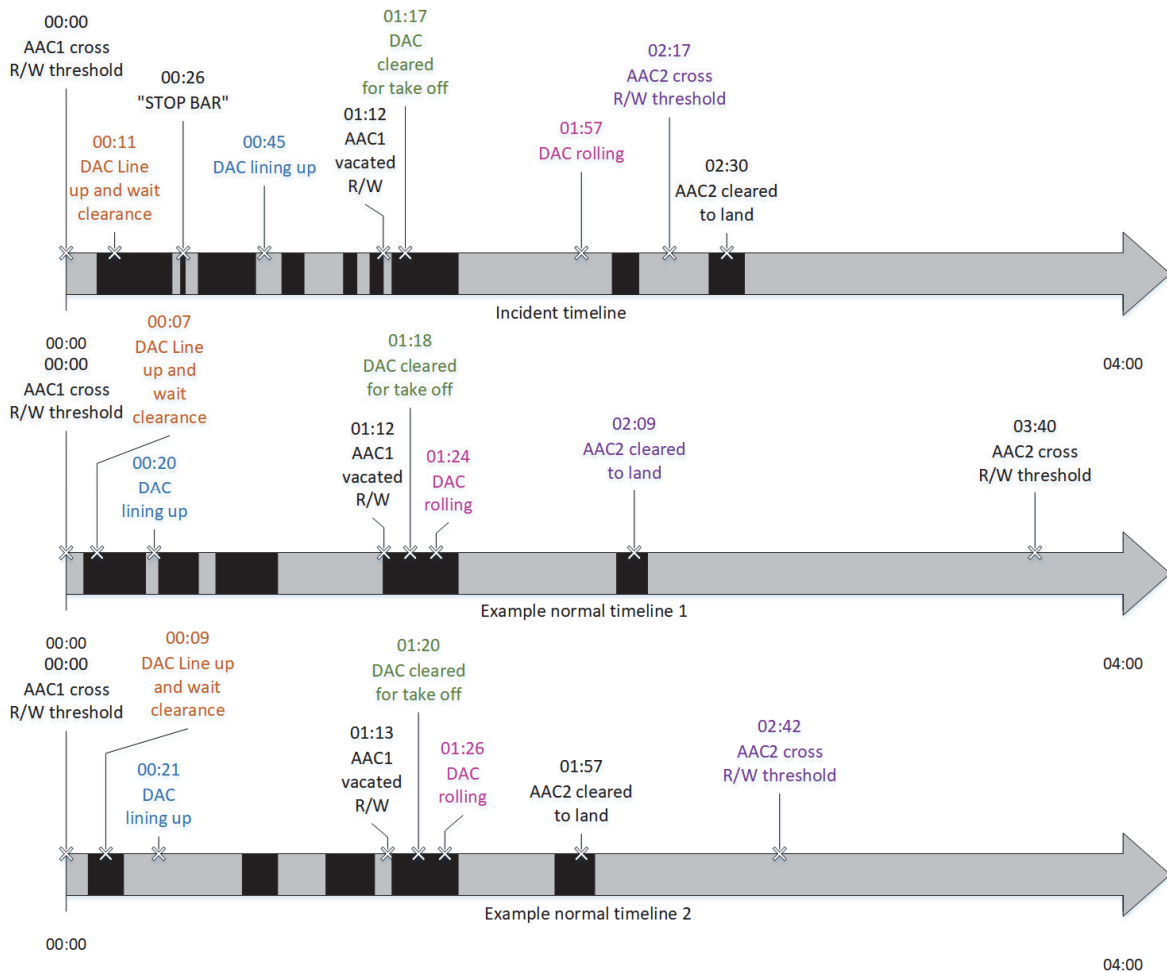
Figure 7

Incident timeline compared to normal examples

The comparison shows three significant timeline differences between the incident and the two normal examples:

- In the incident example, the approach speed of EI-FJW resulted in the aircraft arriving at the runway threshold quicker than in the examples.
- In the normal examples, the time between line up clearance being issued and starting to line up was 12 to 14 seconds as opposed to 34 seconds in the incident.

- In the normal examples, the time between receiving takeoff clearance and starting the takeoff roll was six seconds compared to 40 seconds in the incident.
