## Serious incident between the Bombardier CRJ700 registered F-GRZG and the Boeing 717-200 registered EI-EXB

on 12 April 2019

at Strasbourg Entzheim airport (Bas-Rhin)

### Immediate departure, low-level missed approach, near collision

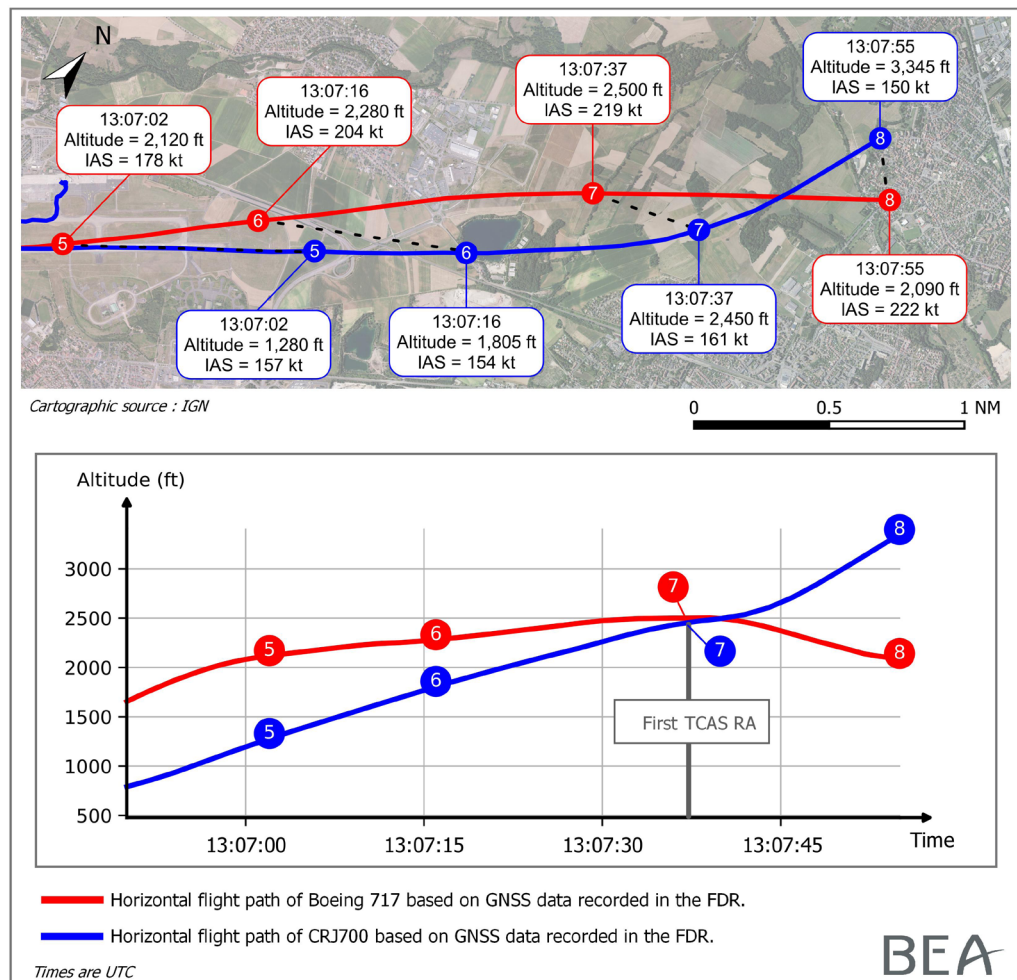
Figure 3: paths of the Boeing 717 (red) and the CRJ700 (blue)

The LOC controller asked (point ⑤ Figure 3) the crew of CRJ700, at an altitude of 1,300 ft and climbing to 6,000 ft to directly turn left towards MIRGU, the last standard instrument departure point (SID)<sup>(5)</sup>, and the crew of the Boeing 717, at an altitude of 2,300 ft and climbing to 2,500 ft, to immediately turn right to heading 050° (point ⑥ Figure 3). The CRJ700 started turning at 2,100 ft. The horizontal and vertical separations between the aeroplanes were respectively 0.6 NM and 300 ft. The speed of the Boeing 717 was 60 kt higher than that of the CRJ700. The LOC controller asked the crew of the CRJ700 to stop climbing at 2,000 ft. The PM of the CRJ700 asked him to repeat the instruction. The CRJ700 flew through 2,400 ft and was climbing with a vertical speed of around 1,300 ft/min and the Boeing 717 was stable at 2,500 ft. At the same time, the TCAS of the two aeroplanes transmitted traffic advisories (TA). The LOC controller replied to the PM of the CRJ700 by telling him to immediately stop climbing at 2,000 ft. A second later, resolution advisories (RA) were generated on board each plane: MAINTAIN CLIMB for the CRJ700 and DESCENT for the Boeing 717 (points ⑦ and ⑧ Figure 3). The horizontal and vertical separations between the two aeroplanes were respectively 0.40 NM and 50 ft. The resolution advisory (RA) of the CRJ700 was reinforced to INCREASE CLIMB and the PF increased the rate of climb. Five seconds later, the separations were 0.28 NM and 95 ft. The minimum horizontal distance between the two aeroplanes of 0.17 NM was reached five seconds later with a vertical separation of 500 ft.

At 13:07:55, the path conflict had ended and the two crews continued their flights (points ⑧ and ⑧ Figure 3).
