Final Report

IN-063/2019

Incident involving an AIRBUS A320-214, registration EI-IKL, operated by ALITALIA, and a BOEING B737-8AS, registration EI-ENN, operated by RYANAIR, 58 NM east-southeast (ESE) of the Madrid-Barajas Airport (SPAIN) on 7 September 2019

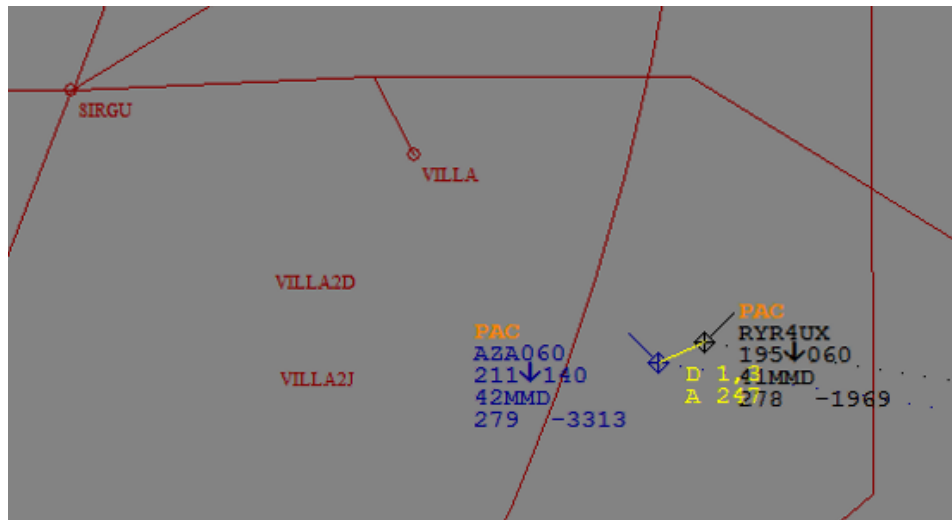
Fig. 12 Palestra image for 13:59:36

At the same time, AZA060 was en route to ASBIN point (IAF) at FL211 and descending to FL140 at a rate of descent of -3313 fpm. RYR4UX was en route to the same point at FL195 and descending to 6000 ft at a rate of descent of -1969 fpm. The two aircraft were 1.3 NM and 1600 ft apart. It was at this time that the STCA-PAC alert was issued.

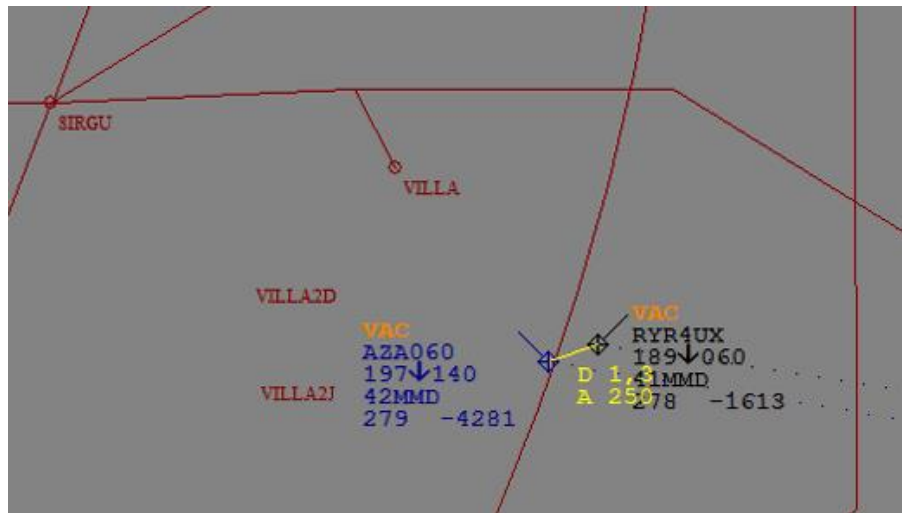
Fig. 14 Palestra image for 13:59:55

At 13:59:55, AZA060 was en route to ASBIN point (IAF) at FL197 and descending to FL140 at a rate of descent of -4281 fpm. RYR4UX was en route to the same point at FL189 and descending to 6000 ft at a rate of descent of -1613 fpm. The two aircraft were 1.3 NM and 800 ft apart. It was at this time that the STCA-VAC alert was issued.

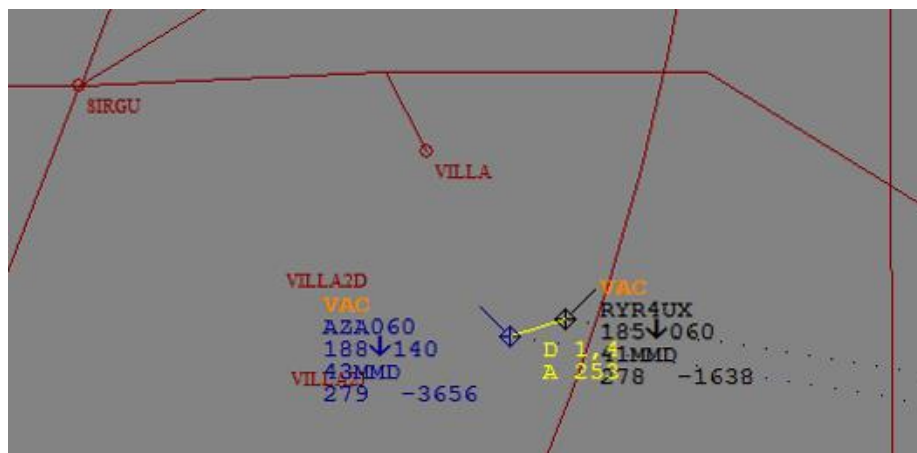
Fig. 15 Palestra image for 14:00:12

At 14:00:12, AZA060 was en route to ASBIN point (IAF) at FL188 and descending to FL140 at a rate of descent of -3656 fpm. RYR4UX was en route to the same point at FL185 and descending to 6000 ft at a rate of descent of -1638 fpm. The two aircraft reached their closest point of approach, 1.4 NM and 300 ft apart. The STCA-VAC alert remained active.

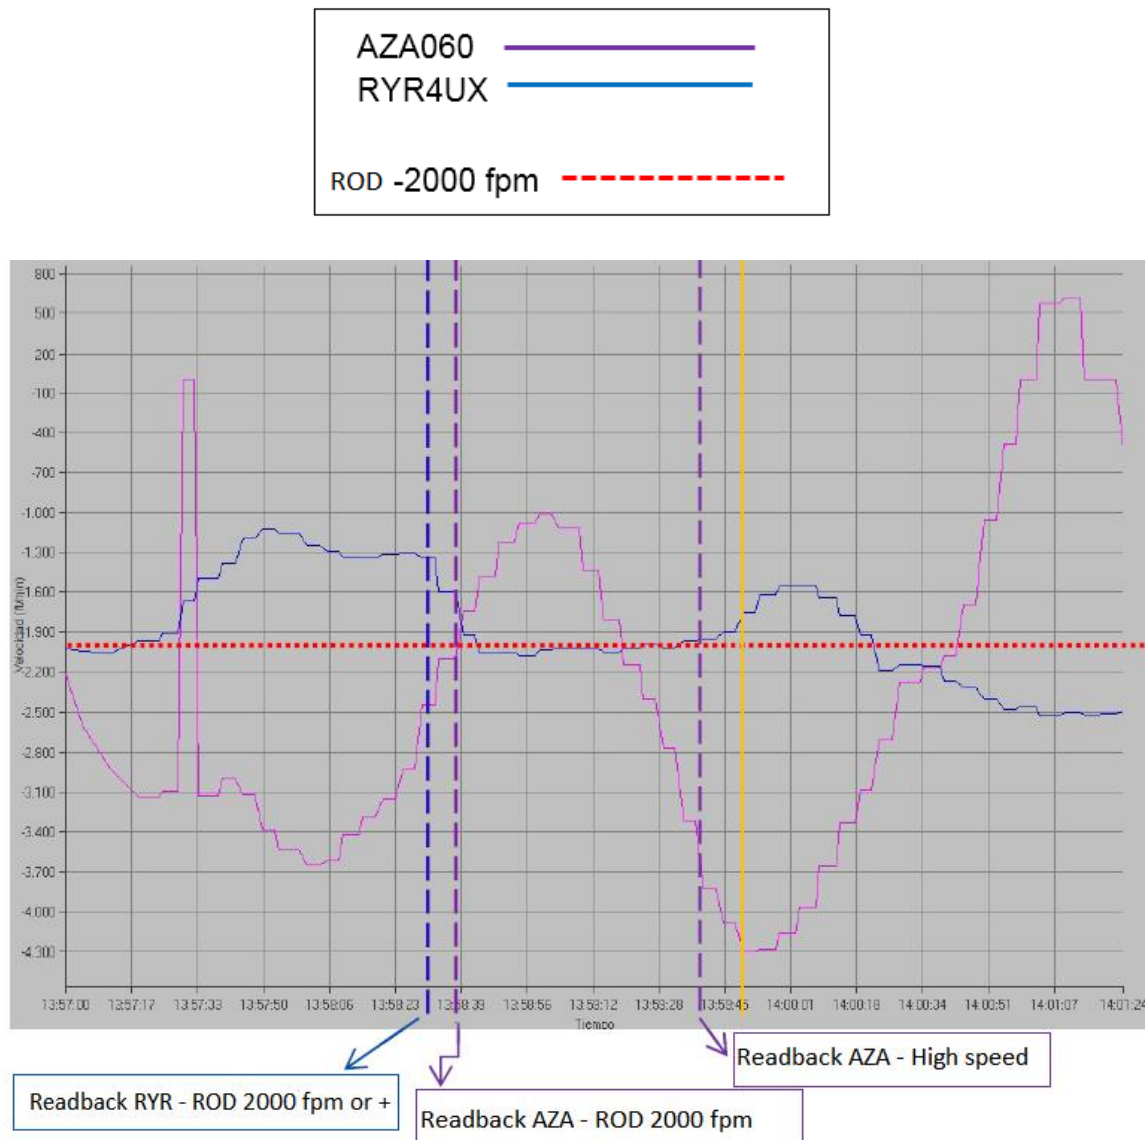
Fig. 26 Graph of rates of descent (ROD) of the two aircraft between 13:57:00 and 14:01:24

The graph shows that the rates of descent instructed by the controller, and readback by the crews, were not adhered to satisfactorily by the crews.
