*Accident
which occurred
on 30 January 2000
in the sea near Abidjan Airport
to the Airbus 310-304
registered 5Y-BEN
operated by Kenya Airways*

REPORT

This report presents the conclusions of the Commission of Inquiry on the circumstances and causes of the accident that occurred on 30 January 2000 in the sea near Abidjan airport to the Airbus 310-304 registered 5Y-BEN operated by KENYA AIRWAYS, which was undertaking the Abidjan - Lagos -Nairobi flight KQ 431.

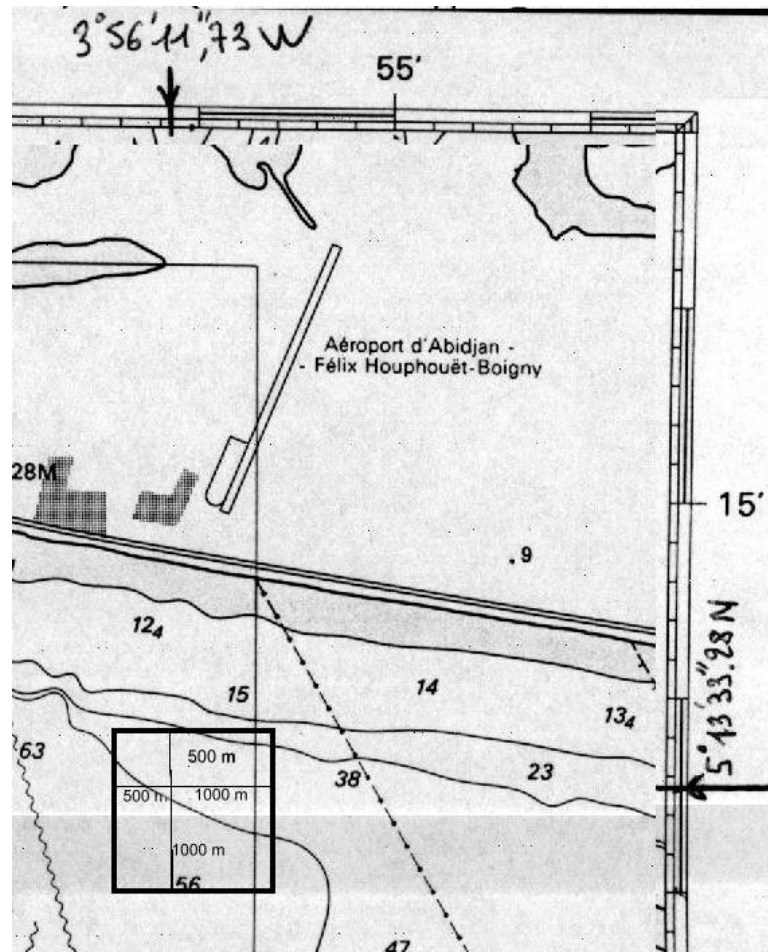
The 1.5 square on the site plan above corresponds to the wreckage search area. The inner rectangle delineates the area where most of the debris was found.

The detail on the wreckage distribution map, within the rectangle, gives the dimensions of the debris as identified during the sonar location phase (appendix 8).

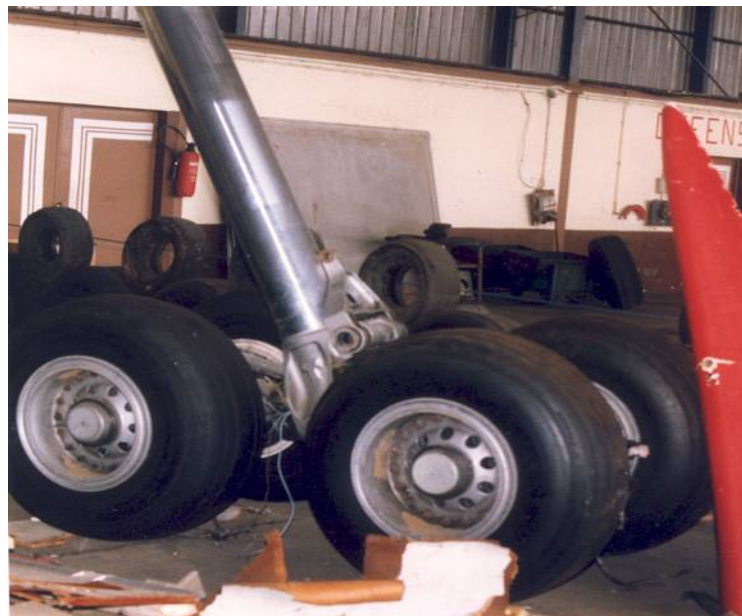
Train d'atterrissage repêché

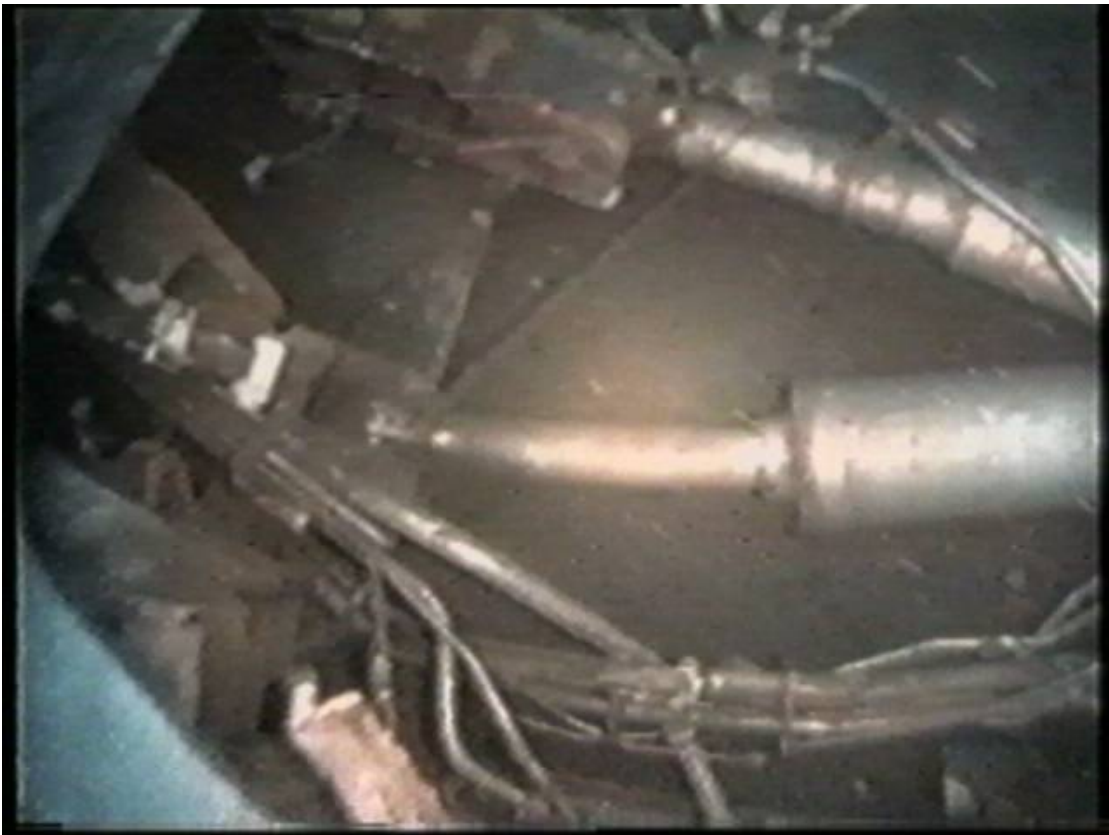
- the landing gear shock absorber that was twisted and in extended position;
- the flap actuator screw jack in the 15° position;
- a slat guide rail broken on the side where it was connected to the wing;
- the elevator actuator screw jack in a 1.2° nose up trim position;
- the fan blades on one engine severely damaged ;
- the second engine observed in two parts;
- on the cockpit center console, spoiler levers in the armed position (raised and locked).

Amortisseur du train d'atterrissage

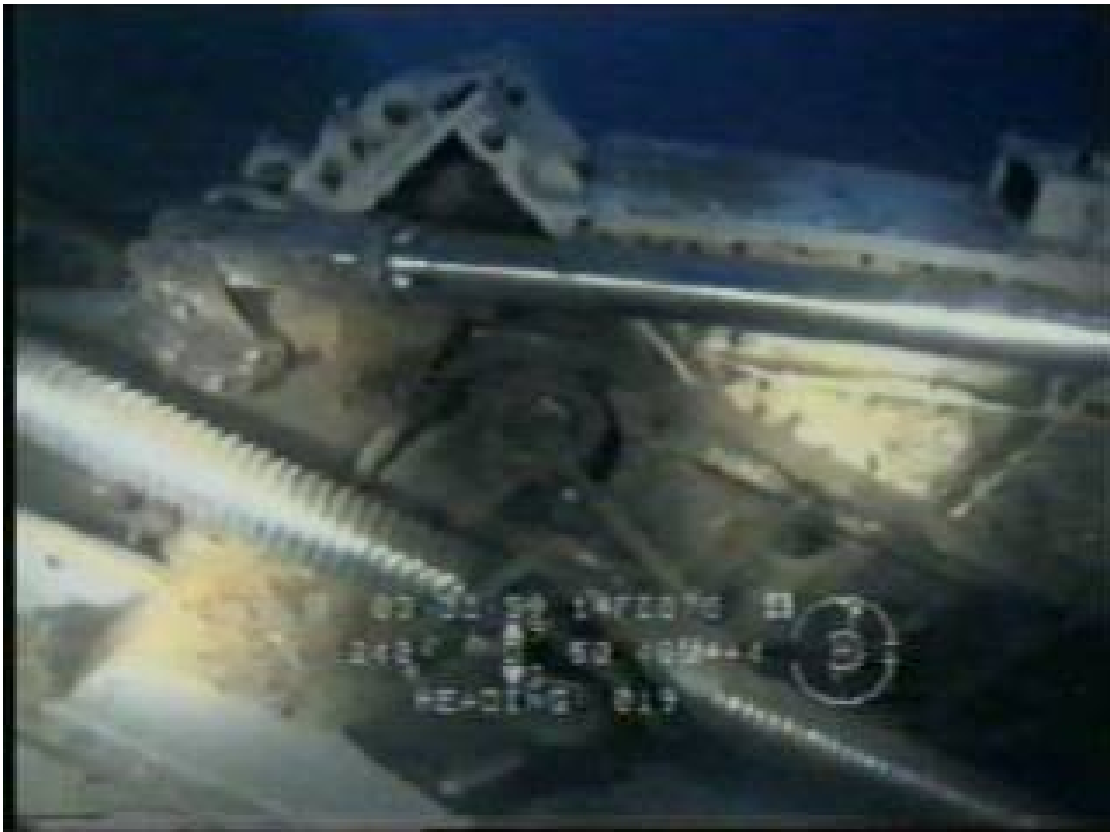
Vis de vérin de volets

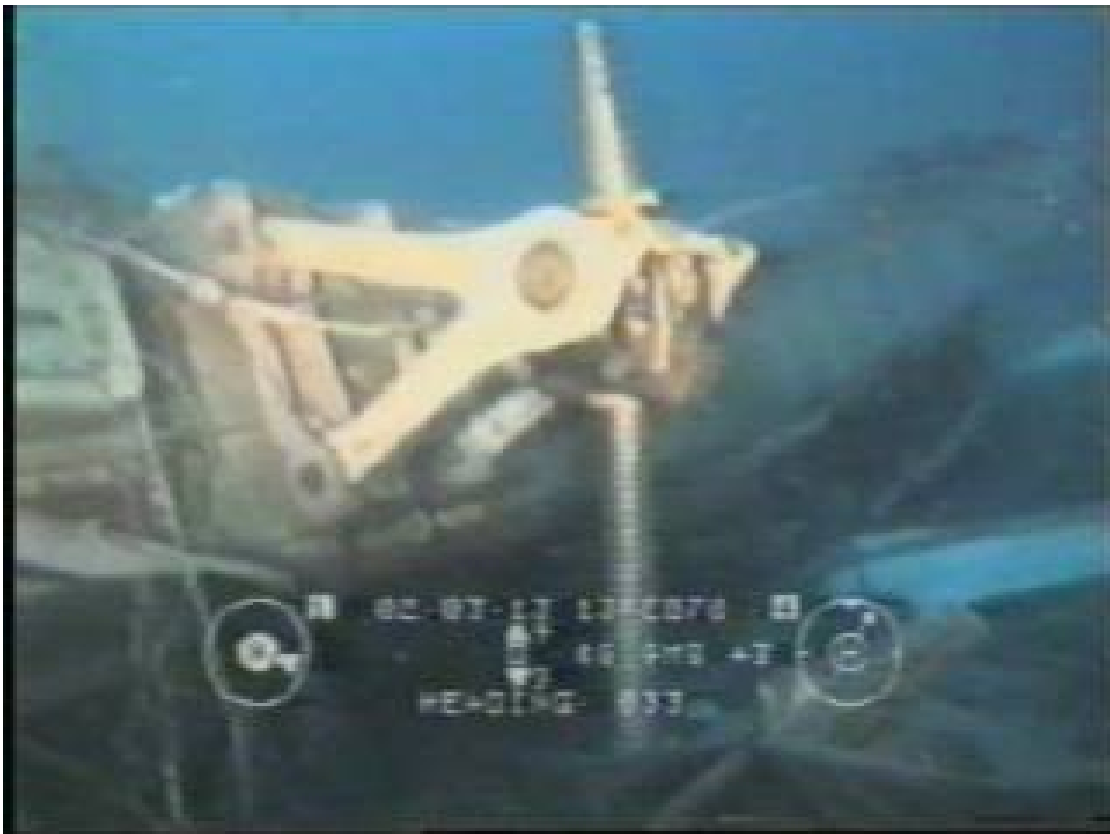
Vis de vérin du plan horizontal réglable

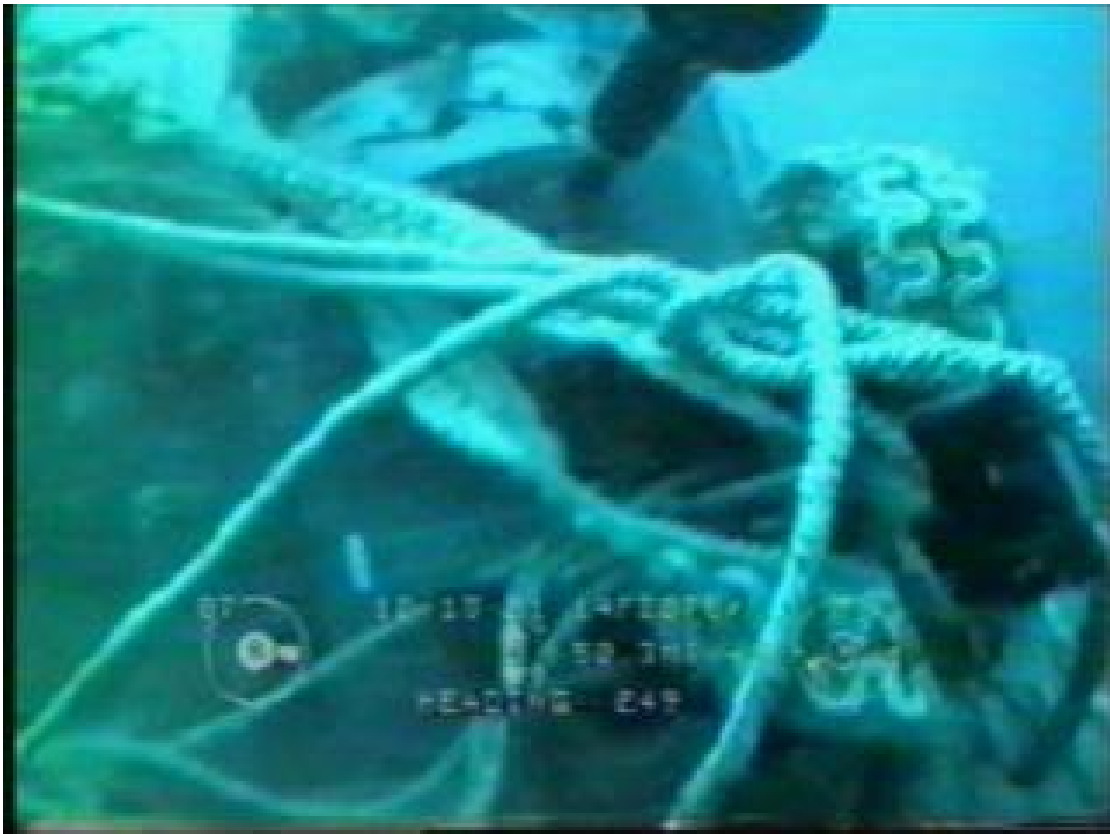
Console centrale du cockpit

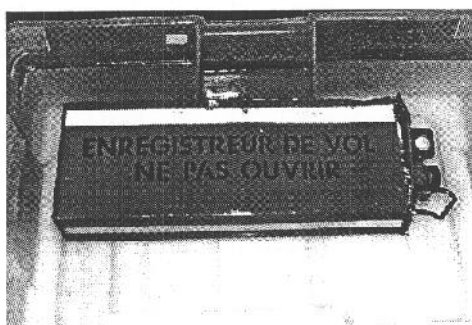
The recorder was transported in water to minimize oxidation. It was found to exhibit slight impact damage to the outer casing and face plate (Figure 1). The recorder was rinsed with fresh water and disassembled in order to remove the tape medium. The internal crash protected memory module and the tape medium were found to be in pristine condition (Figures 2 and 3). There was no corrosion damage to the recording.

Figure 1: FDR as received

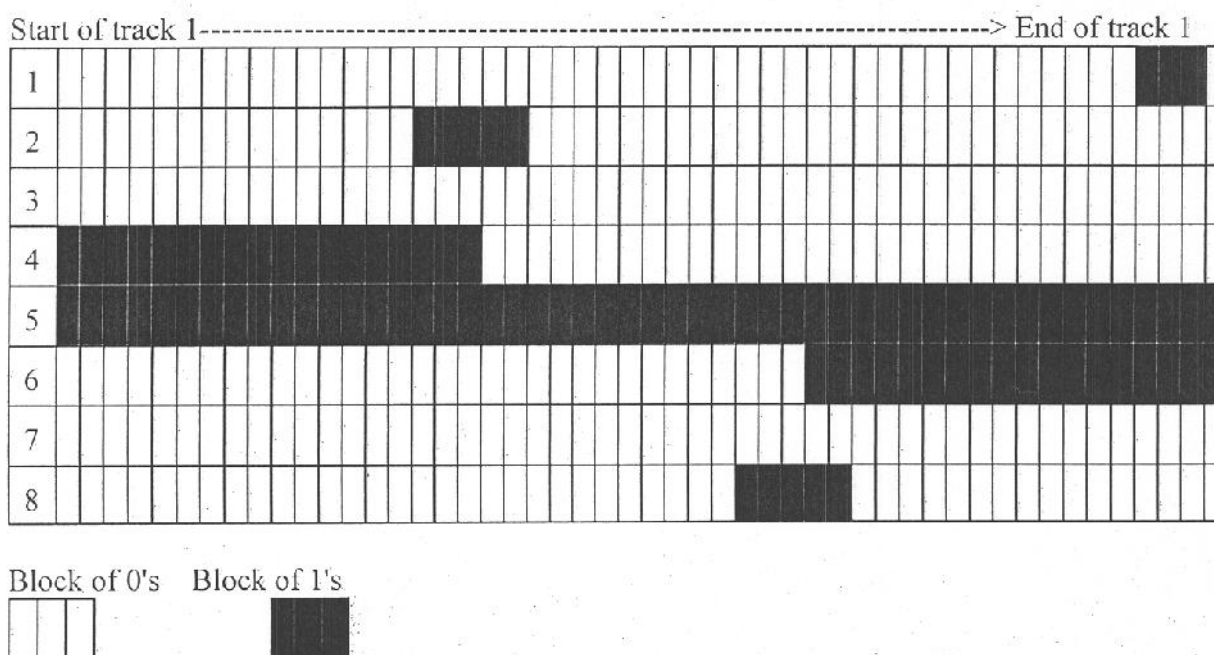
Figure 4 depicts the relative percentage of blocks of 'ones' and/or 'zeros' on each of the eight tape tracks. It should be noted that for odd tracks (1, 3, 5, 7), the recording proceeds from left to right (i.e. forward). For even tracks (2, 4, 6, 8), the recording proceeds from right to left (i.e. reverse). Data is recorded onto each track in sequence, starting on track 1 in the forward direction. At the end of track 1, the recording switches to track 2 and records in the reverse direction. At the end of track 8, after approximately 25 hours of data is recorded, the recording switches back to track 1 and the process repeats, overwriting the previous data. A large section of 'ones' was found, starting near the 2/3 point of reverse track 4, continuing for the entire forward track 5, and then changing to 'zeros' about 1/3 into reverse track 6.

Figure 4: Percentage of tape that contained blocks of 'ones' and/or 'zeros'

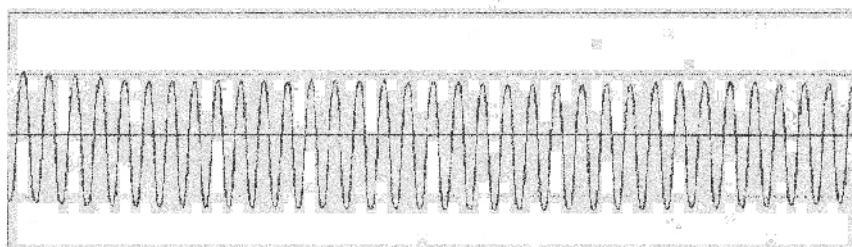
Decoding of the recorder revealed that tracks 1, 2, 4, 6 and 8 contained a steady stream of digital 'zeros', with occasional steady streams of digital 'ones'. Tracks 3 and 7 contained only digital 'zeros' and track 5 contained only digital 'ones'. No synchronization codes nor valid data were found, which typically consists of an alternating pattern of 'ones' and 'zeros'.

Figure 6: Sample pattern of 'zeros' from accident FDR

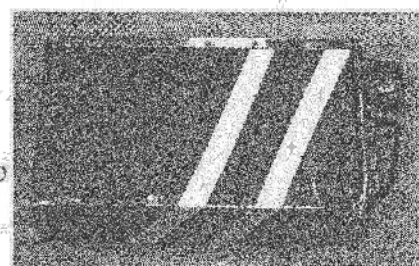
The recorder was transported in water to minimize oxidation. Some impact damage was observed to the outer casing and face plate (Figure 7). The recorder was rinsed with fresh water and disassembled in order to remove the CVR tape. The tape medium was found to be in pristine condition with no corrosion damage. The tape was originally played back on an open reel tape deck at the normal speed of 1 7/8 inches per second using 400 hz AC power. A comparison of the CVR communications with the identical communications recorded on the ATS tape indicated that the original playback speed was too slow, requiring a 1.23% increase in speed. This was considered due to a slight difference between the playback speed

Figure 7: CVR as received
