### Final report on aircraft serious incident

Case no.: **18-104F018**

Date: **16. June 2018**

Description: **Foreign Object Damage**

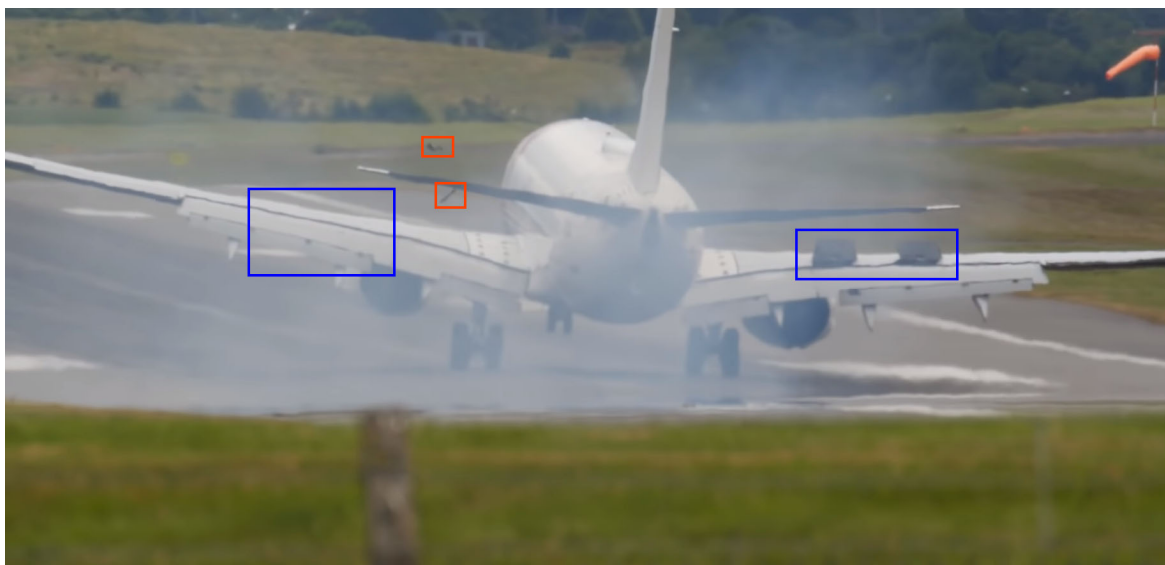
before it also came down on the LH MLG followed by the NLG. During the landing, the left wing ground spoilers did not deploy. In addition tire debris was released from the LH MLG after it touched down on the runway.

**Figure 3: Spoilers on Left wing did not deploy (blue) and tire debris flying (red)**

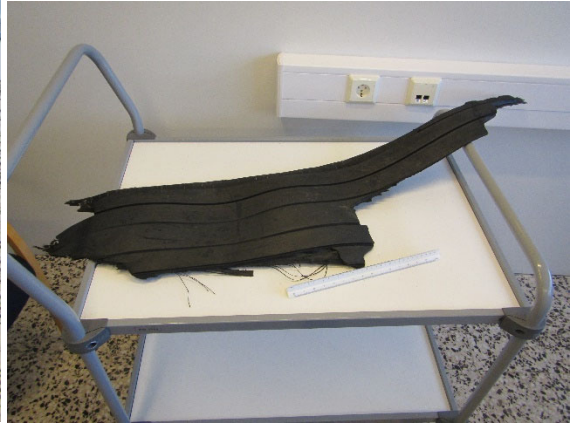
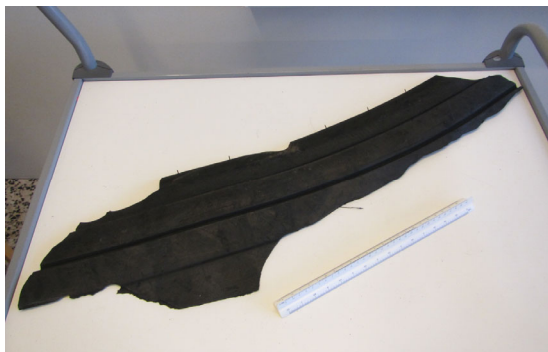
**Figure 7: Tire rubber debris found at Keflavik Airport after the takeoff**

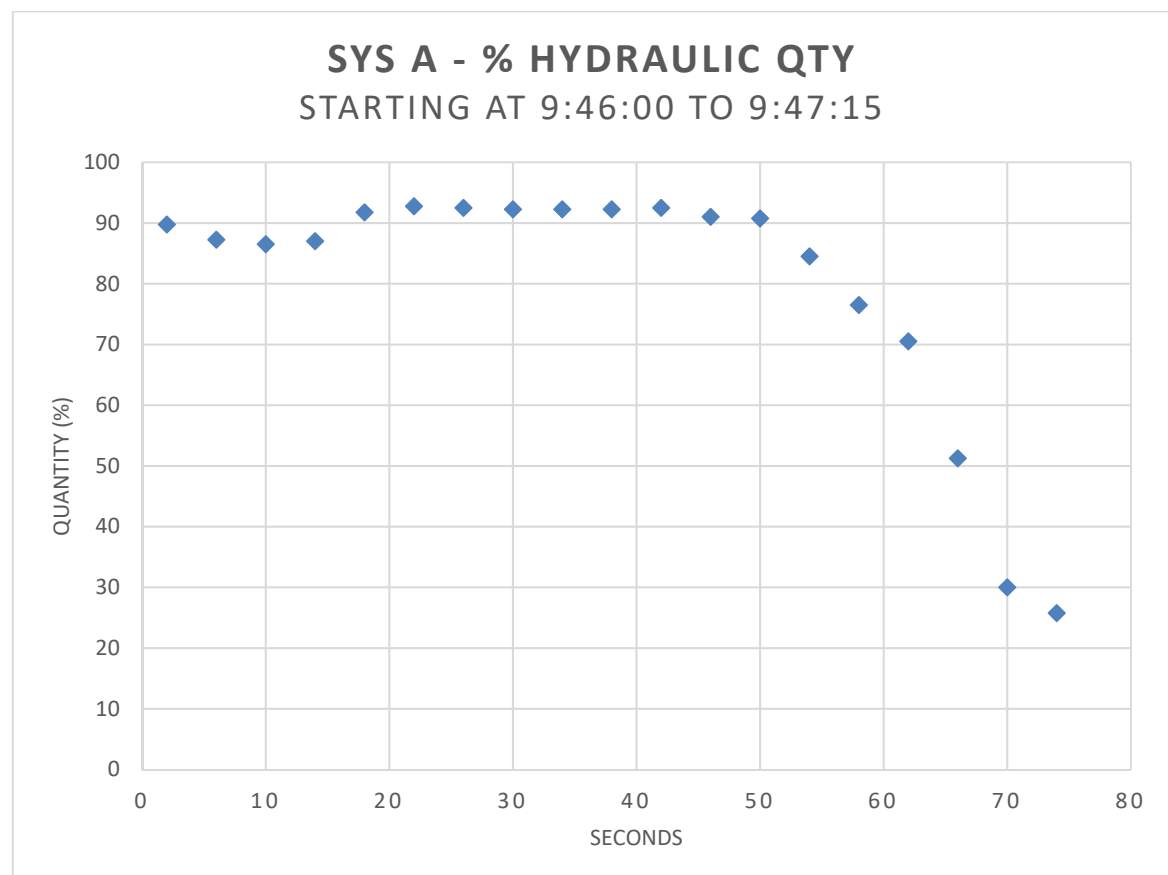
The analysis of the flight recorders confirmed that hydraulic system A started to loose hydraulic quantity at 9:46:50.

**Figure 8: Hydraulic system A leakage started at 9:46:50**

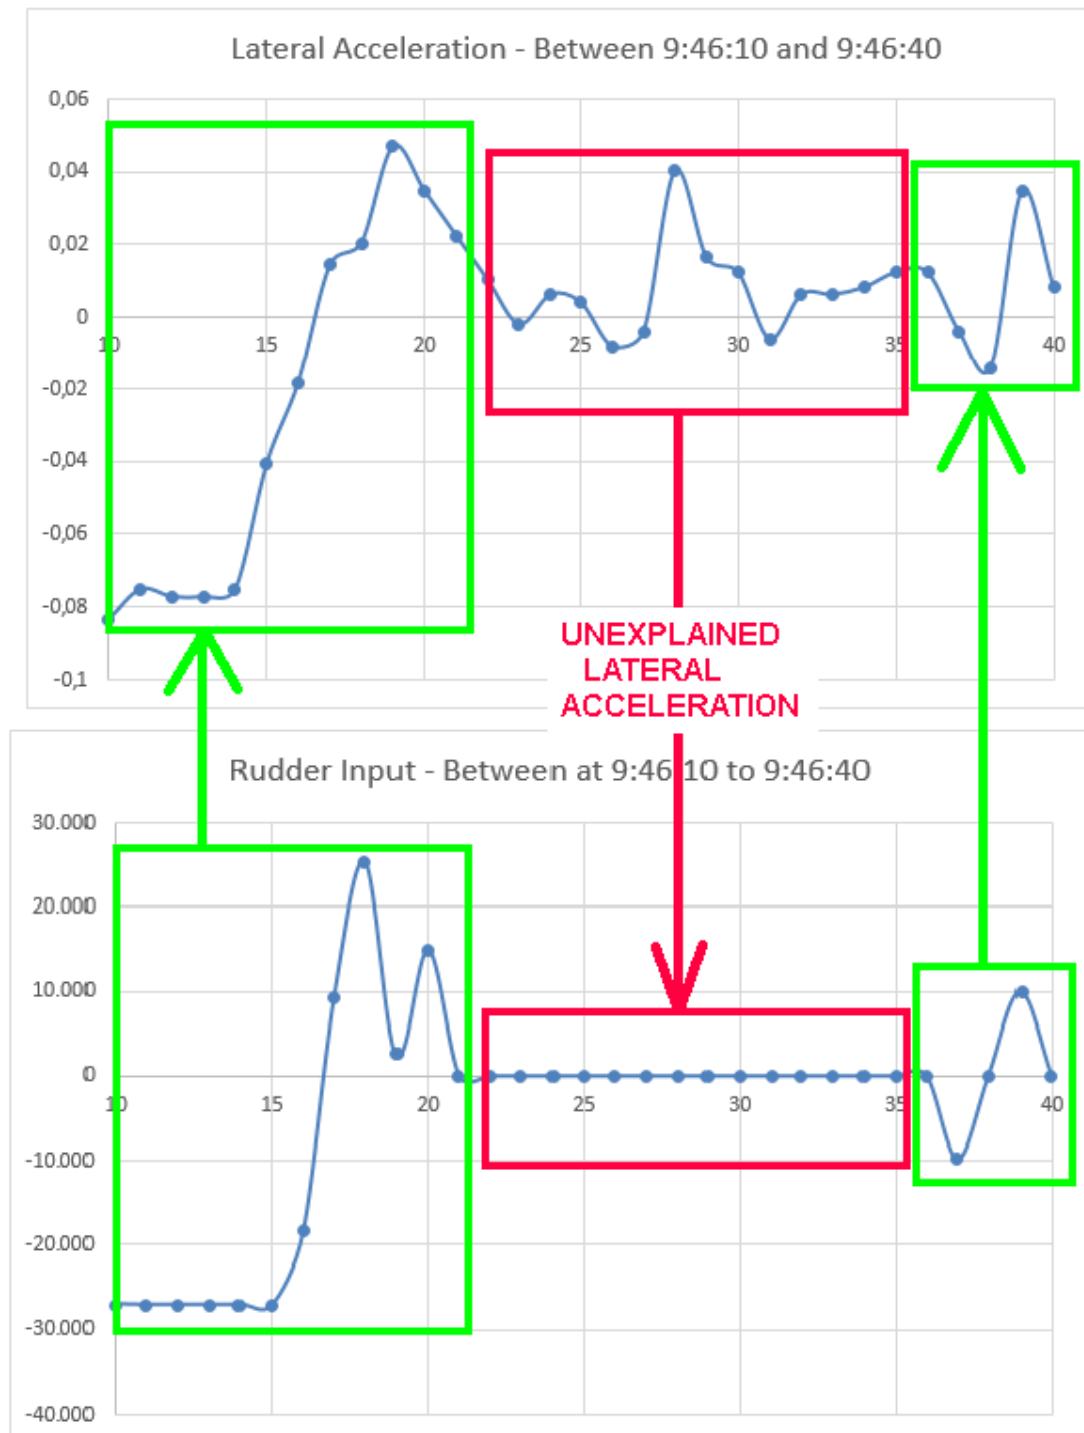
The rudder input explained some of the lateral acceleration (seen in green in Figure 14). It could however not explain the lateral acceleration in the area where the debris was located between taxiway S-2 and high speed RWY taxiway A-1 (seen in red in Figure 14).

**Figure 14: Unexplained lateral acceleration as the aircraft passed the area of the debris**

The ITSB believes that a tire rupture by debris on the runway may have caused the lateral acceleration in the red box in Figure 14.

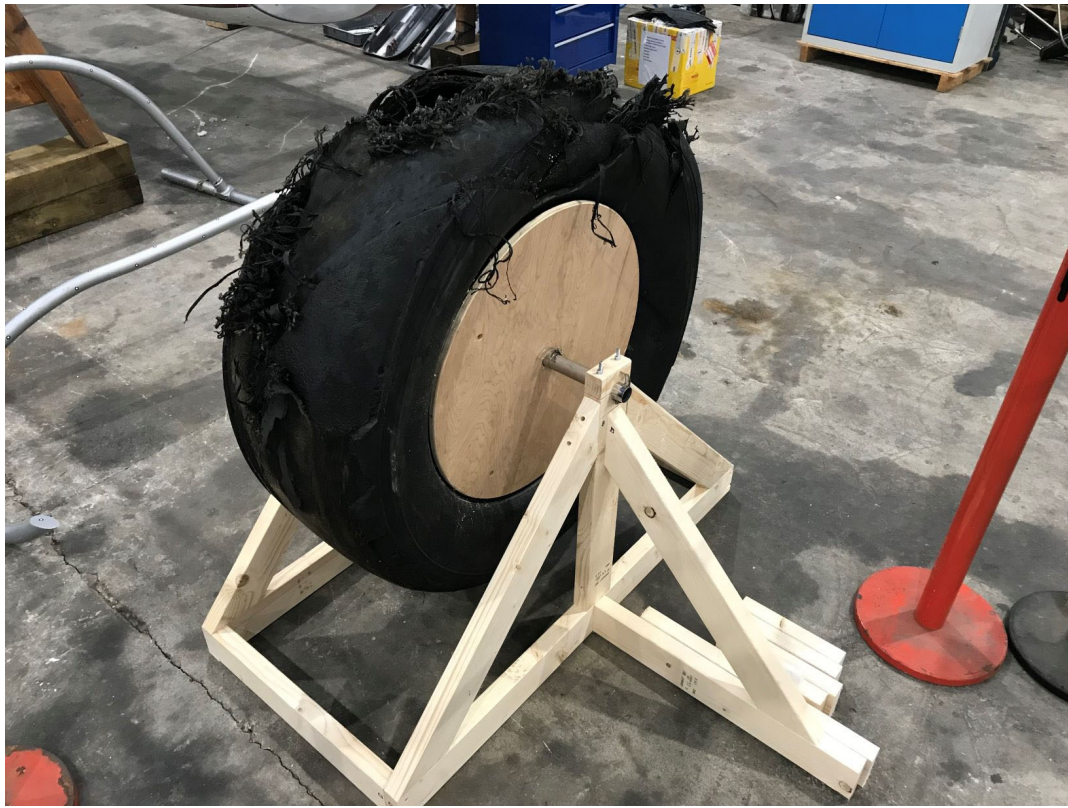
**Figure 15: Tire and tire debris reassembled in a jig**

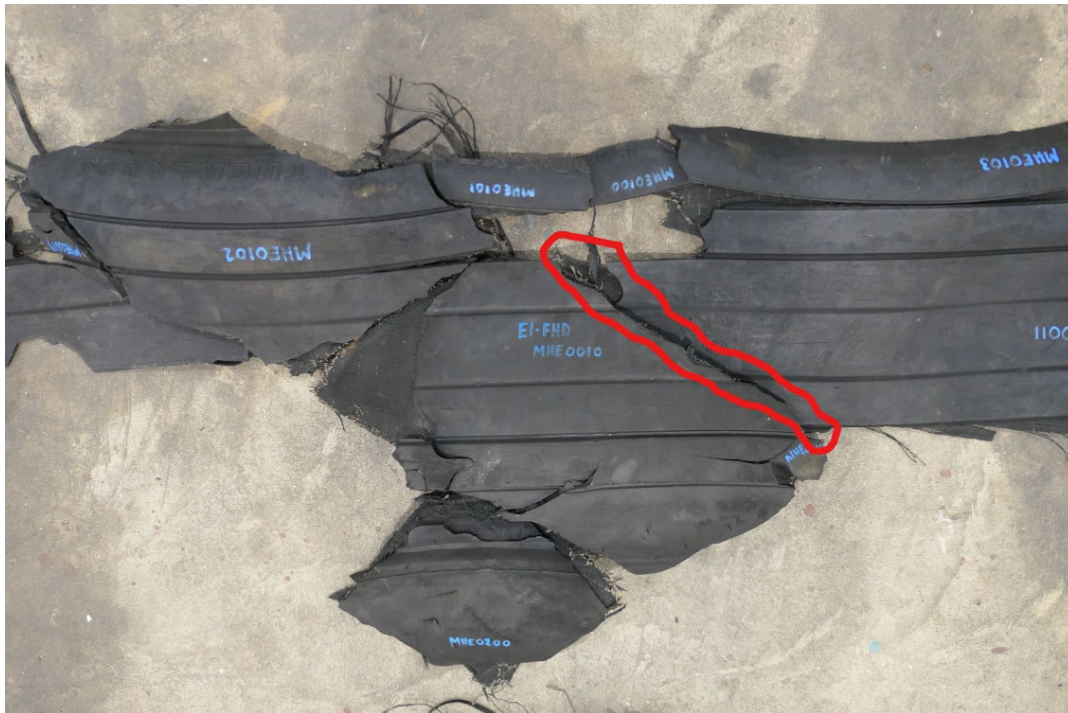
**Figure 16: Probable initial failure – Recovered from landing gear wheel well**

Investigation of the tire debris revealed the probable initial failure to have occurred by Foreign Object Damage (FOD).

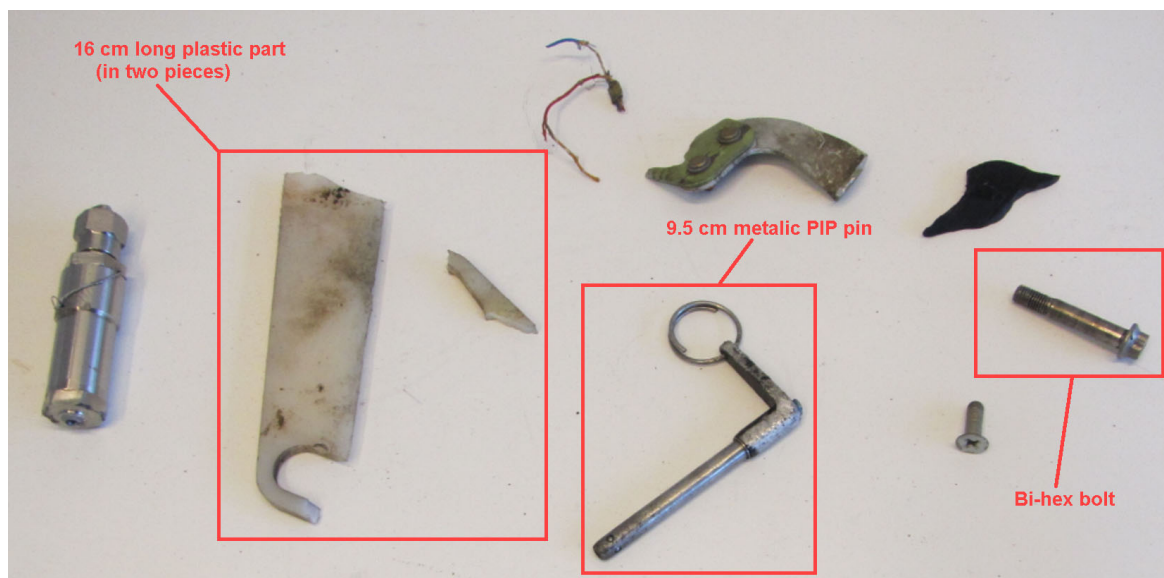
- 16 cm long plastic part (in two pieces)
  - The ITSB could not identify this plastic part
- 9.5 cm long metallic PIP pin
  - The ITSB could not identify this PIP pin as part of the aircraft
- Bi-hex bolt
  - The ITSB could not identify this bi-hex bolt as being missing from the aircraft

**Figure 18: Unidentified objects shown in red boxes**

Review regularly the FOD program and procedures associated, to ensure that runways are as far as possible clear of debris.
