***Final report RL 2012:20e***

**Serious incident involving the aircraft EI-DAD  
at Skavsta Airport, Södermanland county,  
on 25 April 2011**

Case L-30/11

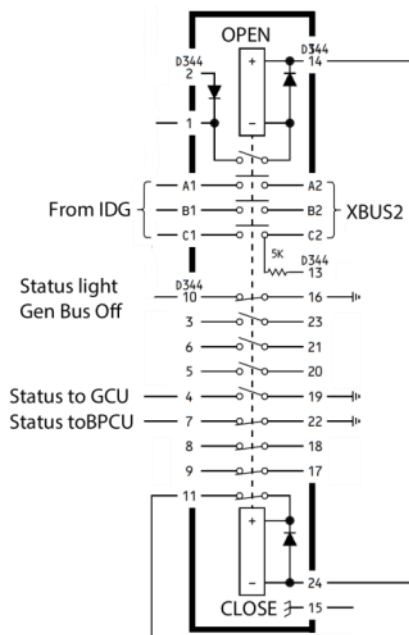
Fig. 11. The breakers GCB2. Connections 1 and 11 are control current to the electromagnets.

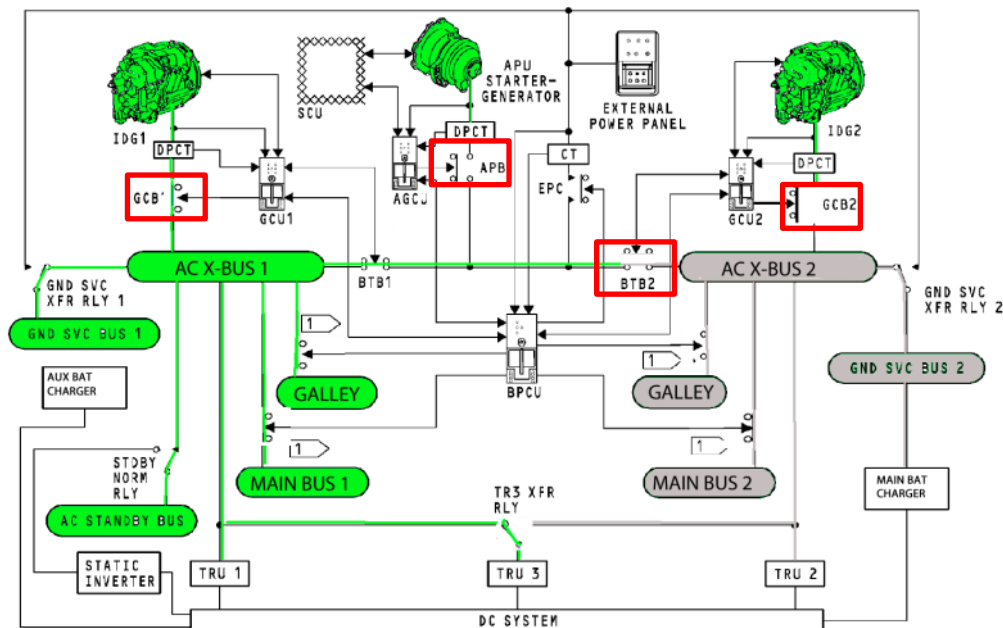
The system was at this point unpowered at X-bus2 and its subsystem, which is explained by both BTB2 and GCB2 being open – see Figure 20.

Fig. 20. Electrical system with open BTB2 and GCB2 or APB, which was the situation in the incident.

It can be established that GCB2 did not close and connect IDG2. When X-bus2 lost electrical power, BTB1 and BTB2 should have closed.

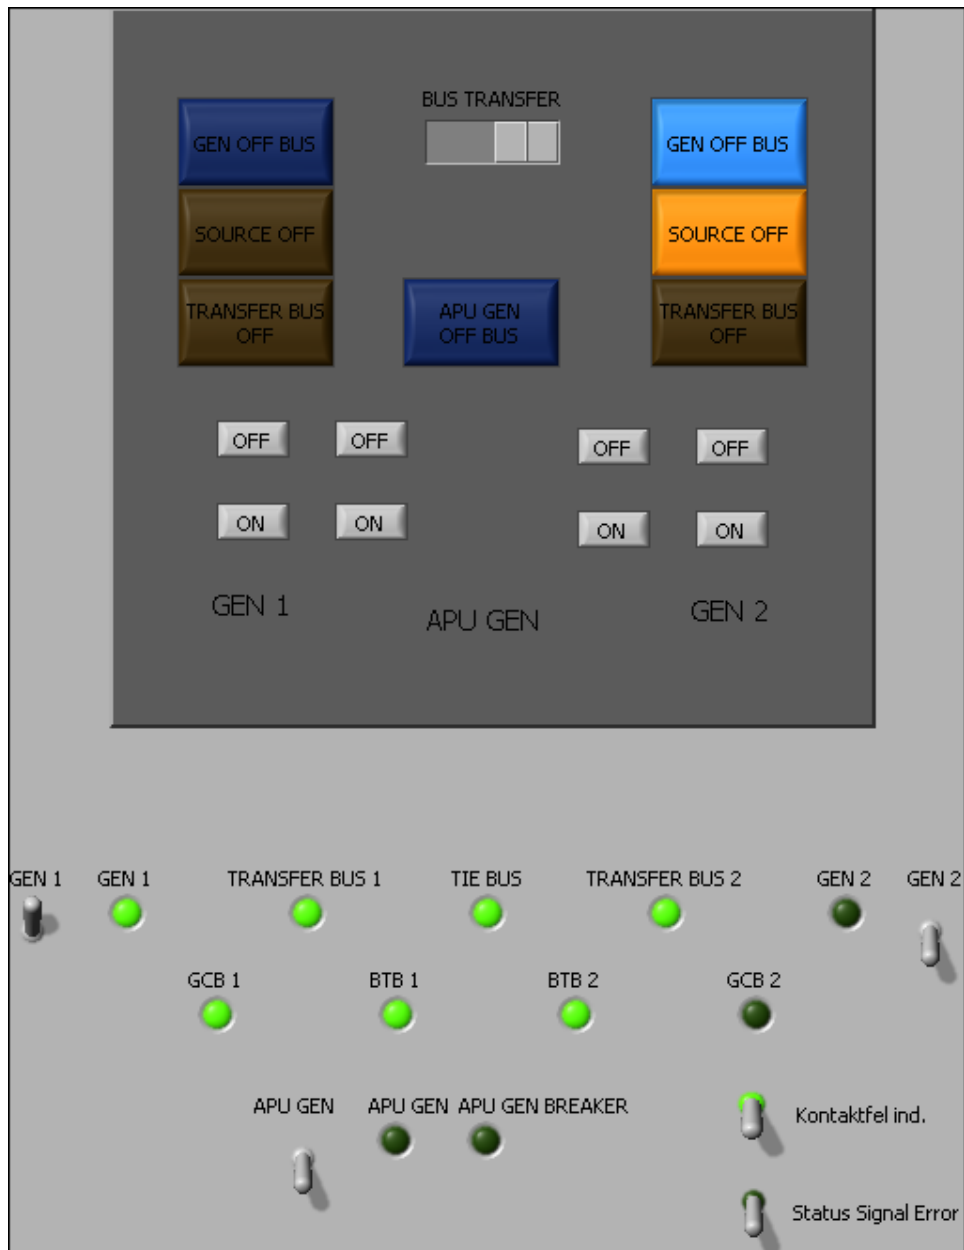
Fig. 22. GUI showing operating conditions when generator 2 has been disconnected from the system

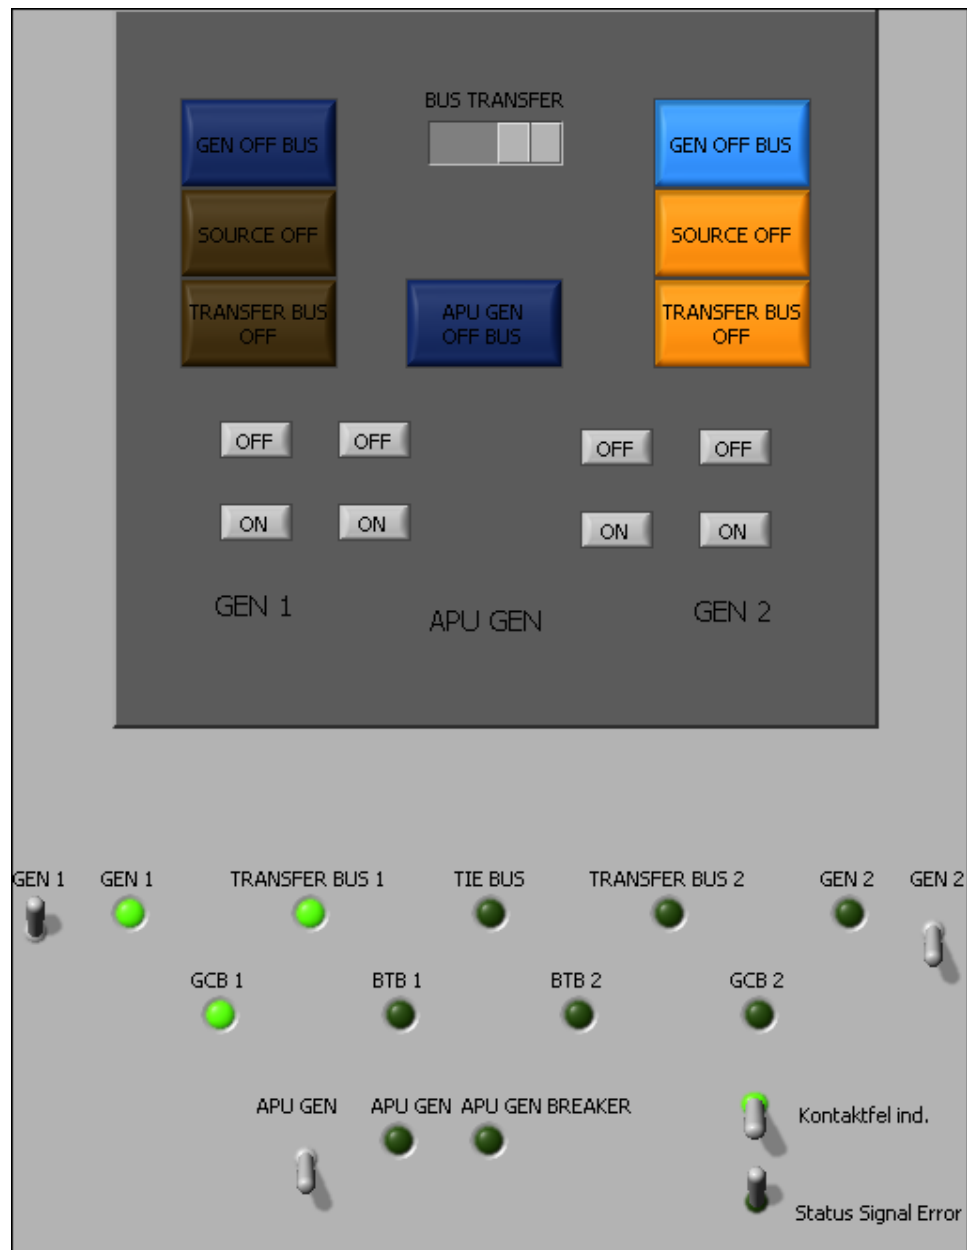
Fig. 23. GUI showing operating conditions when generator 2 has been disconnected from the system and a status signal fault has been introduced to BCB2.

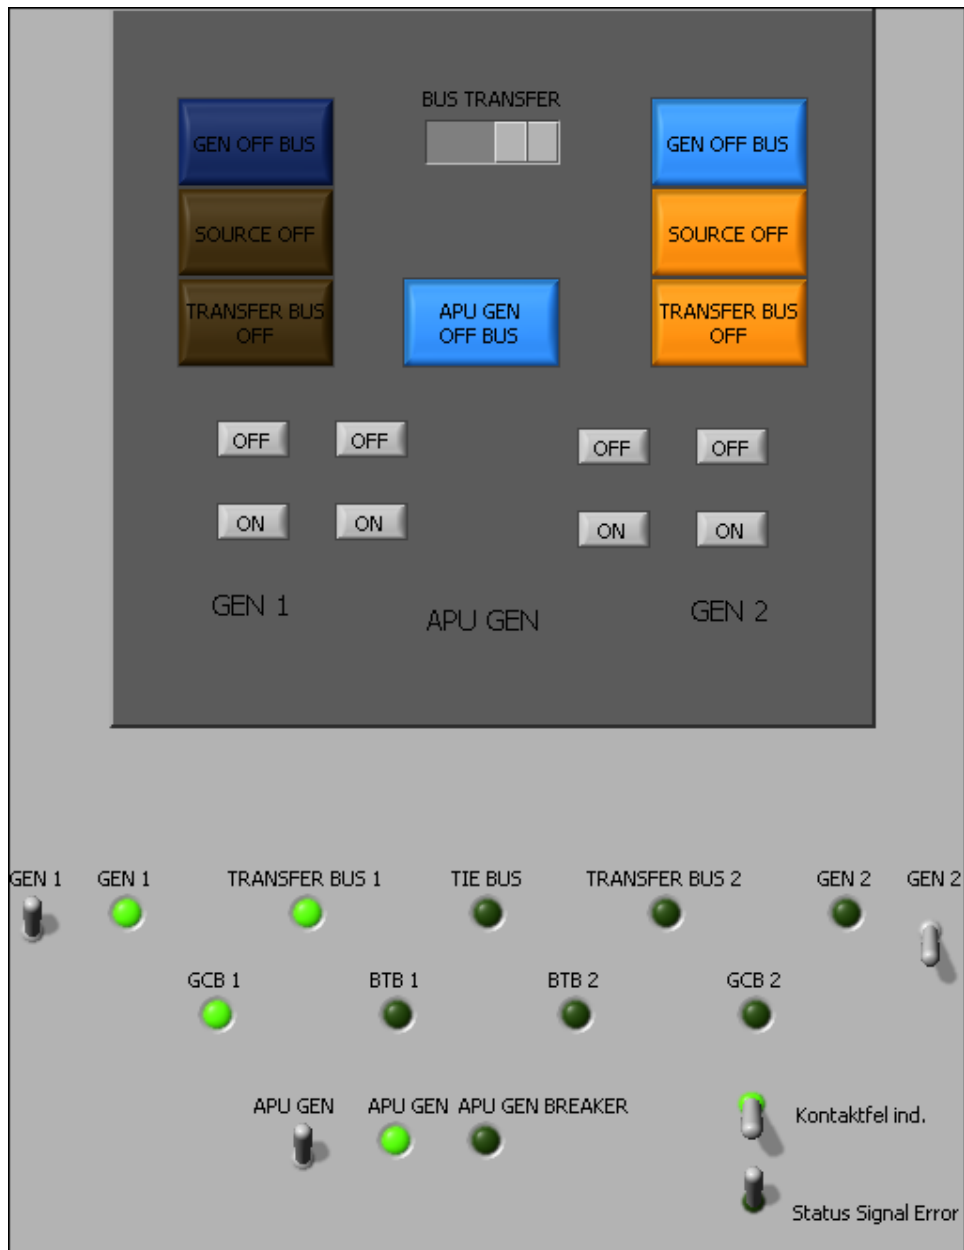
Fig. 24. GUI showing operating conditions when generator2 has been disconnected from supplying current to the system, APU has been started and a status signal fault has been introduced to GCB2.

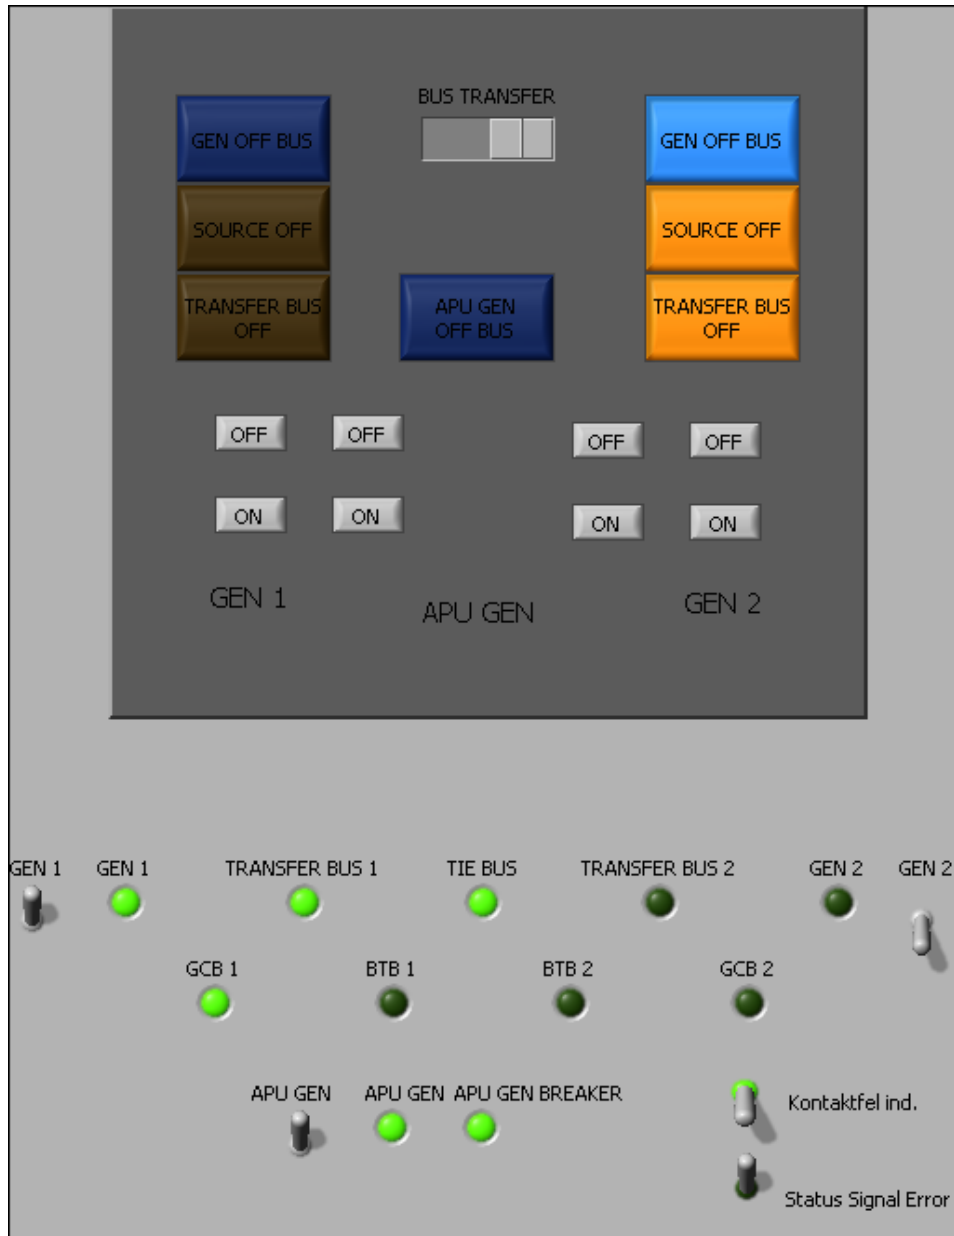
If GCB2 is open but its status signal to GCU2 has the value “not closed”, the system responds with the same symptoms as in the incident. This is confirmed by the analysis and the program run by FOI, and is supported by the incident, in which the connection of the auxiliary contact to GCB was loose.

Fig. 25. GUI showing operating conditions when generator2 has been disconnected from supplying current to the system, APU has been started and connected at the same time as a status signal fault has been introduced to GCB2.
