Final report RL 2012:04e

Aircraft incident to EI-DHG at Skavsta airport, Södermanlands county, Sweden on 11 July 2011

Case L-74/11 2012-02-07

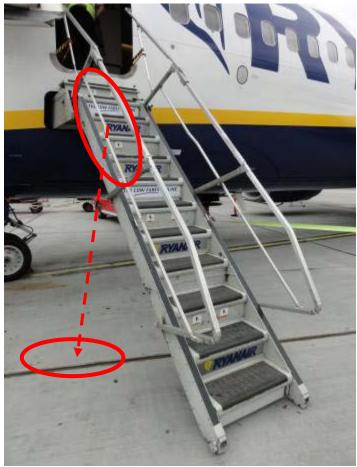
The co-pilot, who was standing at the foot of the stairs facing the aircraft, said that he saw how the four-year old, who was holding the lower handrail, lost his balance and fell feet first out through the gap between the lower handrail and the steps. The mother said that the boy intended to get hold of the lower handrail but lost his balance and fell through the gap between the lower and upper handrails (see fig. 1). The four-year old fell down to the ground, cushioning the fall somewhat with his hands, but his head struck the concrete aircraft parking area. The height of the fall was about 150 cm.

Fig. 1 – Air stair with an illustration of the four-year old's fall.

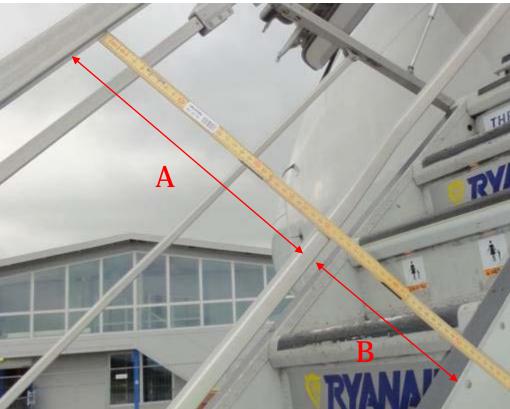
Fig. 2 – Distances between the stairs and the two handrails

The distance between the two handrails (A, see fig. 2) is 29.5 cm. The distance between the steps and the lower handrail (B) is 21.5 cm.

The design of the aircraft stairs would not comply with current recommendations in Swedish construction standards, "Boverkets byggregler", (which do not apply in this case). Since the stairs have to be portable, the design must be considered adequate, providing that the use of the stairs is encompassed by procedures to prevent accidents.

- The design of the stairs is unsuitable for unaccompanied small children.
- The request to escort small children was not comprehended by the parents.

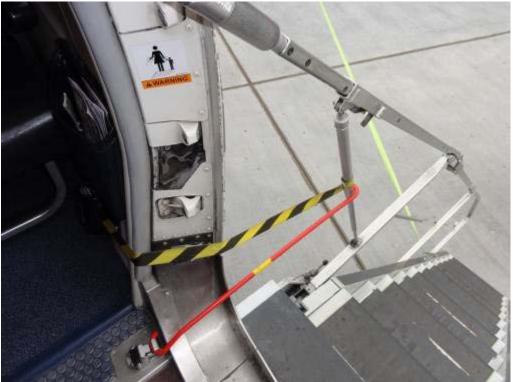
In Great Britain an incident was investigated in 2009 concerning the same type of stair design, where a three-year old fell from the top of the stairs down to the ground. On this occasion there was an opening at the top of the stairs, but after the incident in 2009 the operator, in consultation with TC¹ installed

protection and introduced procedures to ensure that a similar incident could not take place (see fig. 3).

Fig. 3 – The upper part of the aircraft stairs with fall protection installed. Note also the warning sign.

Protection at the upper part of the stairs is fitted by the cabin crew before embarkation or disembarkation is allowed to take place.

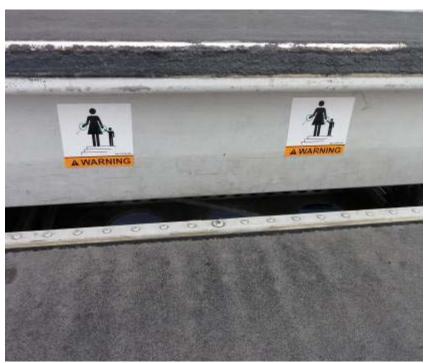
Inside the terminal the passengers are informed by a public announcement to hold children by the hand during embarkation and disembarkation. When passengers stand in front of the stairs warning signs are displayed as shown in fig. 4 on four of the steps going up to the aircraft.

Fig. 4 – Warning signs on the steps. Similar signs are also present inside the aircraft door to be visible to passengers when disembarking.
