# FINAL REPORT

*AAIU Report No: 2003-006*  
*AAIU File No: 2000/0063*  
*Published: 2 May 2003*

**Operator:** Ryanair  
**Manufacturer:** Boeing  
**Model:** 737-204  
**Nationality:** Ireland  
**Registration:** EI-CJH  
**Location:** Dublin Airport  
**Date/Time (UTC):** 3 December 2000, 10.30 hours

As the aircraft taxied onto the active runway in preparation for take-off, the right hand axle of the nose undercarriage leg failed, causing the wheel and axle to separate from the aircraft. There were no injuries or other damage.

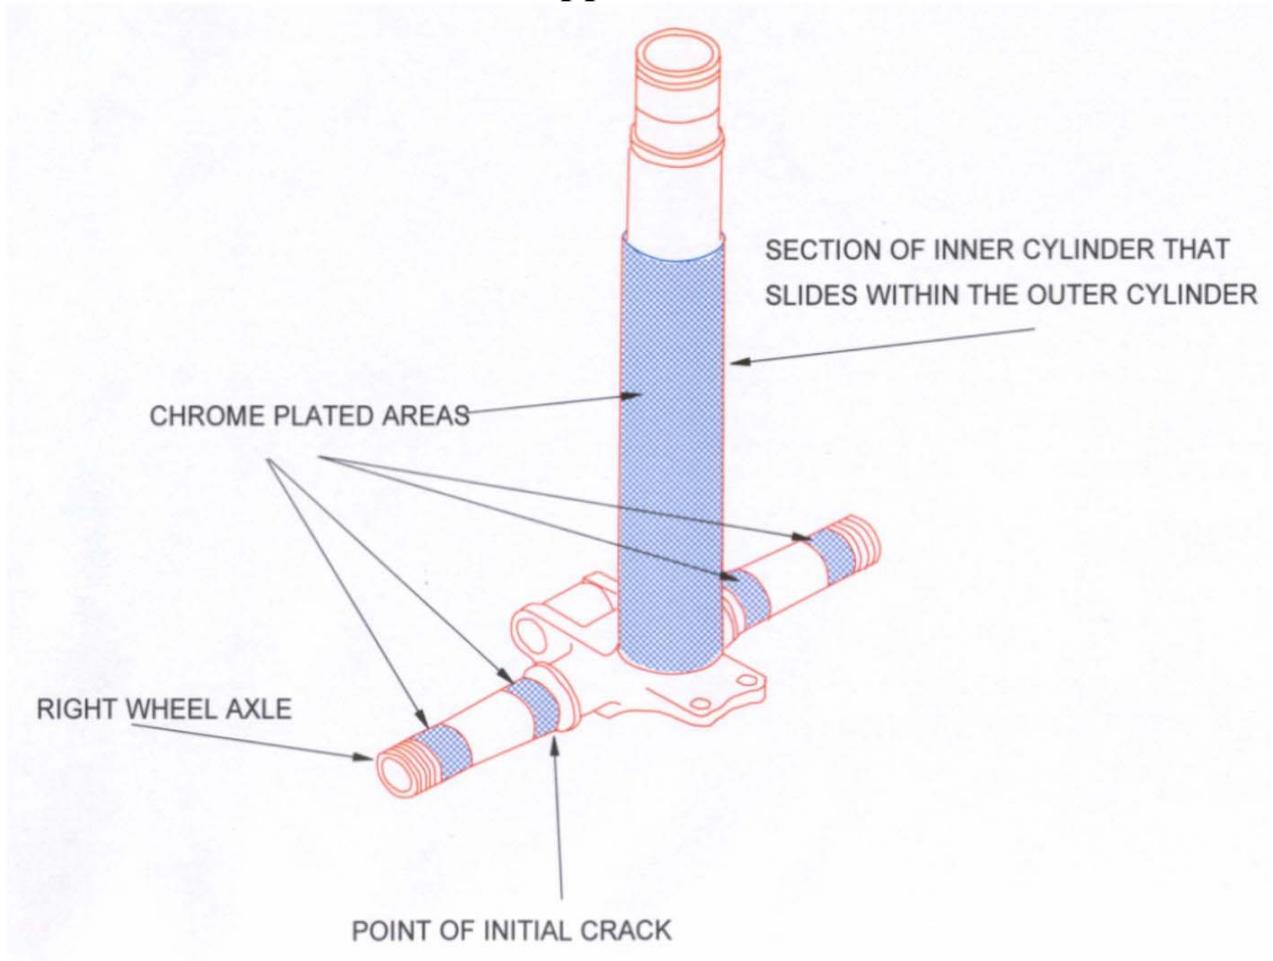
## Appendix A

A preliminary visual inspection of the fracture surface indicated that a crack had originated at the bottom (6 o'clock) portion of the axle (See **Appendix A** and **Appendix B**). Initial visual inspection indicated a crack of a fatigue nature.

SKETCH OF INNER CYLINDER

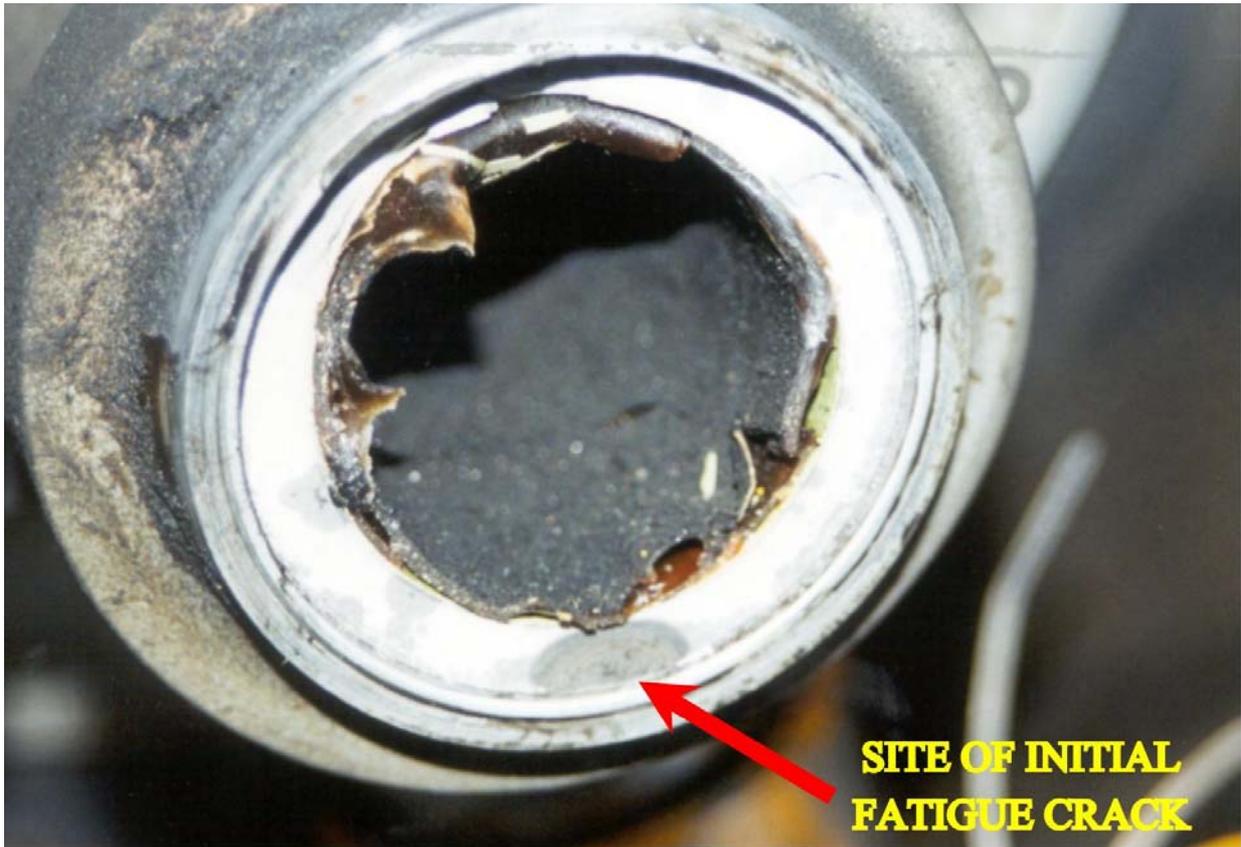
Appendix B

**1.16.2** **Appendix B** shows the fracture surface of the failed axle. The component is orientated as it would be in service. The initial fracture can be clearly seen at the bottom. The examination indicated that the crack initiated at the bottom outer surface of the axle and slowly grew until it reached a surface length of about 14 mm and a depth of about 6 mm, which is slightly less than the wall thickness of the axle. When the crack reached this size, it then spread rapidly, causing the axle to fail.

- 2.1 The metallurgical examination shows that the right hand axle was subjected to localised overheating, in the area of the failure. This overheating may have occurred during grinding operations to remove damaged, scored or worn chrome plating. Alternatively, the overheating could also have occurred in the post-replating grinding, when the axle was being ground to achieve the final dimensional requirements. However the absence of burn marks on the cadmium plating would indicate that the overheating probably occurred when the damaged plating was being removed. The cause of the localised overheating was, most probably, due to an excessive rate of grinding or insufficient application of cooling, or a combination of both these factors, during the grinding operation.

- 2.2 The axle suffered overheating damage in the 6 o'clock position, which is the point of maximum bending-induced tensile loads in the axle. These loads result from normal landing impacts in the vertical direction.

- 2.3 The result of the localised overheating was to cause change in the temper of the steel from normal tempered martensite to over-tempered martensite (OTM). Another effect of the localised overheating was to produce heat-induced cracks in the surface of the steel.

- 2.4 The heat-induced cracks in the surface of the steel served as initiation sites for the fracture that was propagated by fatigue. The axle was then liable to failure at a service life well below the specified service/overhaul life.

PHOTO OF AXLE FRACTURE  
(INNER CYLINDER END)
