AAIU Synoptic Report No.2002-015
AAIU File No.: 2002/0035
Published:22/11/2002

Aircraft Type and Registration	Jetstream 41 G-MAJA
No. and Type of Engines	Two, type TPE 331-14HR/GR
Aircraft Serial No.	41032
Year of Manufacture	1994
Date and Time(UTC)	26 July 2002, 07.50 hrs
Location:	Dublin Airport, Stand 12
Type of Flight	Public Transport
Persons on Board	23
Injuries	Nil
Nature of Damage	Nose gear damaged by towbar
Commanders Licence	UK ATPL
Information Source	Aer Rianta Duty Office

SYNOPSIS.

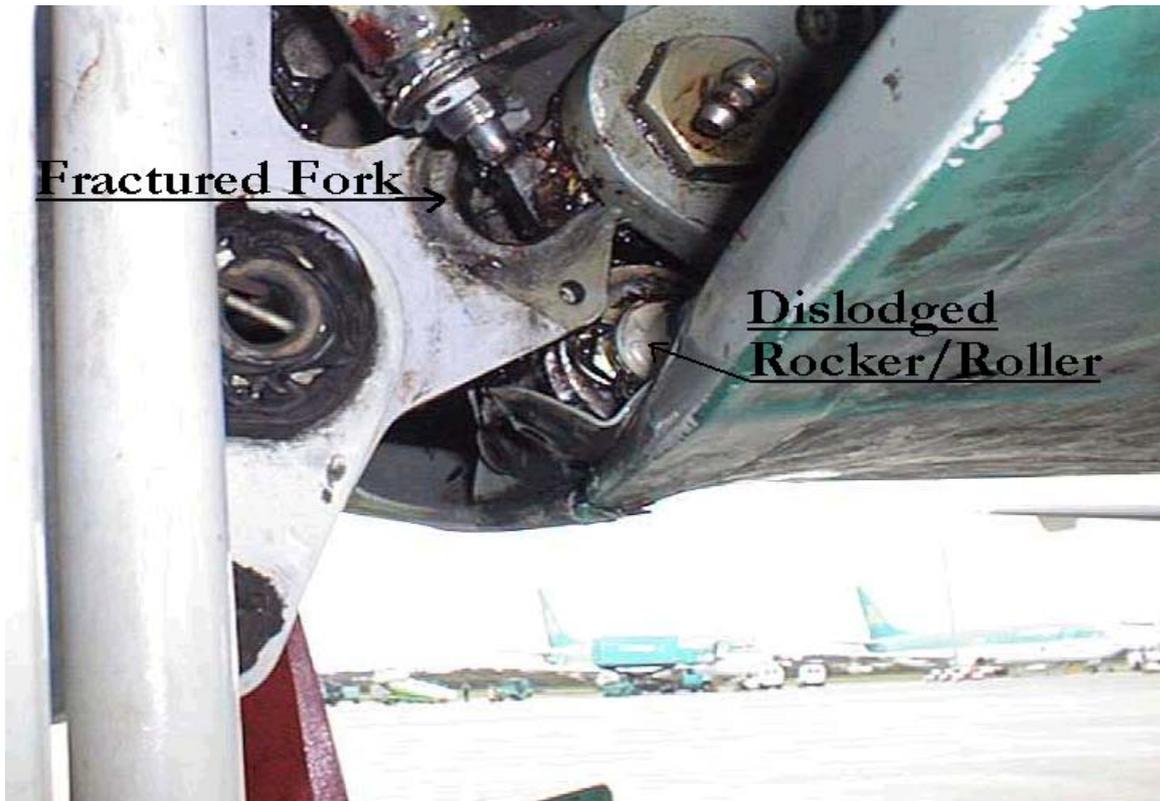
The nose undercarriage strut was pulled forward breaking the forked mounting which holds the down lock roller. The down-lock roller was found between the forward pressure bulkhead and the damaged undercarriage door clip fixture.

The nose undercarriage strut was pulled forward by the action of the tug. This force was such as to separate the down-lock roller from its forked mounting, fracturing the fork lugs. Under pressure from the down lock ram, the steel housing moved rearwards towards the forward pressure bulkhead. As the tug was stopped, the fractured lugs and the leg moved rearwards and embedded the dislocated roller between the front pressure bulkhead and the lower aircraft skin. The down-lock roller was found held by the forward pressure bulkhead and the damaged undercarriage door clip fixture. (See Appendix A).

Top Picture: Position of nose gear roller following the incident.

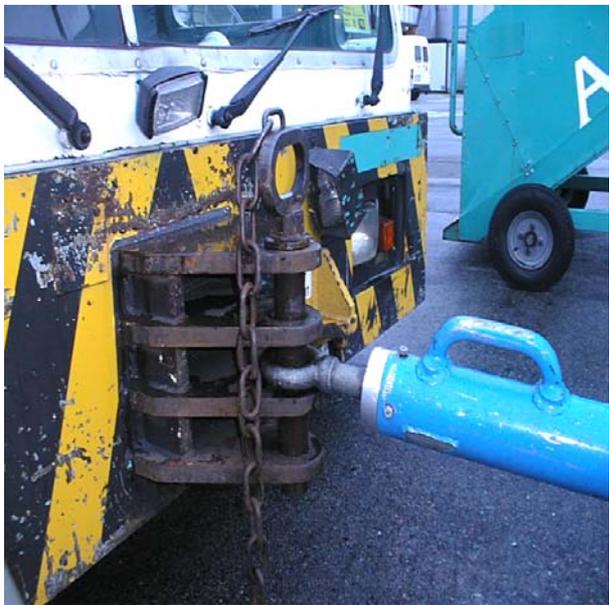
The towbar in use had an eyebolt of 2.1335 inches internal diameter. The three top lugs on the tug had an internal diameter of 2.020 inches and the towing pin used had an external diameter of 2.001 inches. This leaves a clearance of 20 thousandths of an inch in diameter between the pin and the lugs and a clearance of just over one tenth of an inch in diameter between the pin and the eyebolt.

Bottom Left: Tug and Towbar eyebolt attached.

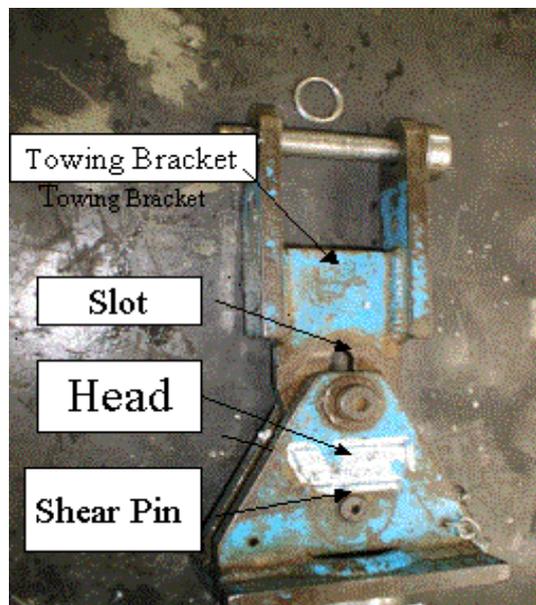
The recommended attachment head for use with this towbar on the Jetstream 41 is 11 inches in length and has a “dual shear” capability (See Appendix A) The manufacturer states that dual shear attachment heads are made to break a shearpin, should maximum turning radius or straight overload limits be exceeded - without the head separating from the towbar. When the shearpin breaks there is relative movement between the head and the towbar of 0.44 inches before the shock absorber is again engaged.

Bottom Right: Head, with towing bracket elongated and with the shearpin removed, following the incident with aircraft G-MAJA.

4.1 It is recommended that the Operator review with the aircraft manufacturer and towbar manufacturer the specifications of the required towing equipment which would be more compatible with the weight of this aircraft. **(SR 33 of 2002)**
