# **Air Accident Investigation Unit Ireland**

**FORMAL REPORT  
APPENDICES**

**ACCIDENT  
Sikorsky S-92A, EI-ICR  
Black Rock, Co. Mayo, Ireland  
14 March 2017**

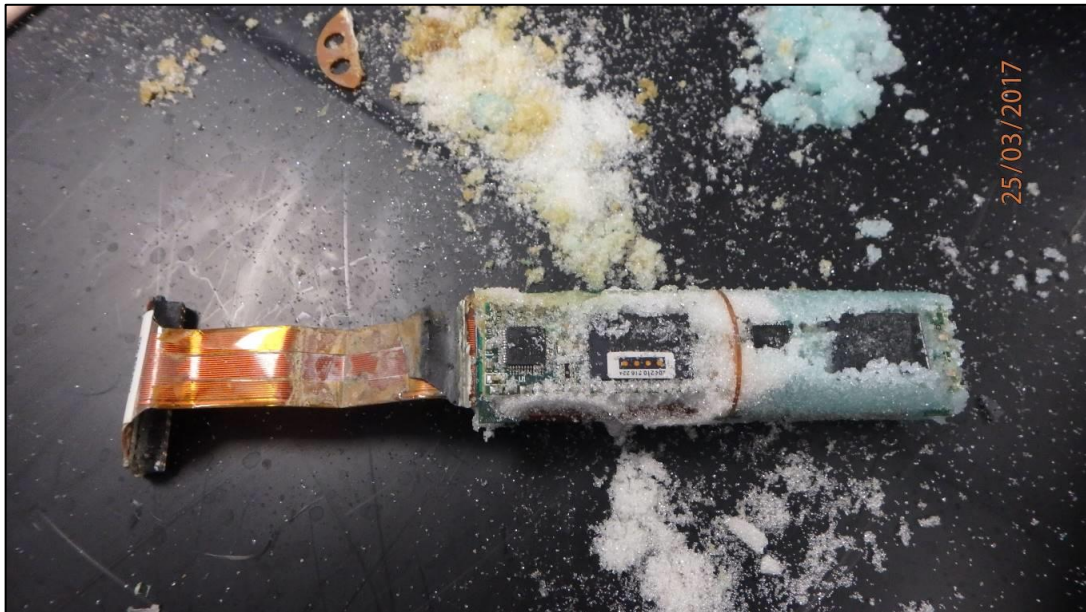
A common feature during disassembly of units fitted with the copper based insulation and where water had entered the inner cylinder of the CSMM, was discolouration of the glass spheres surrounding the APMB, which were stained 'blue' by the copper based insulation. **Image No. K7** is of the APMB from EI-ICR taken shortly after removal from its CSMM. It was also noted by the AAIB that the Polyurethane conformal coating did not appear to have been applied 'evenly' to all surfaces of the APMB and it had not penetrated behind all pins of the memory devices. This has also been observed on other APMB's by the AAIB.

**Image No. K7:** APMB from EI-ICR showing copper based insulation staining of glass beads

From the 15 reported cases of MPFRs that have been submerged in sea water, five had suffered from corrosion of the APMB. All five of these units were fitted with the second generation CSMM fitted with a combination of copper based insulation and APMB's coated in Polyurethane. Four out of five of these units suffered from the loss of electrical pins on the memory devices due to corrosion.

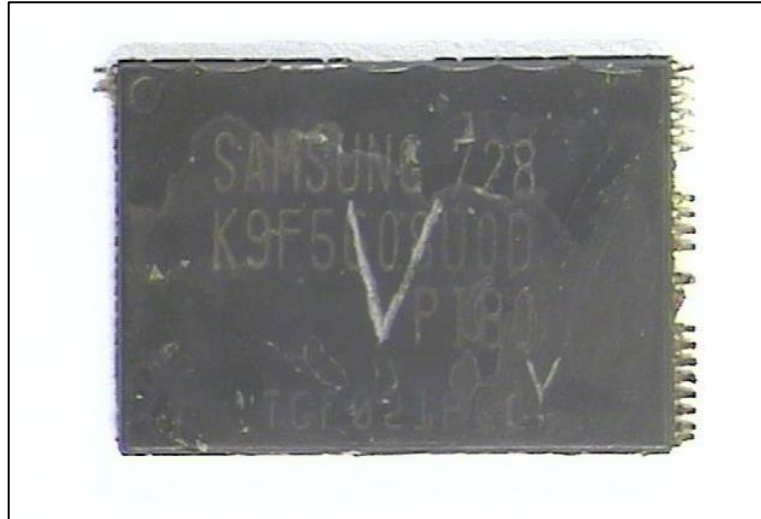
The recorder from helicopter registration B516 was transported to the AAIB '*dry*'<sup>25</sup>, which may have exacerbated the level of damage by some degree, but did not account fully for the extensive damage.

**Image No. K8:** Helicopter registration B516 missing pins from MPFR non-volatile memory device due to corrosion

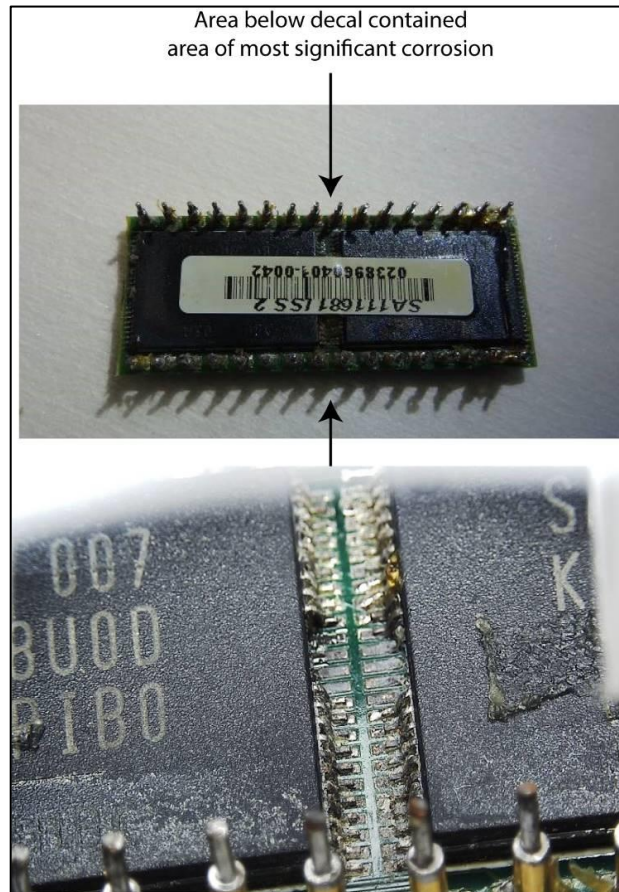
The corrosion of the MPFR fitted to EI-ICR had effected two DOC modules (FDR1 and CVR1), causing electrical '*short circuits*' that prevented the normal recovery of data.

**Image No. K9:** Underside of FDR1 DOC module from EI-ICR showing missing pins due to corrosion

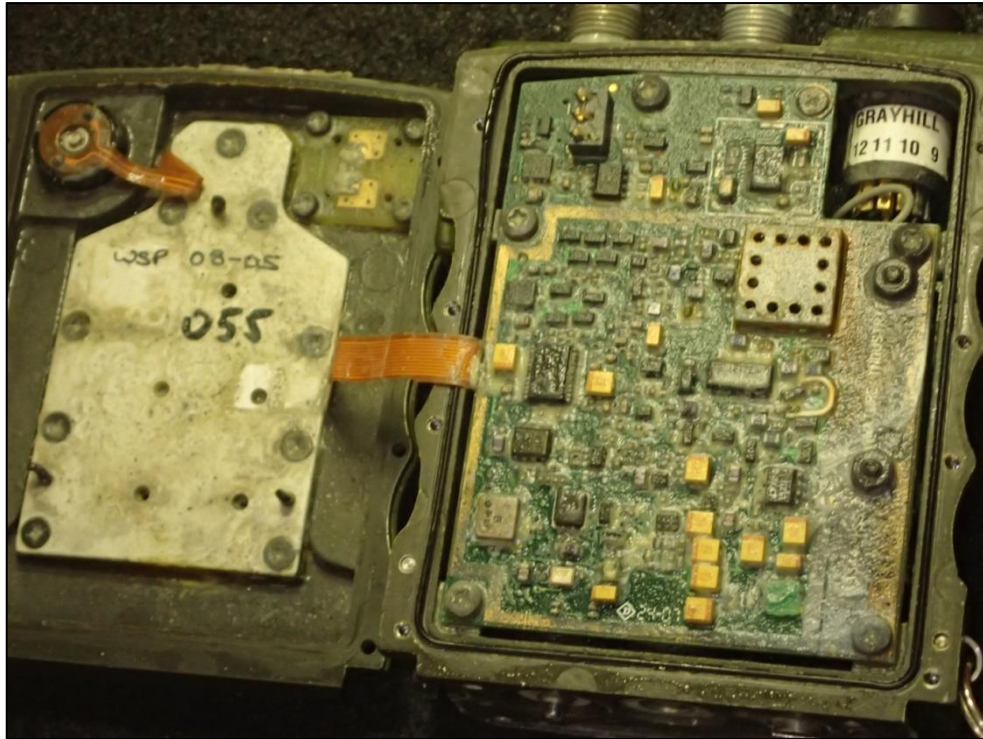
<sup>28</sup> When tested, this unit exhibited a leak on the right-hand side of the unit's self-test button

**Photo No. R1:** Internal Water Damage to Commander's SARBE 6-406G
