Air Accident Investigation Unit Ireland

SYNOPTIC REPORT

**Cessna F172P Skyhawk, EI-SKP
Abbeyshrule Airfield, Co. Longford**

26 September 2020

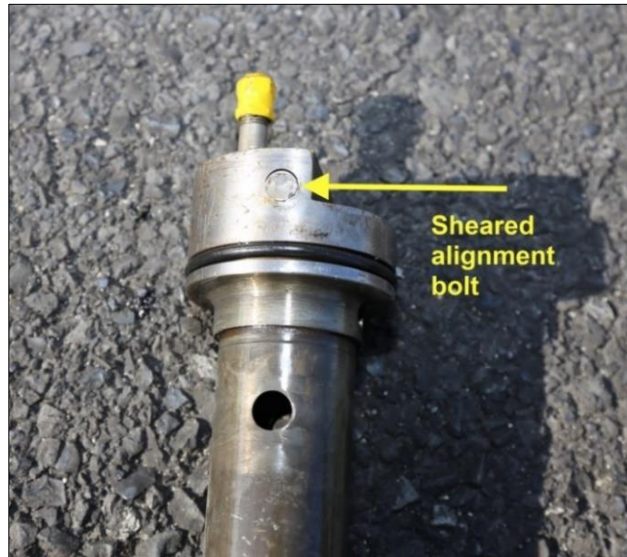
Prior to the arrival of the AAIU, the aircraft had been recovered to the maintenance ramp where the upper and lower engine cowlings had been removed. The nose of the aircraft was supported by stand equipment as the nose oleo had separated from the aircraft. The nose gear and propeller sustained considerable damage due to impact and the engine was likely shock-loaded. The top alignment bolt of the nose oleo had sheared due to the heavy impact (**Photo No. 1**).

Photo No. 1: Sheared alignment bolt at top of oleo assembly

This shearing of the top alignment bolt allowed the inner tube of the oleo to exit upwards from the top of the oleo housing. The top attachment bracket between the nose leg and the firewall was separated from the primary airframe structure due to rivet shear; the bottom bracket had also sheared and separated from the structure. The bottom bracket is designed to separate from the structure (by means of rivet shear, rather than the bracket itself shearing) in the event of a gross overload to protect the primary airframe structure from buckling damage. The top and bottom bracket attachment failures are illustrated in **Photo No. 2**.

The aircraft was subsequently repaired and returned to service.

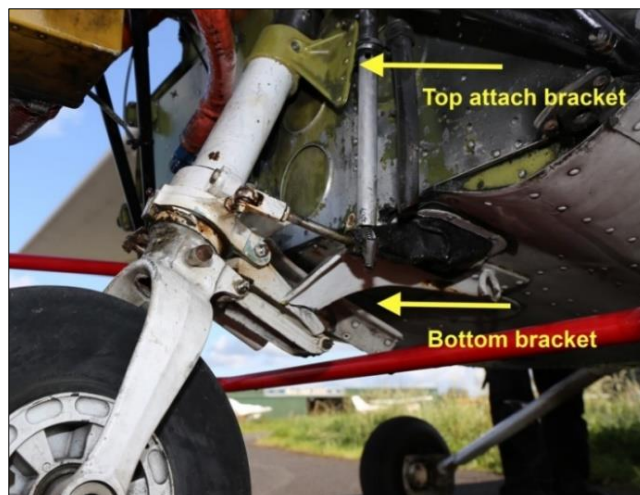
The nose-down attitude of the touchdowns significantly damaged the nose landing gear. The upper and lower nose undercarriage (oleo) attachment brackets fractured, allowing the nose landing gear to rotate forwards which permitted the rotating propeller to contact the runway surface. The Student kept the aircraft on the runway following the final bounce and brought it to a stop just past the intersection with Taxiway (TWY) C South. Following an attempt to taxi, the Student made a call on the airfield frequency that he *'needed assistance'* and secured the aircraft by completing the shutdown checks. He exited the aircraft normally but sustained a minor injury after he exited the aircraft. There was no fire.

Photo No. 2: Damage to nose oleo upper and lower attachment brackets

As a result of the bracket failures, the nose leg rotated forwards, allowing the nose of the aircraft to drop and causing the propeller, which remained under power, to contact the runway. Both propeller blades showed evidence of runway contact, with resulting likely shock-loading of the engine.

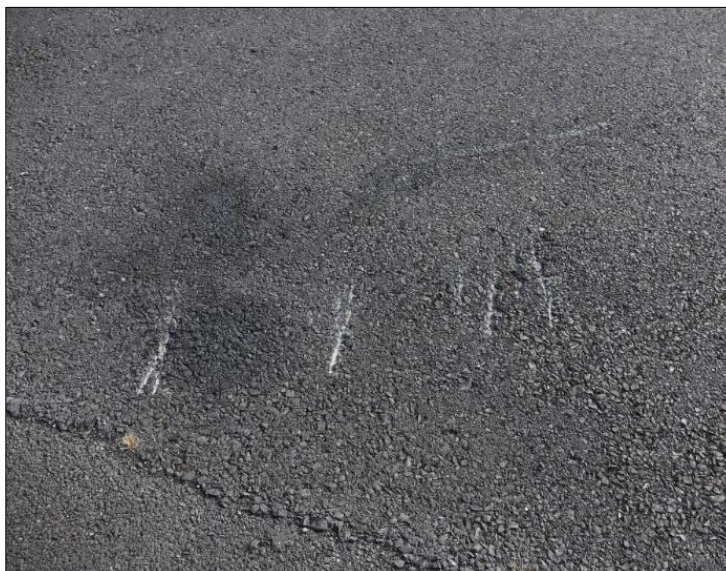
The runway surface (on RWY 28) was inspected by the AAIU following the accident. No evidence of the initial touchdown point was apparent. A total of 17 witness marks consistent with a propeller strike were noted 5.2 m to the left of the runway centreline. The marks were new with no debris or dirt present. The marks began at a distance of 55 m along RWY 28 from abeam the western edge of Taxiway A North and continued for 94 m to just beyond Taxiway C South, where the aircraft came to a stop. Hydraulic fluid was also noted on the runway surface close to where the aircraft came to a stop (**Photo No. 3**).

Photo No. 3: Propeller marks in paved surface where aircraft came to a stop
