# **Air Accident Investigation Unit Ireland**

**FACTUAL REPORT**

**PESZKE S.C. GP-14-SE VELO, OM-M821  
Gowran Grange Airfield, Co. Kildare**

**27 March 2019**

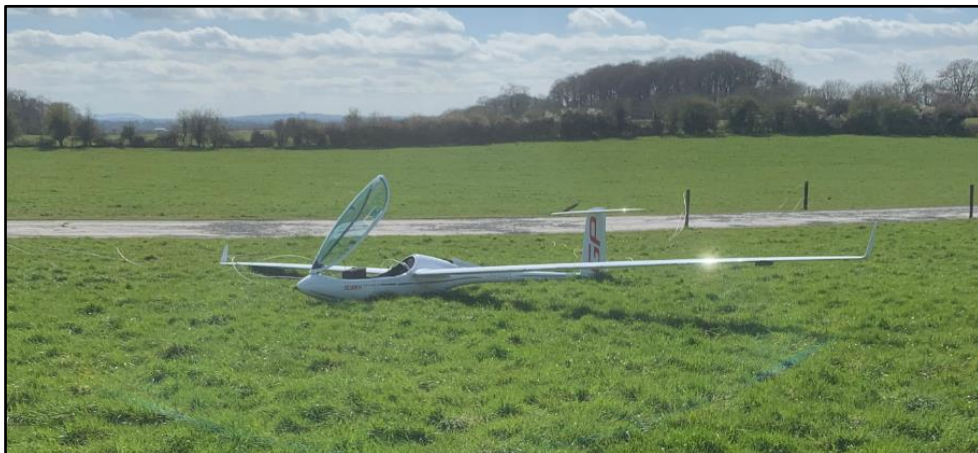
The towing aircraft, a Piper PA-18 150 Super Cub, and the glider, commenced the take-off roll at 13.08 hrs. The glider Pilot stated that the glider became airborne during the roll due to bumps on the runway but settled back down on the runway again. The Pilot said that the glider eventually became fully airborne, but that it was too late to clear the top of the hedge. The Pilot stated that the glider *'glanced off the hedge'* and that the towing cable released. The glider climbed momentarily and then *'dived into the ground, slid and went through two electric fences'* before coming to rest (**Photo No. 1**). The Pilot was uninjured.

**Photo No. 1:** Final position of OM-M821

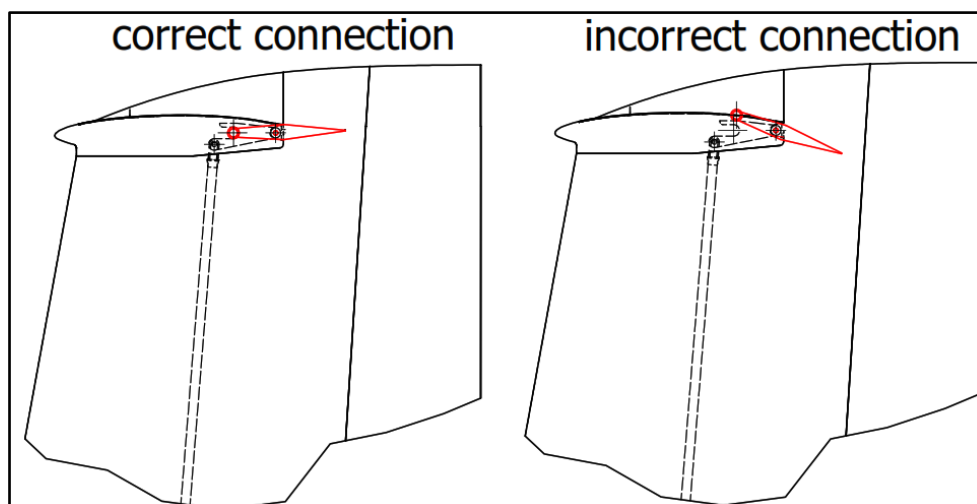
**Figure No. 5:** Elevator control system, horizontal tailplane installed  
(Source: Adapted from Glider Manufacturer's Construction Drawings)

During discussions with the Glider Manufacturer, the Investigation established that when the elevator is incorrectly installed, as illustrated in the image on the right of in **Figure No. 5**, movement of the control stick in the cockpit would still provide movement to the elevator.

During physical installation of the horizontal tailplane, which incorporates the elevator, the configuration and design of the elevator hook mechanism was such that the elevator lever may be installed incorrectly without it being visually obvious to the installer. Bullet Point 3, from the *'Rigging Instructions and Tips'* document supplied with the glider, highlights this potential hazard. The Pilot confirmed that prior to the flight a flight control functional check was completed, with the assistance of an observer on the ground.

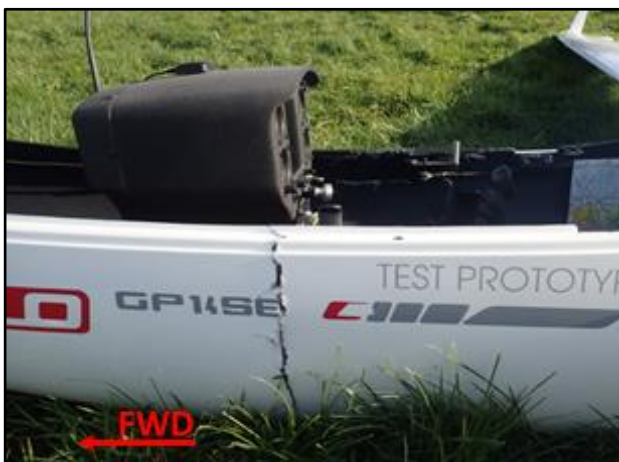
The cockpit area of the glider sustained a number of fractures as a result of the impact with the ground. A significant fracture to the cockpit structure was evident on the left side of the glider as shown in **Photo No. 2**. The fracture penetrated to the internal surface as shown in **Photo No. 3**.

**Photo No. 2:** Cockpit fracture (external)

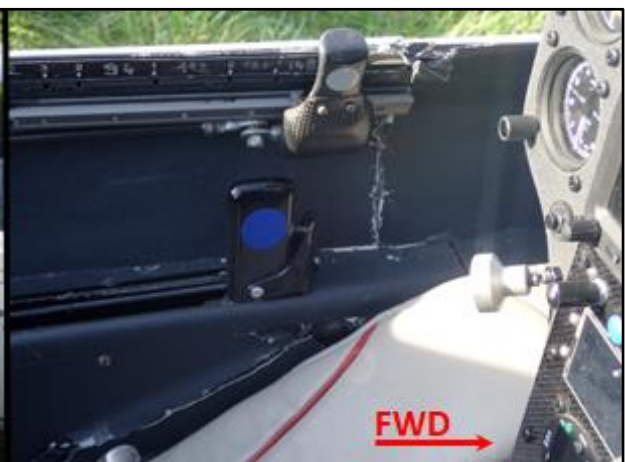
**Photo No. 3:** Cockpit fracture (internal)

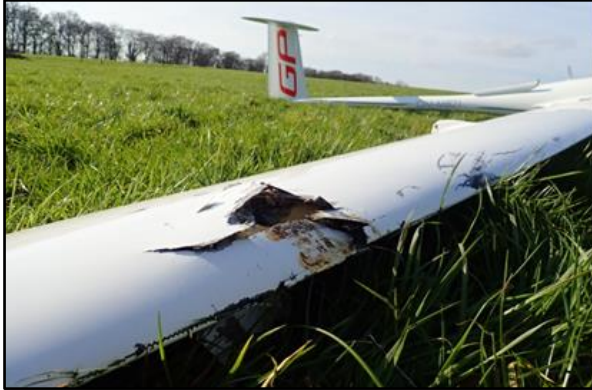
As a result of the impact with the wooden fence posts and associated electric wires, both wings sustained significant impact and splitting damage, in particular to the leading edge area.

Transfer marks from the wooden posts were observed at a number of areas on the wings in addition to scuff markings from the electric wire fence.

**Photo No. 4:** Leading edge damage

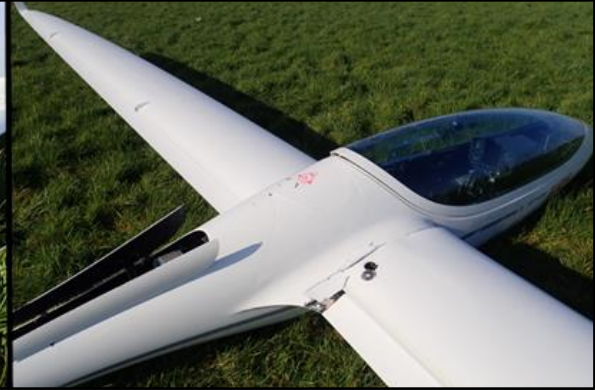
Both wings, but most notably the right wing, were pushed rearward due to the impact with the fixed fence poles causing displacement damage at the wing root attachment point and flaperon area as shown in **Photo No. 4** and **Photo No. 5**. Impact marks on the canopy from the fence poles were also observed.

**Photo No. 5:** Flaperon area damage

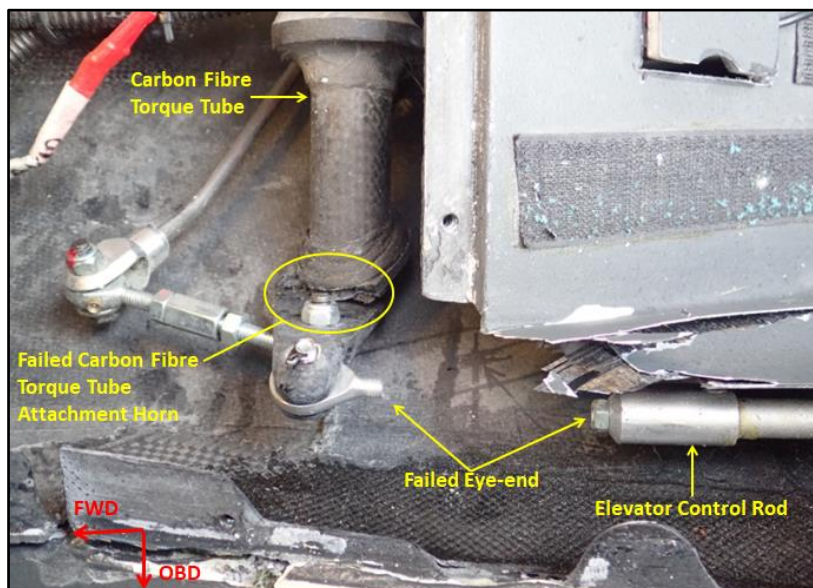
Further examination of the elevator control system, which involved the removal of some panels in the cockpit area to gain access, found that the control linkage located between the control stick and the elevator had failed at two points as shown in **Photo No. 6**.

**Photo No. 6:** Failure of elevator control linkage

An elevator control rod (Refer to **Figure No.4**, Connection Points 1-2), which runs along the left side of the cockpit under some panelling, was found to be fractured at the carbon fibre torque tube attachment horn area. The point of failure was observed as the threaded portion of an eye-end, which connects the control rod to the carbon fibre attachment horn. In addition, the carbon fibre attachment horn itself was also found to have failed at its root area.

At the accident site, continuity checks completed on the glider's elevator control system by the AAIU revealed that the elevator did not move in response to movement of the cockpit control stick. Further examination identified that there was a double failure of the control linkage under the floor in the cockpit area of the glider. Detachment of either one of these points individually would result in complete loss of elevator control. This double failure corresponded with the main impact area of the glider with the ground.

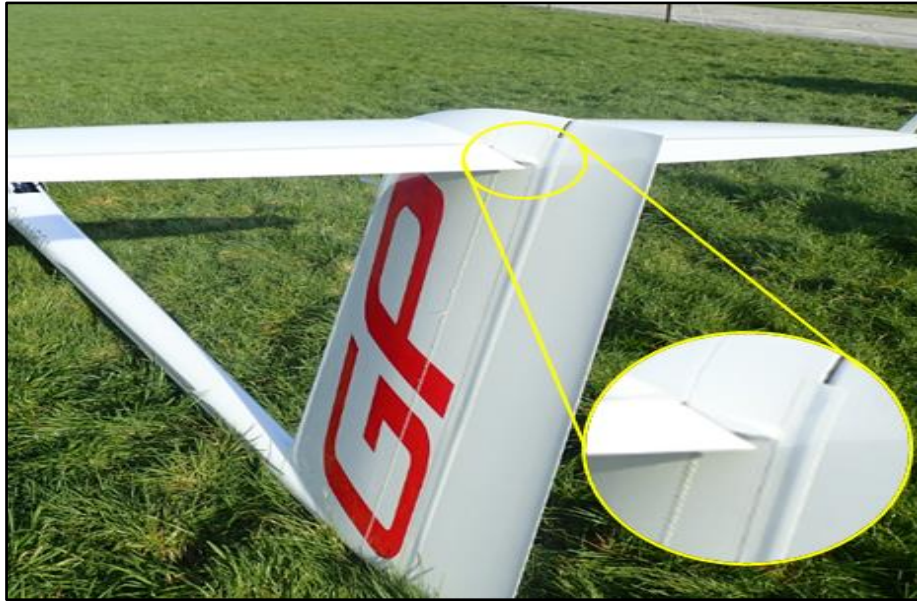
During examination of the glider at the accident site it was noted that the elevator was resting in a downward deflected position (**Photo No. 7**).

**Photo No. 7:** Elevator position at accident site

In discussions with the Glider Manufacturer, the Investigation established that when the horizontal tailplane is correctly installed as per the '*Rigging Instructions and Tips*' document, **Section 1.4.2**, (elevator lever, hook and tongue correctly positioned and secured), and the control linkage is fractured in the area shown in **Photo No. 6**, the natural resting position of the elevator would be in a slightly upwards deflected position and not the slightly downward position shown in **Photo No. 7**.

Further examination of the elevator's position at the accident site found that the elevator was resting in a downward deflected position. The Glider Manufacturer confirmed that in the subject glider when the elevator is correctly installed, and the control linkage is separated at the area where the double failure in the elevator control run was located, the elevator would deflect slightly upwards. The downwards deflection of the elevator at the accident site indicates that the elevator was most likely incorrectly installed prior to flight.

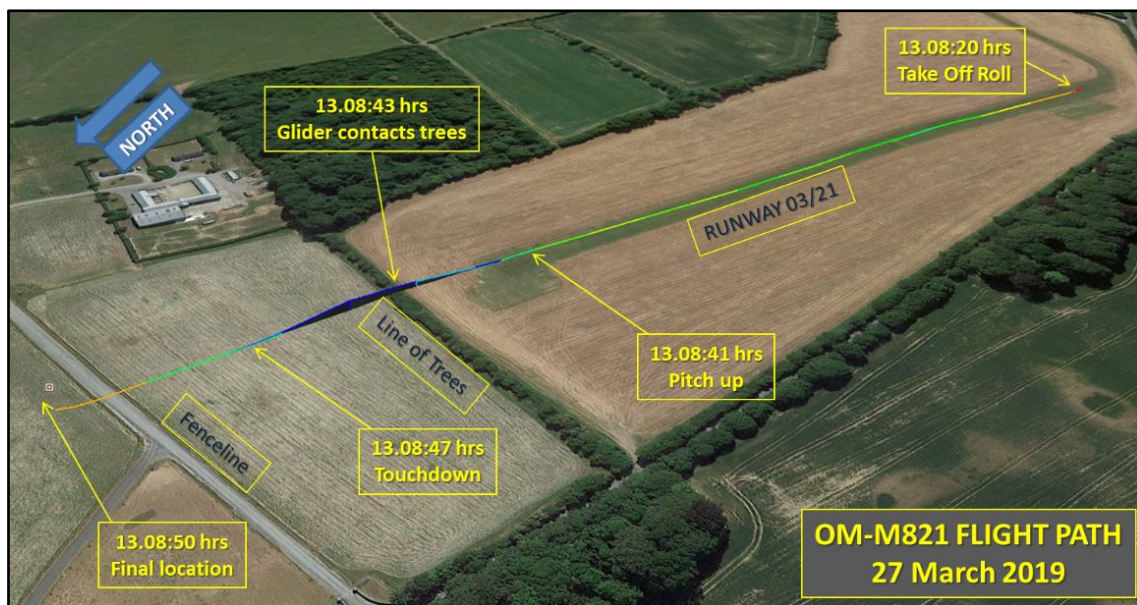
The data (shown in **Figure No. 6**) indicated that the glider, which was being towed by a powered aircraft, commenced the take-off roll at 13.08:20 hrs. During the roll, the glider lifted off the grass, and maintained a height of between 5 ft and 23 ft above the runway as it accelerated.

At 13.08:43 hrs, the LX-9000 cockpit navigation system recorded a substantial deceleration coincident with the location of the treeline at the end of the runway, and within the subsequent four seconds, the glider's groundspeed reduced and a descent was recorded. At 13.08:47 hrs, the data indicated that the glider touched down in a field adjacent to the runway, and came to a stop at 13.08:50 hrs. A number of additional pertinent parameters from the flight are shown in **Appendix A**.

**Figure No.6:** OM-M821 Flightpath based on recorded data (Google)

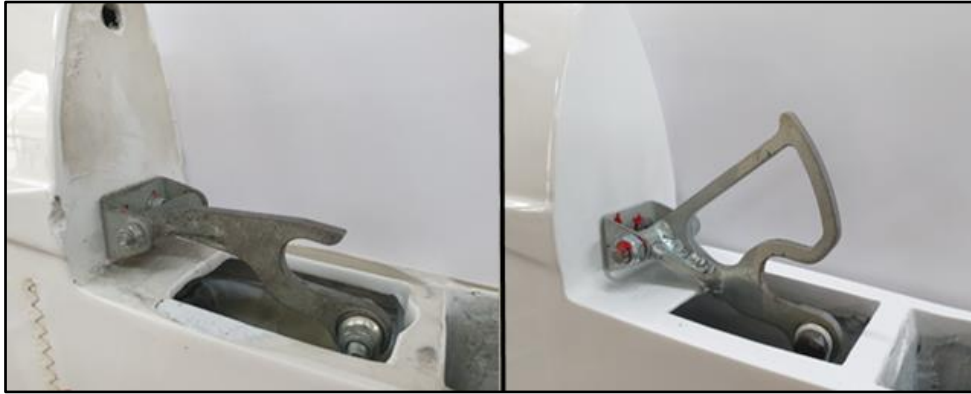
**Figure No. 7** illustrates the design change showing redesign of the hook mechanism. The old design is shown on the left and the new redesigned mechanism is shown on the right. The Glider Manufacturer stated that this new design has *'completely eliminated the risk of incorrect rigging [installation] during elevator installation'*.

**Figure No. 7:** Old (left) and new (right) redesigned hook mechanism

*'... we have immediately [following] the incident redesigned the elevator hook to eliminate the risk of incorrect rigging [installation] and recalled and replaced it on all other gliders.'*

The Glider Manufacturer provided the Investigation with details surrounding the redesign of the hook mechanism. This redesign was completed by the Glider Manufacturer in order to mitigate the possibility of future incorrect installation. In response to questions regarding the redesign in the elevator area, the Glider Manufacturer now considers that the redesign has eliminated the risk of incorrect installation on their aircraft. In addition, the Investigation was informed by the Glider Manufacturer that the original design was recalled and replaced on all their other gliders which were affected.
