DEPARTMENT OF TRANSPORT AND POWER

A.A.P. No. 4

**ACCIDENT TO  
VISCOUNT 803 AIRCRAFT EI-AOF  
NEAR ASHBOURNE, Co. MEATH.  
ON 22nd. JUNE, 1967**

REPORT ON AN INVESTIGATION  
MADE UNDER REGULATION 7 OF THE  
AIR NAVIGATION (INVESTIGATION OF ACCIDENTS)  
REGULATIONS, 1957 (S.I. No.19 of 1957)

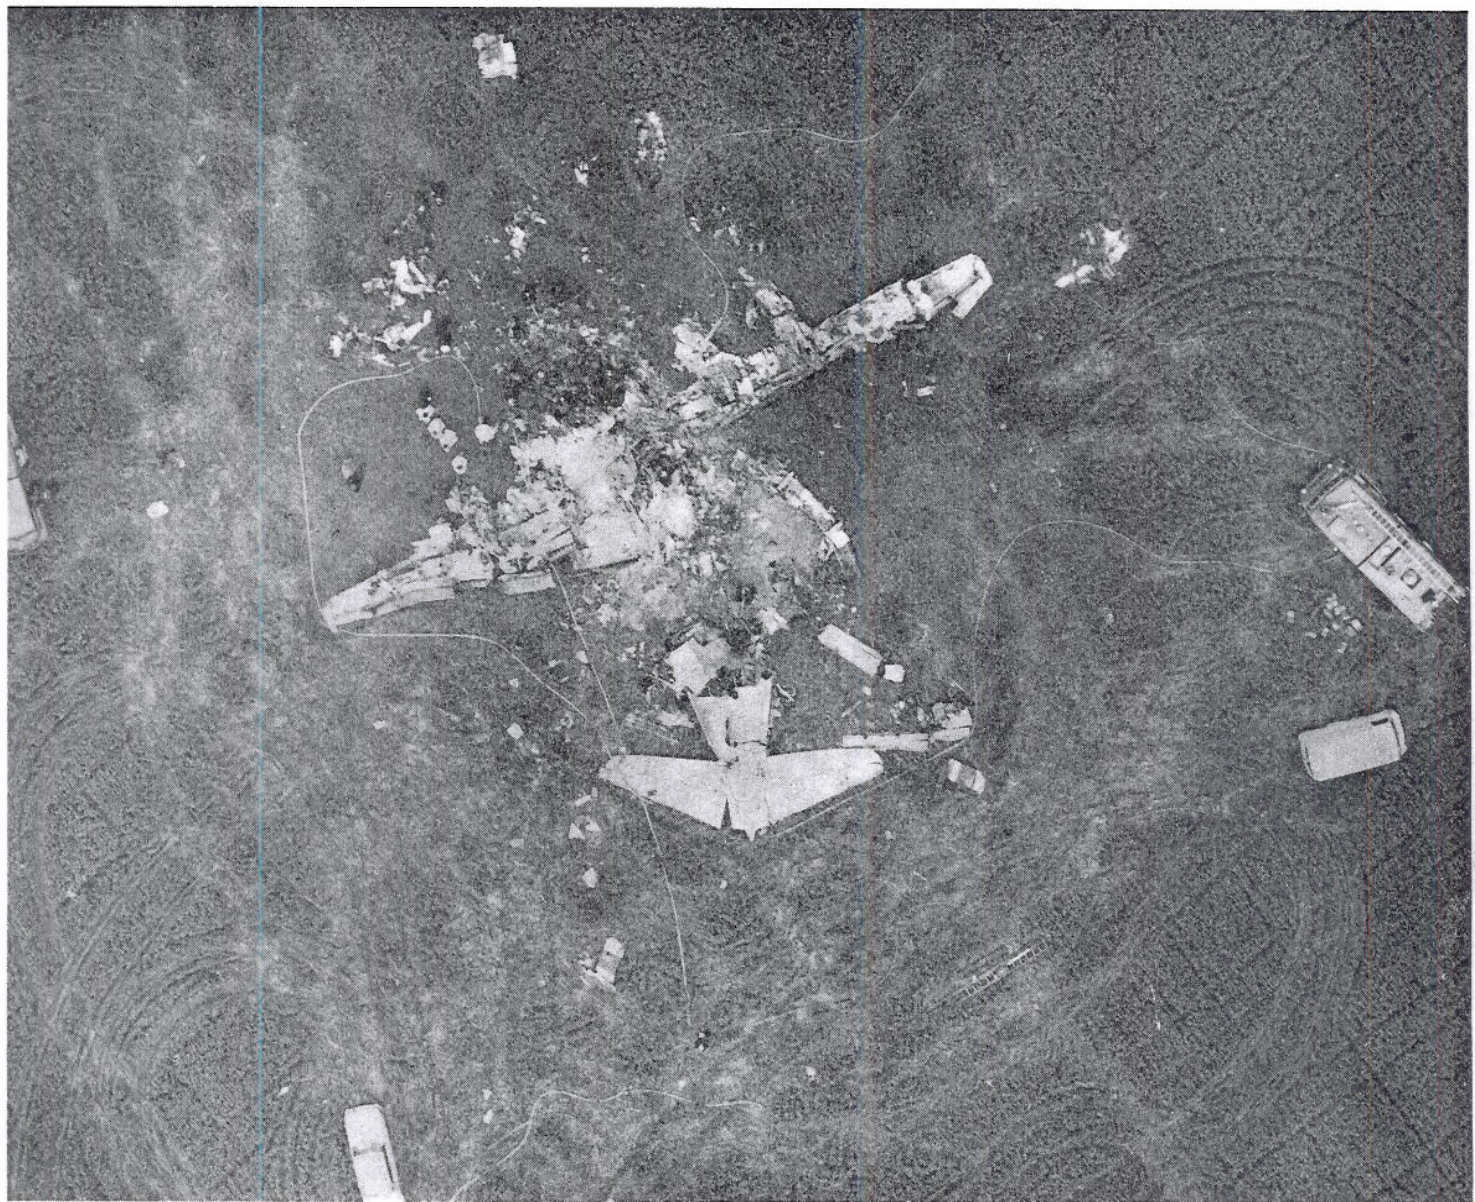
**EI-AOF: Figure IV**  
**Wreckage Layout**

The wings were severely damaged by impact loads, fire and explosion. The stb'd wing components were located in approximately the correct spanwise position but the port wing was disrupted by an explosion occurring in the fuel tanks. This separated the structure spanwise just aft of the main spar, blowing the rear portion completely over and rearwards, displacing flaps, most of the ailerons and undercarriage and scattering bits of tank, nacelle and wing structure over a wide area.

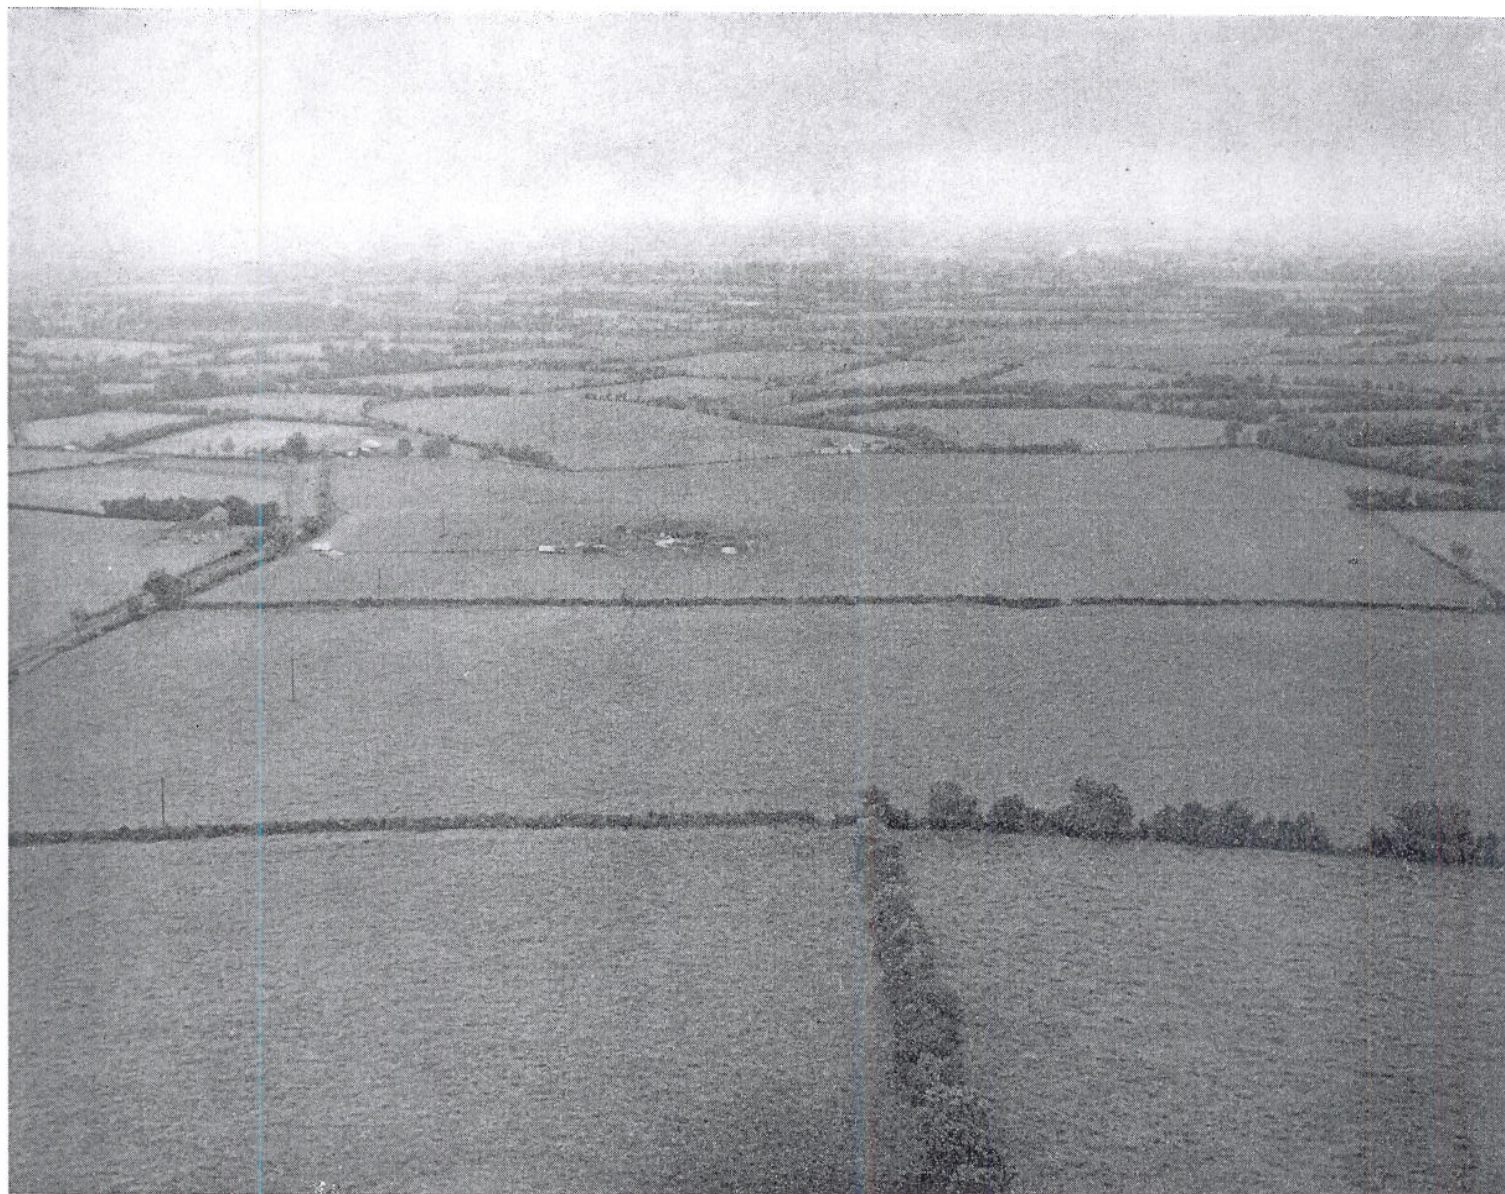
**EI-AOF: Figure V**  
**Area of impact looking west**

The aircraft was found in an inverted position headed in a direction approximately opposite to that of the approach to the field. The position of the wreckage and its alignment are consistent with a nearly vertical impact in a spin.

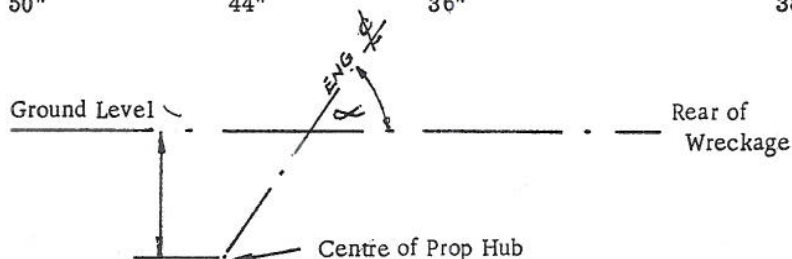
The aircraft was found in the inverted position with the four engines angled into the ground. The angles and depths from left to right looking down on the wreckage were:

1	2	3	4
Angle ( $\alpha$ )	60°	50°	25° to 30°	30°
Depth (d)	50"	44"	36"	38"

The engines pierced the ground at angles varying from 60° to 30° as illustrated in Section 1 of this report. The damage to the canopy skin was symmetrical about the Centre Line and the damage to the nose undercarriage indicated very high inertia forces close to the nose.

The depth the engines pierced the ground and the general impact damage is consistent with the Aircraft having descended a few hundred feet out of control rather than a few thousand.

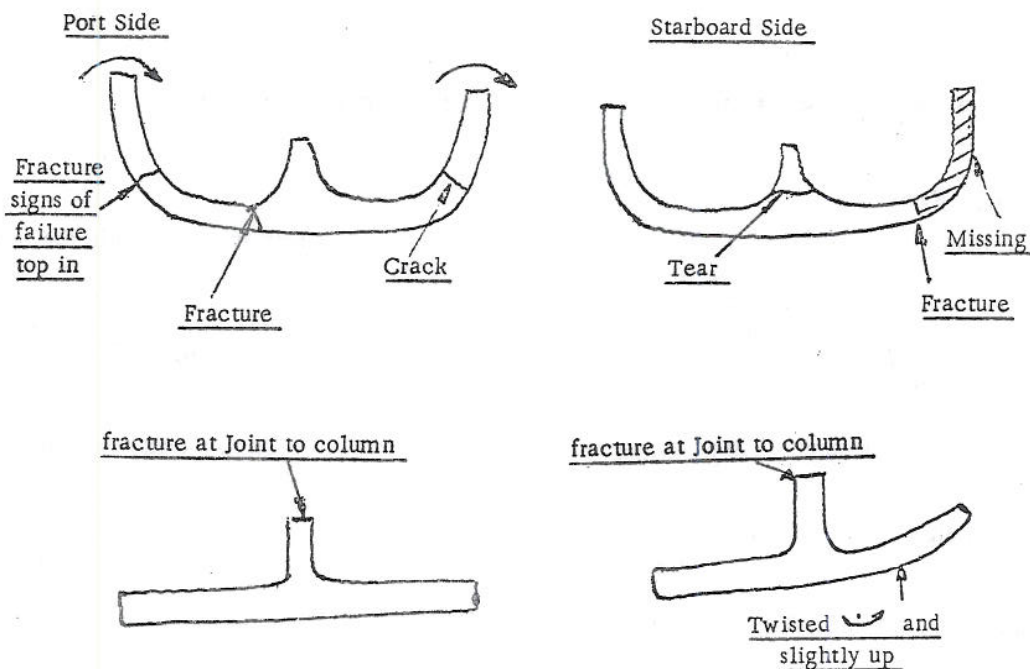
The aileron control run in the fuselage was almost completely destroyed; only small portions were found. The aileron interconnecting chains were broken in several places and the chain wheel was badly damaged. Both hand wheels were broken off control column and damaged as shown below.

The trim tab was found in the neutral position and this was confirmed by the position of the motor and transmitter adjacent to motor. It is difficult to say what reliance can be placed on the aileron angle obtained from the control rod position relative to the stops. If the rod did not move after impact then obviously it gives the aileron angle prior to impact; it was not possible to establish if this was the case. There was no evidence to suggest any pre-crash damage to the ailerons or control run or that the gust locks had been forced on by fouling of the control cable.

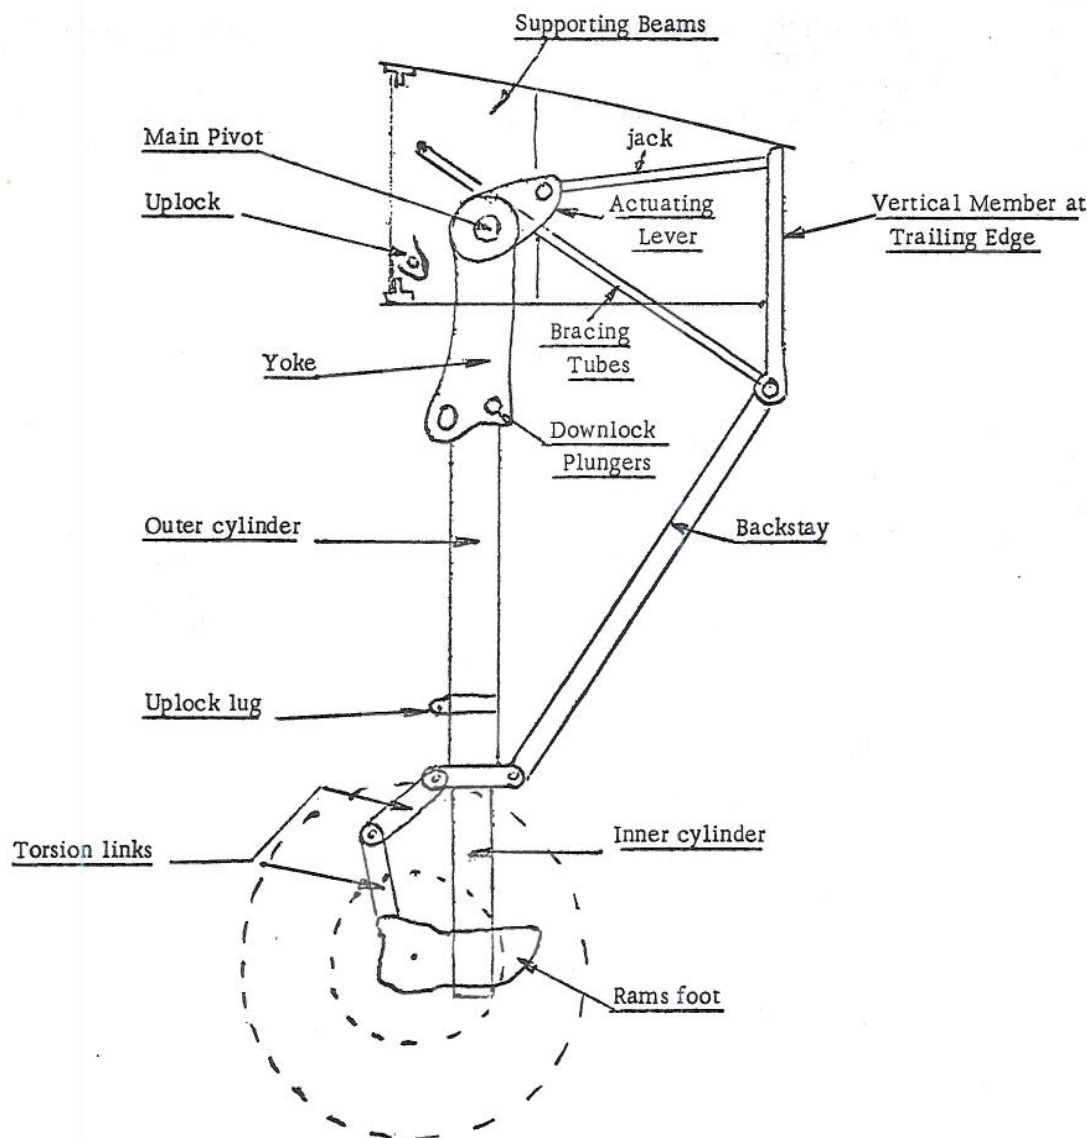
**Damage to Port Main Unit**

The undercarriage was found lying aft and slightly in and the oleo was complete, fully extended, and still attached to yoke with the downlock plungers engaged and the jack fully compressed. Fire damage was extensive at the lower end, the rams foot was completely burnt, the axle and brake units were badly damaged, the wheels and tyres were almost completely destroyed and the torque links were broken clear at the bottom.

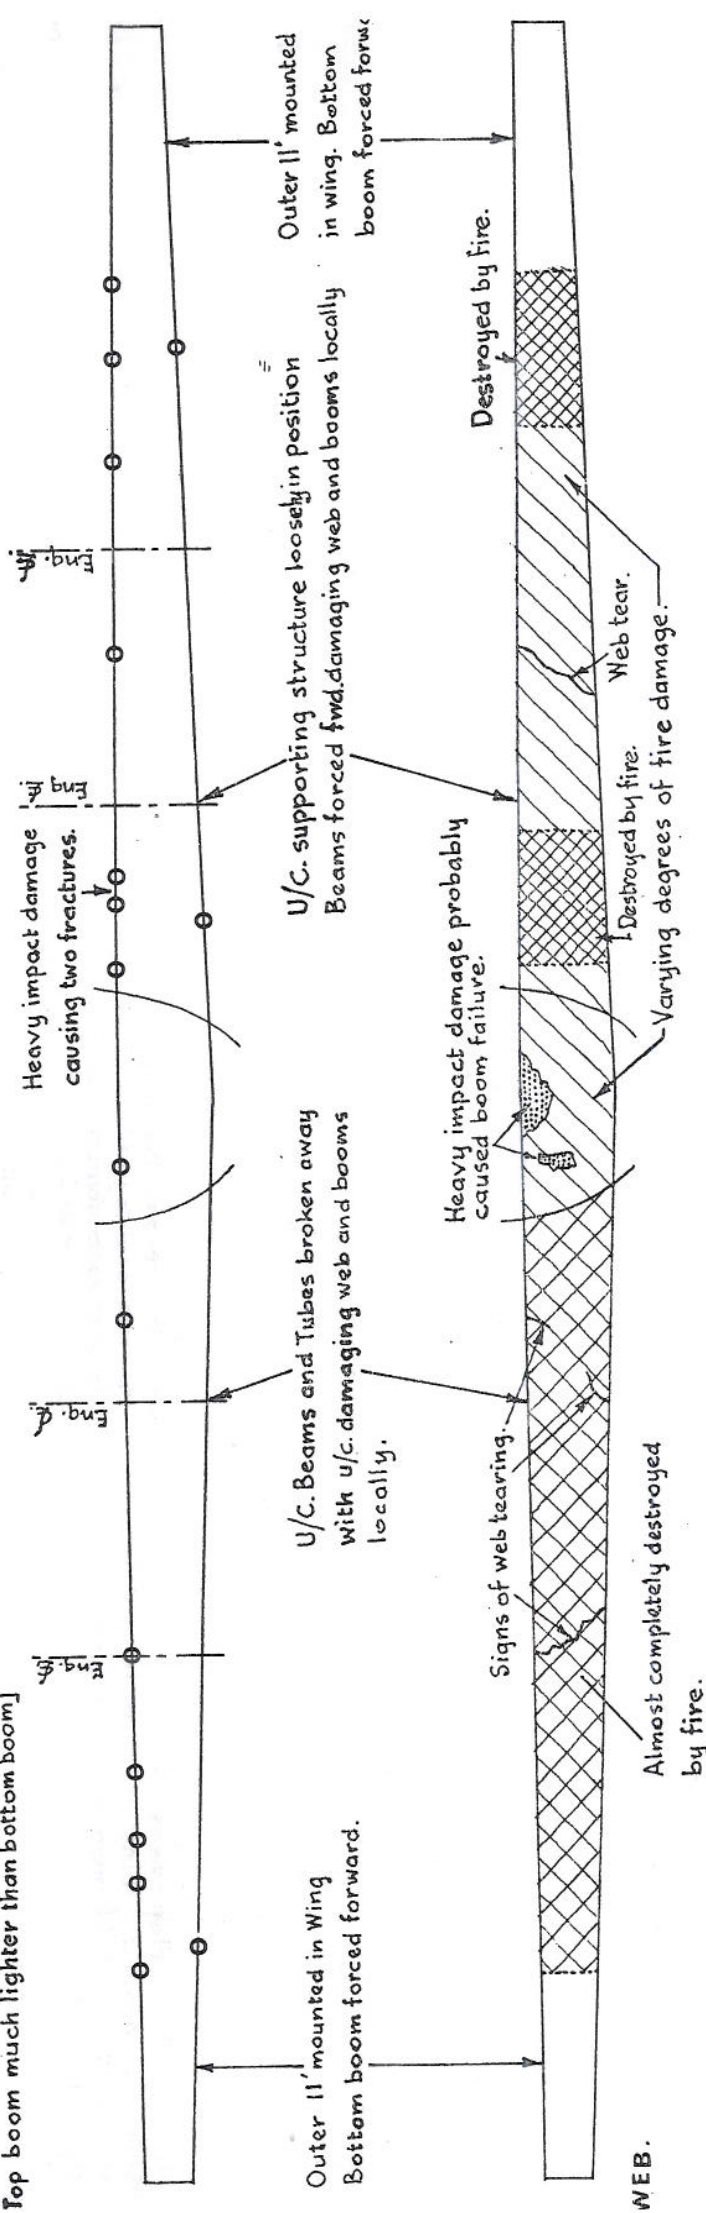
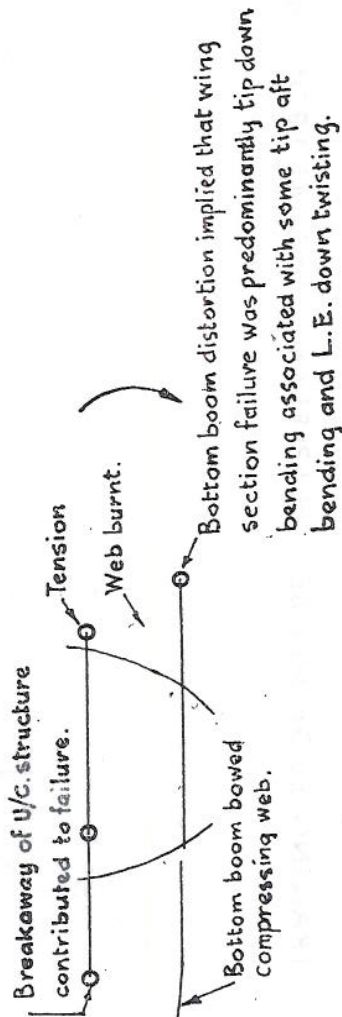
## WING ROOT. Fractures.

The main spar tip to tip was found in the correct spanwise position in the wreckage, thus eliminating any possibility of complete in-flight failure. Detailed examination of the fractures and general distortion revealed no evidence of fatigue or anything to suggest unusual in-flight wing distortion or overload condition prior to impact.

The wing root fractures and distortion illustrated were probably caused by rolling impact loads on fuselage and port wing.

BOOMS. Fractures shown : ⊙  
Top boom much lighter than bottom boom

NOTE: Boom fractures are recorded above, but booms were also twisted and bowed in numerous places. It was noted that the port bottom boom was bent sharply down at outer engine. Booms on both sides, but particularly on the starboard side, were bowed in a forward and aft direction, due mainly to outer engine impact, inertia forces and heat.

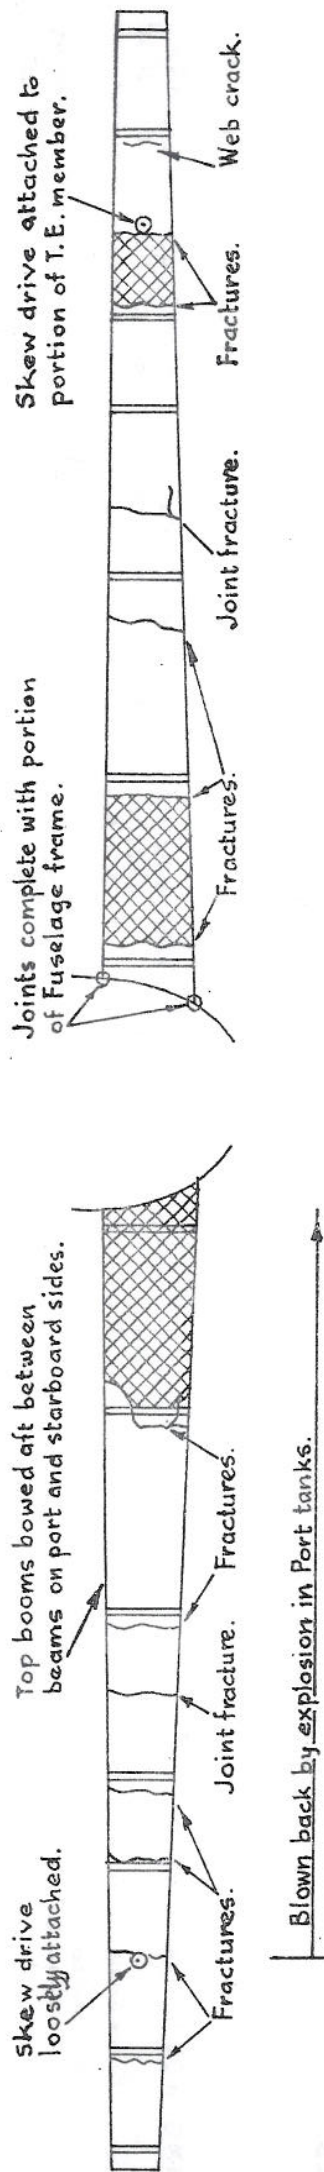
# WING TRAILING EDGE MEMBER · FLAP BEAMS AND AILERON HINGE SUPPORTS.

All the flap beam joints at the trailing edge member with the exception of No. 1 port side upper were intact with flap beams and portions of the trailing edge member and interspar formers still attached. No. 1 Port side upper is in compression under flight loads and the tear-away type of failure was caused by the crash. There was no evidence of pre-crash damage to the trailing edge member, flap beams, or aileron hinge supports.

Areas destroyed by fire shown: [cross-hatched box] Remainder suffered varying degrees of damage [· more extensive on starboard side.]

No. 2 Flap Beam. distorted local to top joint at T.E. member. Some fire damage. Bolt broken at top joint. Bottom joint O.K. with portions of T.E. member and former still attached.

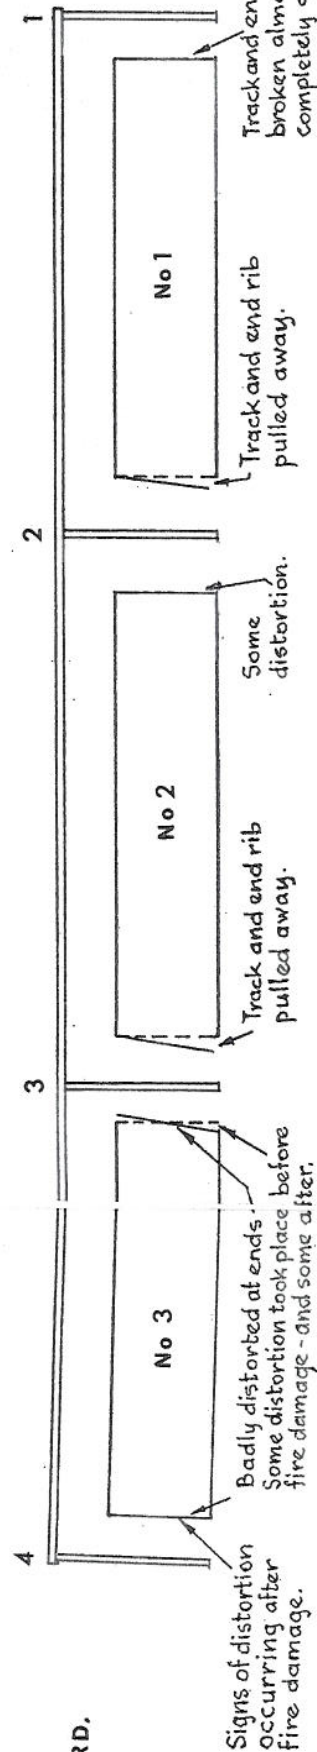
## DAMAGE TO RADIUS RODS :

The damage to the radius rods was caused mainly by loadings (1) and (2) and the remaining damage is readily attributable to the crash.

Lockable tie-rod. Bent and broken at lock coupling. Attached at forward end, but broken clear of outer flap, loosely attached to inner.

Extended bent but not broken. Still attached to flap but broken away at forward attachment.

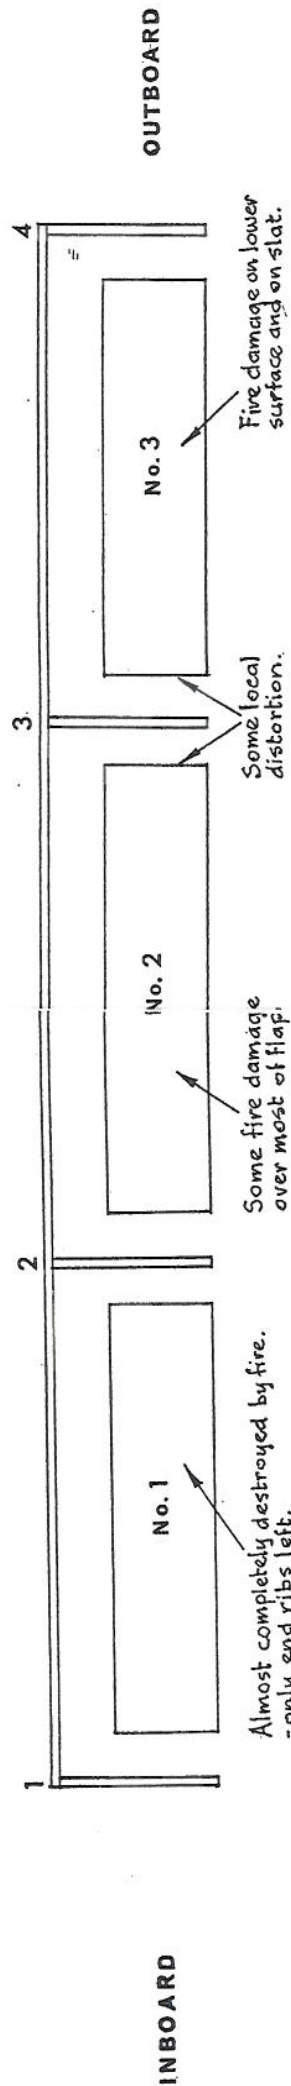
### DAMAGE TO RADIUS RODS:

Bent and fractured, attached at forward end but broken away from flaps.

Broken at forward end. Attached at forward end and at flap.

Chain boxes, complete with splined ends, jockey sprockets and guide rollers were in position and undamaged.

Slats on flaps Nos. 2 and 3 were crushed and distorted.

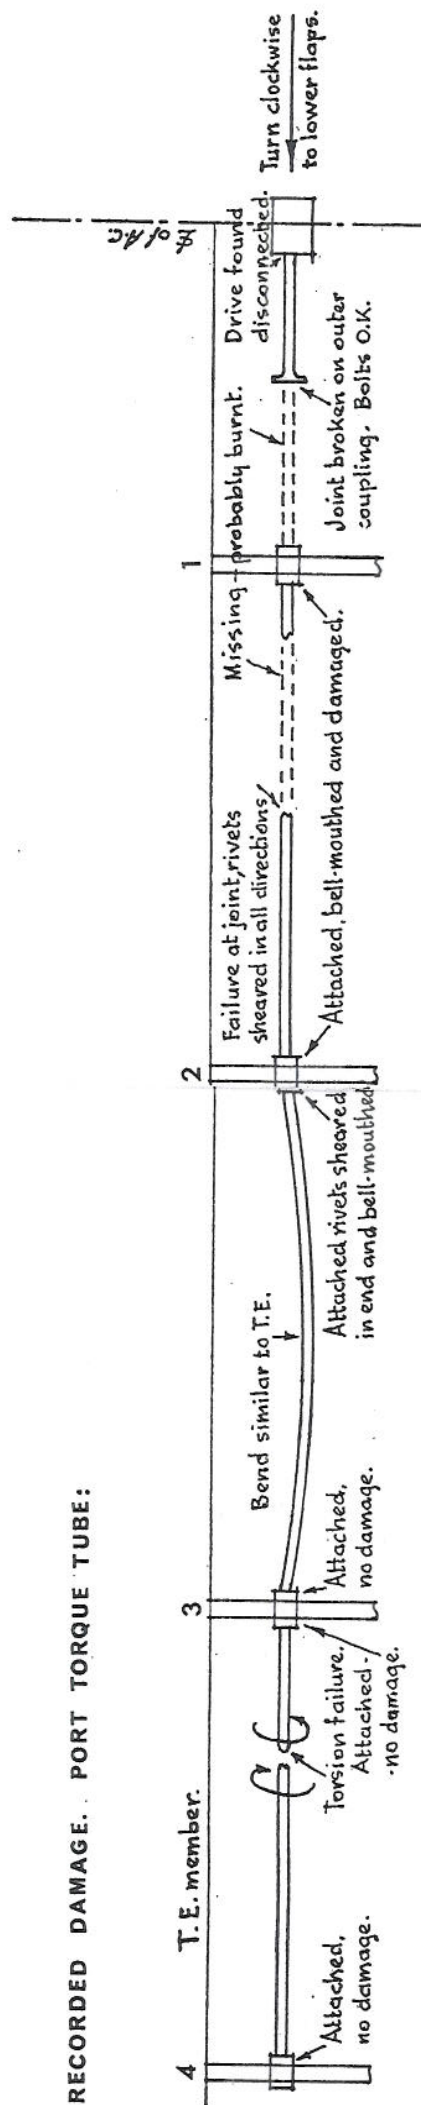
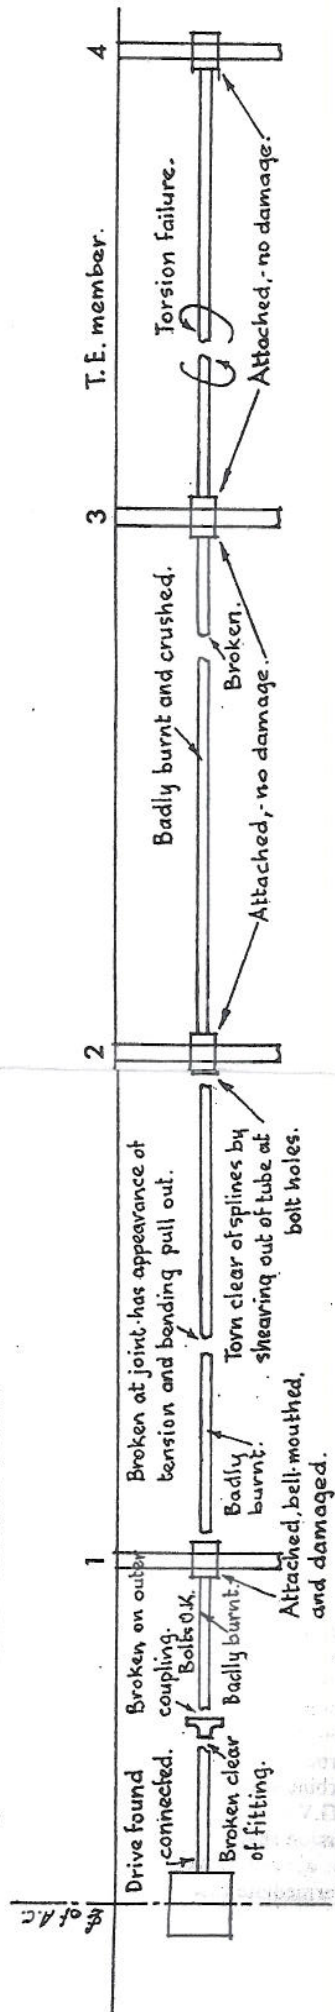
Fig. No. 6.

The torque tube damage is quite similar on both wings and is consistent with having been caused by the above loadings in particular loadings (1) and (3). The torsion failures between flap beams 3 and 4 on both sides were almost certainly caused by unequal forward movement of the flap under loading No. 1 (i.e. inner ends moving in more rapidly than the outer).

## RECORDED DAMAGE. PORT TORQUE TUBE:

## RECORDED DAMAGE. STARBOARD TORQUE TUBE:
