# **Air Accident Investigation Unit Ireland**

**INTERIM STATEMENT**

**Sikorsky S-92A, EI-ICR**

**Accident to Sikorsky S-92A, EI-ICR at Black Rock, Co. Mayo on 14 March 2017**

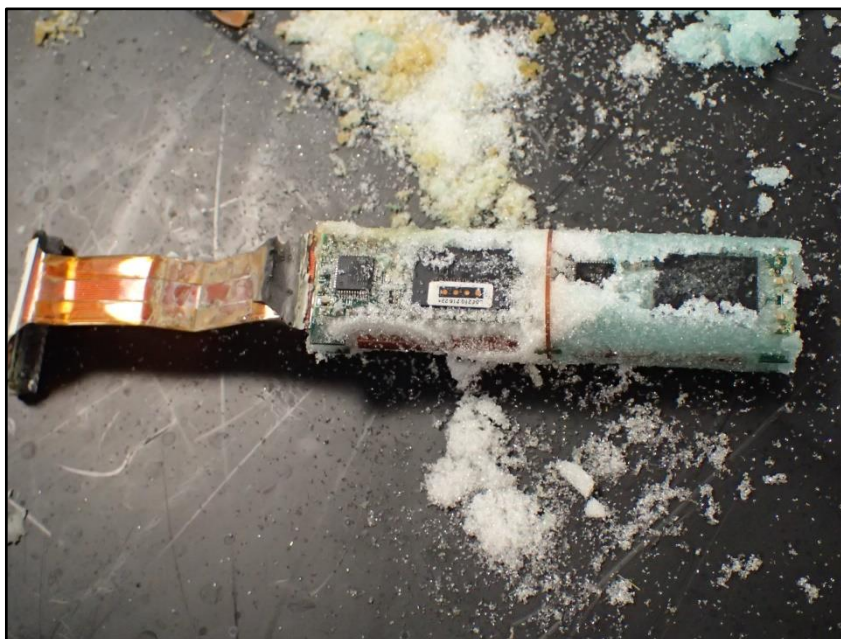
It was noted that water had penetrated the inside of the crash protected enclosure (**Photo No. 1**). Examination of the memory board showed evidence of corrosion on the contacts of several of the memory devices. Electrical testing revealed short circuits which necessitated additional measures to recover the CVR and FDR recordings. These measures included de-soldering individual memory devices and re-installing them on a functional memory board provided by the manufacturer of the MPFR.

**Photo No. 1:** APMB from EI-ICR showing copper based insulation staining of glass beads

However, in 2006 the manufacturer reviewed the design of the MPFR and identified that a change in the composition of an insulation material from boric acid to a copper-based product would improve the performance of the device if subjected to fire. This change was classified by the manufacturer as '*minor*'. As such, it was not deemed necessary to consult with EASA for certification considerations and was approved under the manufacturer's design authorisation. MPFRs with this modification were termed '*second generation (GEN2)*' MPFRs by the manufacturer.

The AAIB's study identified that, of 15 reported cases of MPFR's that had been submerged in sea water, five had suffered from corrosion of the *Accident Protected Memory Board* (APMB). All five of these units were fitted with the GEN2 *Crash Survivable Memory Module* (CSMM) incorporating a combination of copper based insulation and APMBs coated in Polyurethane. Four out of five of these units suffered from the loss of electrical pins on the memory devices due to corrosion (**Photo No. 2**).

- As of December 2017, the MPFR manufacturer started to replace second generation CSMMs fitted to commercial aircraft with third generation CSMMs.
- In February 2018, the manufacturer of the MPFR issued *Service Bulletin (SB) No. D51615-31-22* requiring the replacement of second generation memory modules with third generation memory modules in the affected MPFRs.
- On 8 February 2018, EASA issued *Safety Information Bulletin (SIB) No. 2018-05 Multi-Purpose Flight Recorders* which recommends that owners and operators of the second generation MPFR accomplish the actions specified in the manufacturer's SB No. D51615-31-22.
- EASA has recommended that the MPFR modification program is to be completed by September 2023.

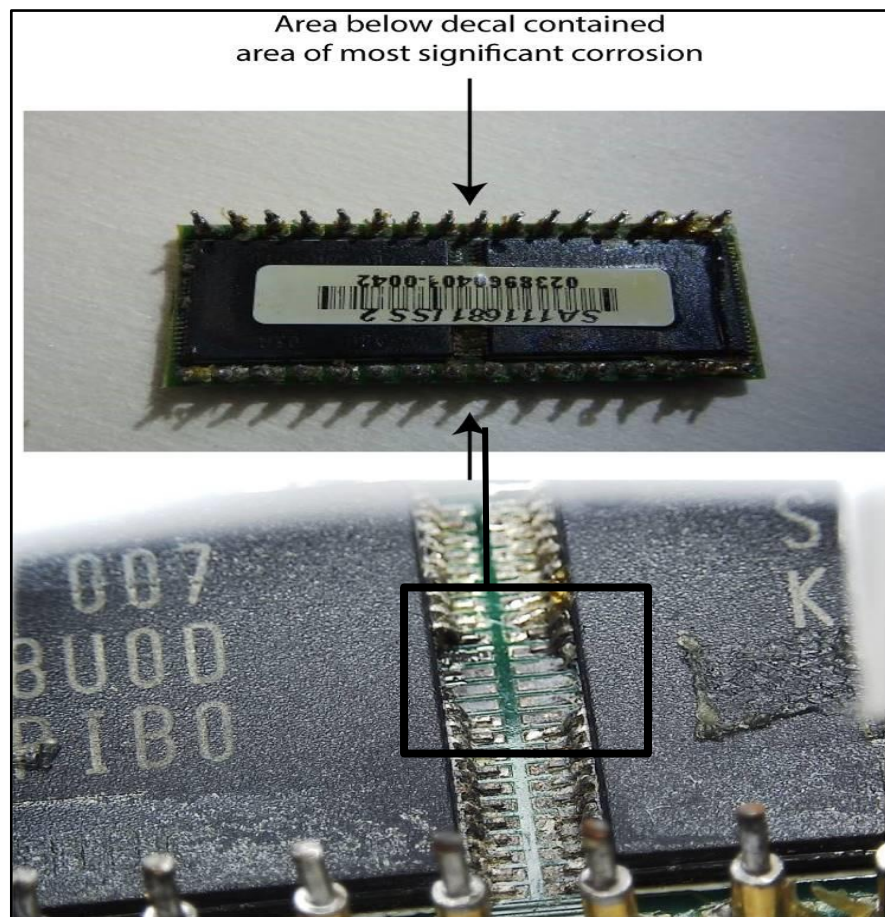
**Photo No. 2:** Underside of FDR1 from EI-ICR showing missing pins due to corrosion

In 2013, a '*third generation (GEN3)*', alternative design<sup>13</sup> of the APMB was introduced. The CSMM insulation materials remained the same, but the conformal coating applied to the APMB was changed to '*Parylene*'<sup>14</sup>.

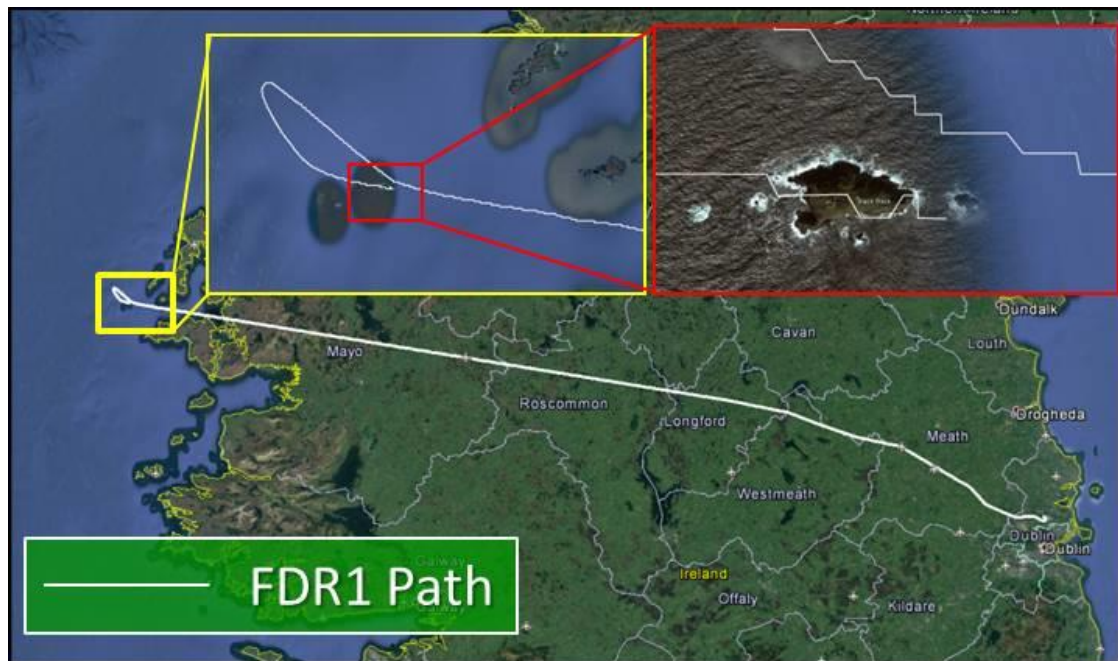
During the examination of the data recovered from the FDR, the Investigation noted that the latitude and longitude position information, whilst generally consistent with the expected flight path, appeared to contain anomalies (**Figure No. 1**).

**Figure No. 1:** Position data from FDR1 showing the flight path of EI-ICR

It was noted that the position information recorded on FDR1 produced a jagged or 'zigzag' flight path. The Investigation reviewed the position information for FDR2 for comparative purposes; this data also indicated a jagged flight path (**Figure No. 2**). The helicopter Manufacturer conducted an examination of the data processing and recording system for present position on the S-92A helicopter.

As a consequence of the issues identified with the coarseness of the latitude and longitude position information recorded on the FDR, as outlined in **Section 2.4** and as further detailed in **Appendix A**, the Investigation makes the following Interim Safety Recommendation to the helicopter Manufacturer:

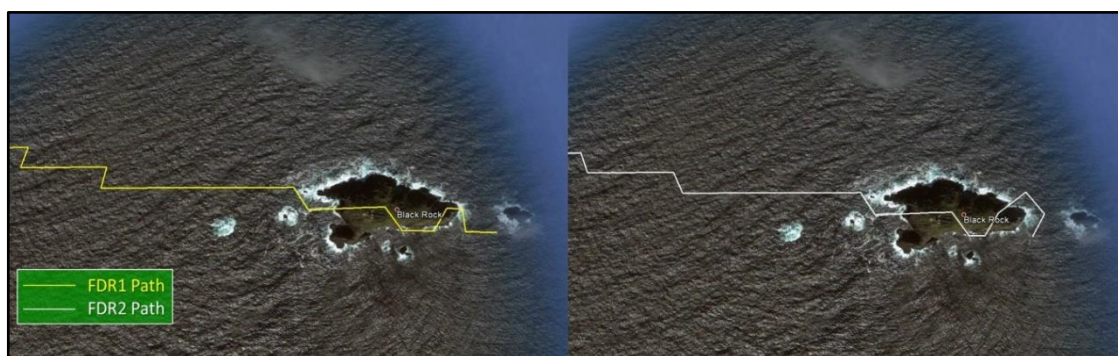
**Figure No. 2:** Position data from FDR1 and FDR2 showing the flight path of EI-ICR

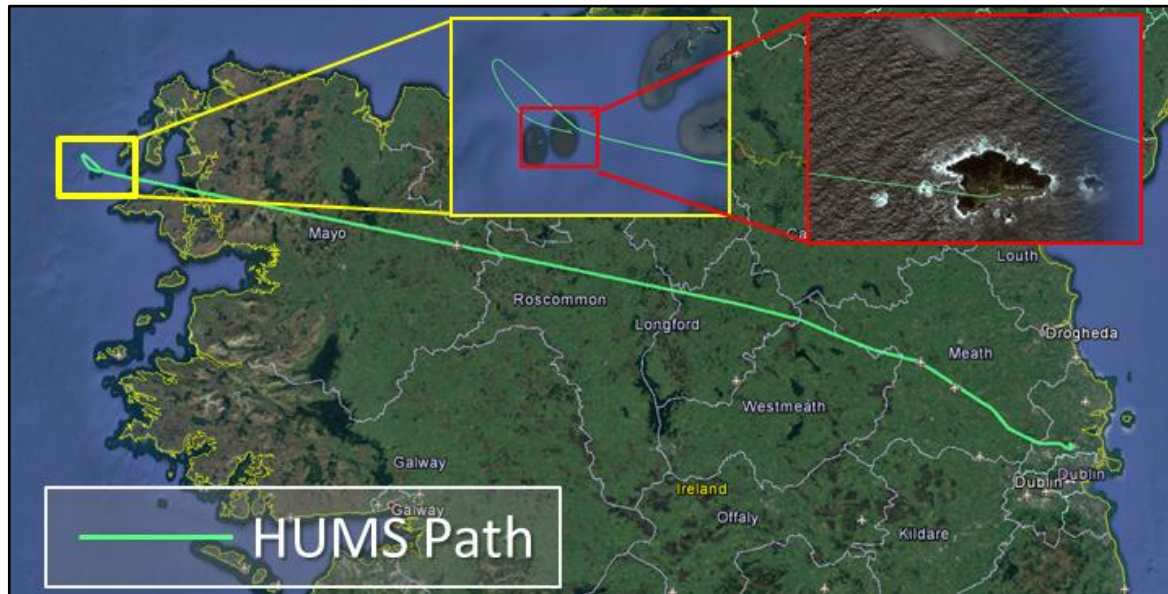
The position provided by the AHRS to the HUMS (**Figure No. 3**) is not subject to the data masking error previously identified by the Investigation in relation to the FDR system. Analysis conducted by the helicopter Manufacturer of the aircraft position recorded by HUMS revealed that HUMS position was not as precise as the AHRS due to the resolution of the aircraft position data in HUMS. Understanding of the resolution limitation allowed the helicopter Manufacturer to analytically correct the aircraft position data.

**Figure No. 3:** Helicopter flight path based on HUMS position data

The corrected position data is estimated by the Manufacturer to be within a margin of error of 2 ft approximately. In light of the errors previously identified in the FDR position data, the Investigation will use the corrected position data recorded on the HUMS for all analysis of the helicopter's flight path or position. The helicopter Manufacturer advised the Investigation that it is changing the HUMS software to increase resolution of aircraft position data to be as precise as the AHRS output.

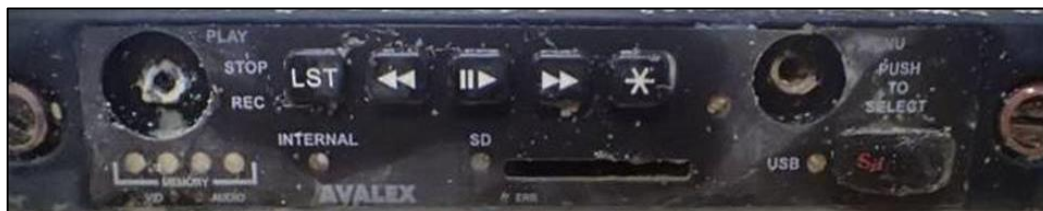
The DVR (**Photo No. 4**) was recovered from the seabed on 23 July 2017. The unit was damaged and both the *Menu* button and *Mode Control* knob were missing from the panel. It was not possible to determine by visual inspection of the panel which position the Mode Control knob was set to at the time of the accident. It was also not possible to determine which media (USB, SD Card, internal) was selected as the storage location for recorded data.

**Photo No. 4:** Avalex AVR-8240-XM Digital Video Recorder from EI-ICR

The unit was brought to the NTSB Vehicle Recorder Section for analysis. Three video files were recovered from a USB flash drive which was present in the USB slot on the front panel of the DVR, including a video file from a mission conducted by a different crew in EI-ICR on 12 March 2017. The files occupied 1 GB of space on the USB drive. There were no files relating to any flights after 12 March 2017 on the USB device, which had approximately 15 GB of free space remaining.
