Air Accident Investigation Unit Ireland

PRELIMINARY REPORT

Partenavia, P68, F-HIRD

Near Carnsore Point, Co. Wexford

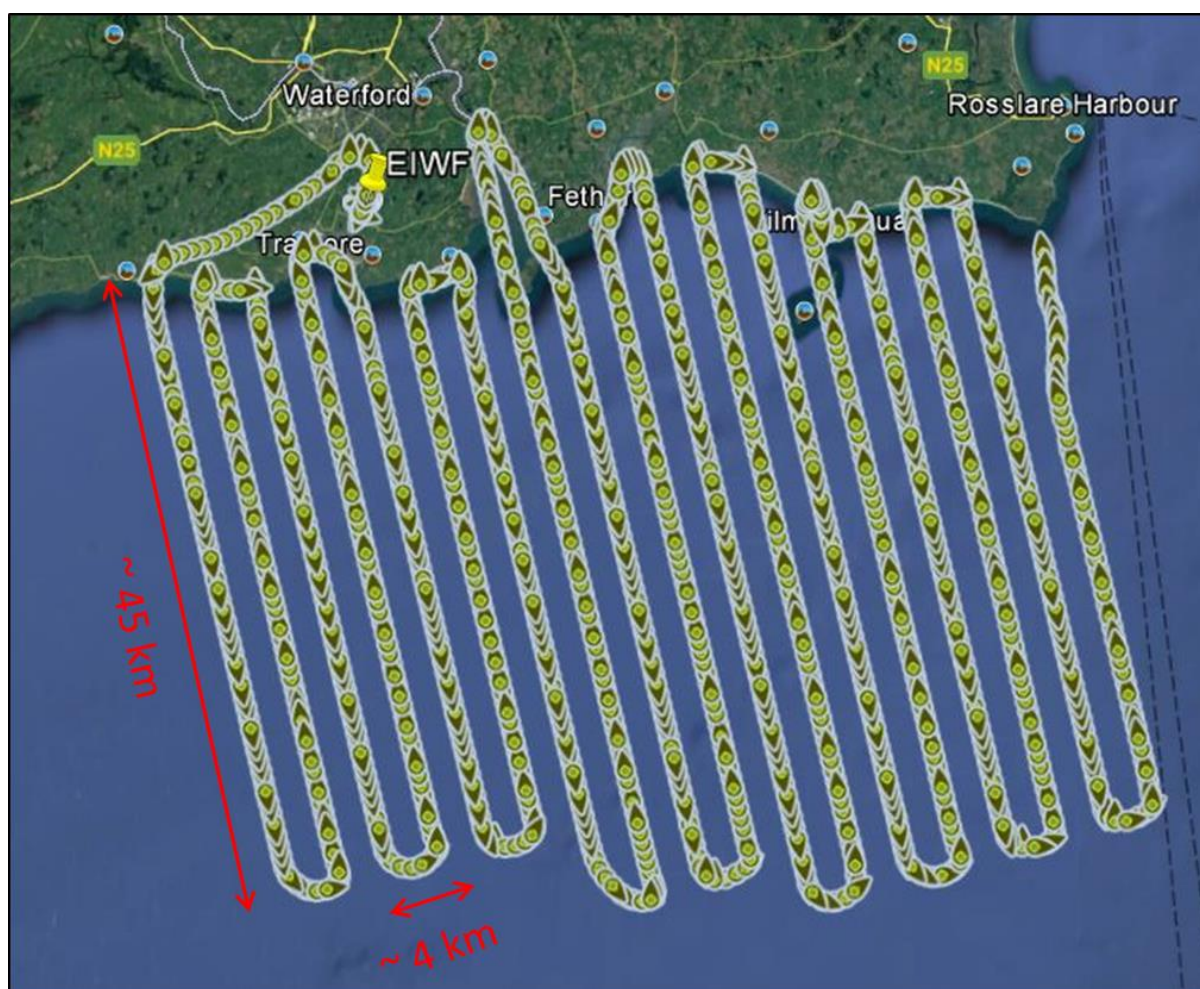
Figure No. 1: Aircraft Track (Spider Tracks and Google Earth)

The plan for the flight was to fly at low altitude along 16 pre-defined survey lines. Each line was approximately 45 km in length and the lines were spaced approximately 4 km apart. The planned 16 survey lines were completed after 4 hours and 30 minutes of flying. Following a discussion with the passengers, and after assessing the remaining fuel, the Pilot determined that there was approximately 1 hour and 45 minutes of fuel remaining and they decided to complete two more survey lines before returning to EIWF (**Figure No. 1**).

The Pilot informed the Investigation that two minutes after commencing the final survey line (i.e. the 18th survey line), an abnormal drop in the indicated fuel quantity was observed, the right engine stopped, and within approximately four minutes the indicated fuel quantity in the right tank dropped to zero.

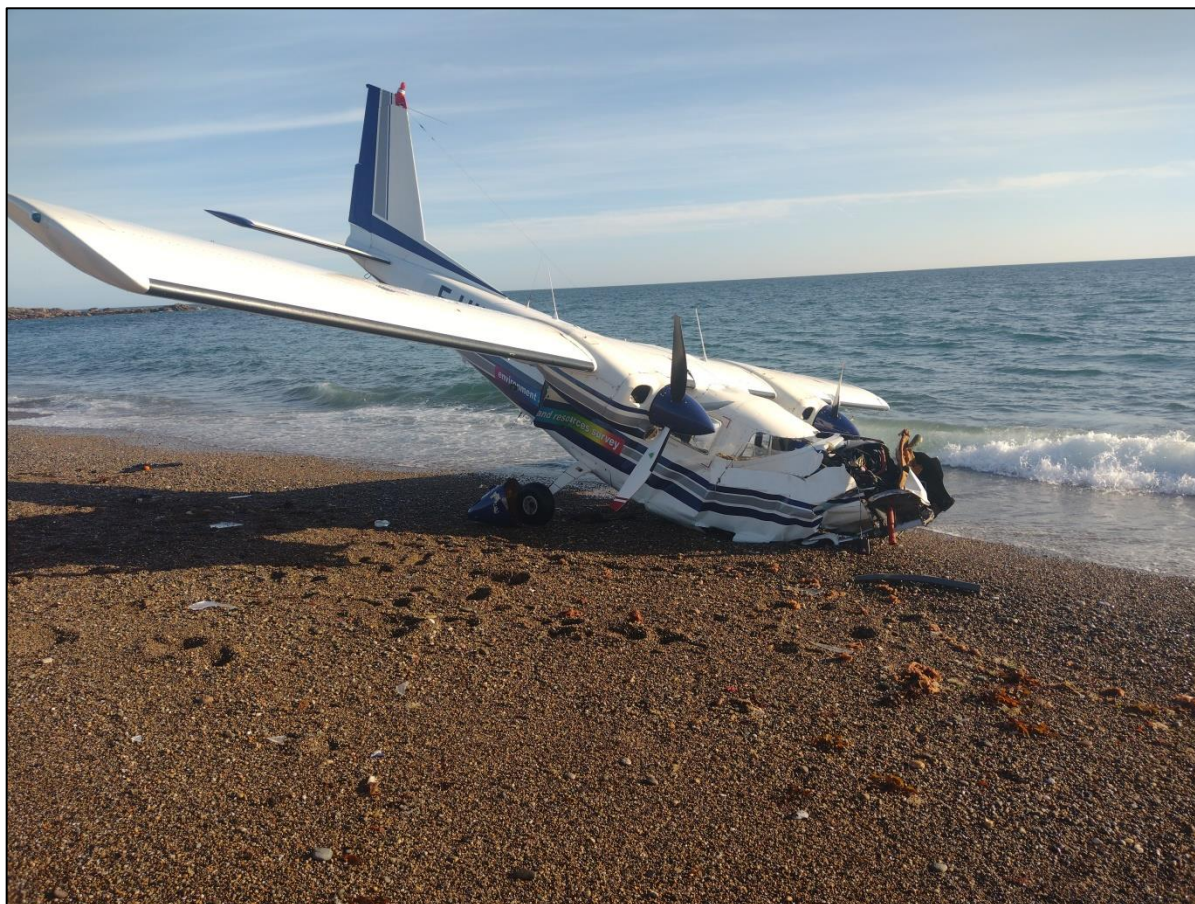
Photo No. 1: Aircraft position shortly after the accident (*courtesy of aircraft passenger*)
[Operator de-identified]

The forced landing was performed on a beach near Carnsore Point, Co. Wexford. The surface of the beach consisted of loose shale and sloped towards the sea. **Photo No. 1** was taken by a passenger of the aircraft shortly after the accident occurred.
