Air Accident Investigation Unit Ireland

SERIOUS INCIDENT REPORT
(1) AIRBUS A321-231, G-OZBS
(2) BOEING 737-8AS, EI-DPT
Dublin Airport (EIDW), Ireland
21 May 2011

AAIU Draft Final Report No: 2012-017

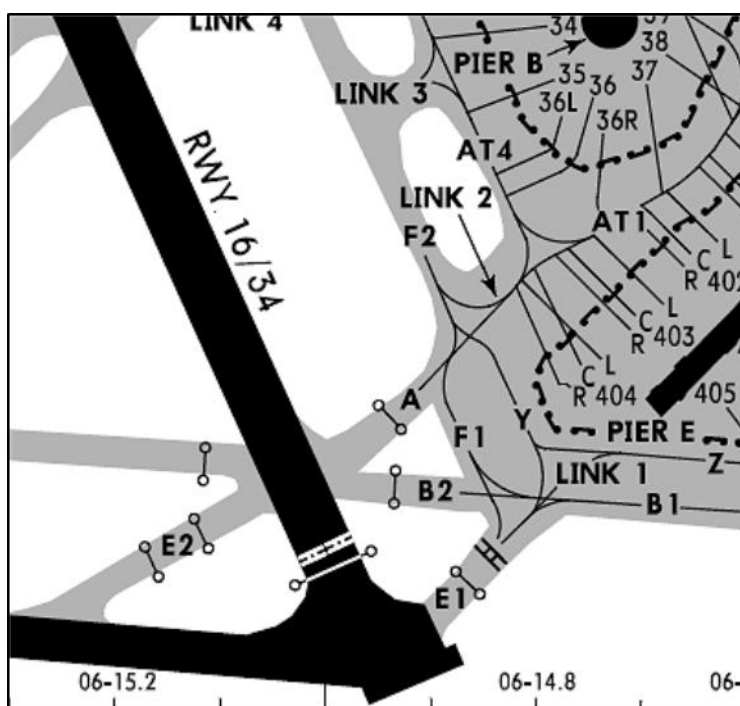
Figure No. 1: Extract Jeppesen EIDW 10-9B (8 Oct 2010)

These were depicted on Jeppesen chart EIDW 10-9 (**Figure No. 3**). Hot spots were not depicted on the larger scale EIDW 10-9B charts (**Figure No. 1**).

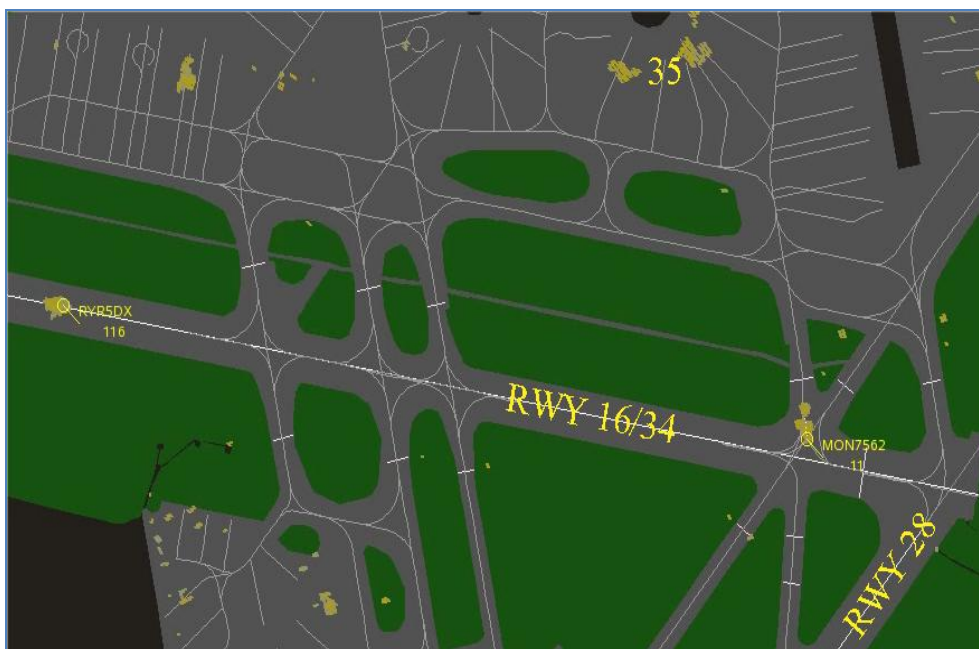
Figure No. 2: ASMGCS Recording of Occurrence

The ASMGCS recording showed the tracks of both aircraft and also their ground speeds. It showed that after start and push back, G-OZBS turned right to taxi on AT₄ and stopped short of Link 2. After 37 seconds it resumed progress and turned right at a slow speed onto Link 2. While it was taxiing slowly along Link 2, an aircraft that had landed on RWY 16 turned off the runway onto B2. It passed by the left hand side of G-OZBS, which was then at the FI intersection. At that point G-OZBS, then clear of the incoming traffic, continued straight ahead on A and accelerated slightly to a ground speed of 14 kts. It then went straight across the Link 2/FI intersection and taxied along A.

At 16.47:39 hrs the ASMGCS recorded G-OZBS at the edge of RWY 16, which it then entered and stopped. In the meantime EI-DPT was accelerating in its take-off run. At 16.47:48 hrs the recording showed that EI-DPT reached a peak ground speed of 118 kts and commenced decelerating; it was then 820 metres from the threshold RWY 16.

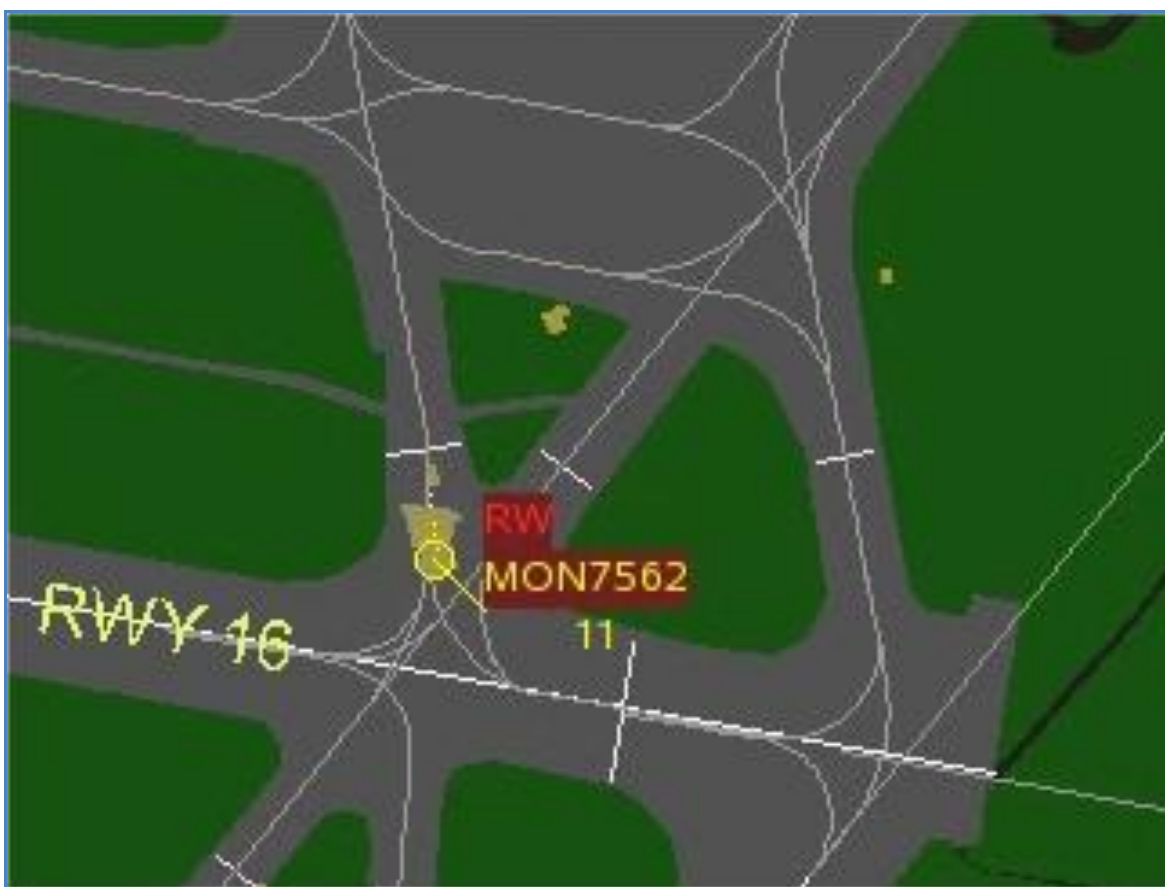
Figure No. 4: RIMCAS Alert in Test Configuration

RIMCAS uses vector calculations to predict possible active runway conflicts between aircraft and other objects. This information assists air traffic controllers by providing both visual and audio alerts and warning of evolving runway incursions that may result in traffic conflicts or collisions. Although RIMCAS was not operational at the time of the occurrence, a replay of the data through its test configuration correctly captured and flagged the active runway incursion by Flight 7562 (G-OZBS) as shown in **Figure No. 4**.

Although RIMCAS can detect the incorrect presence and provide an audio warning of an aircraft, vehicle or person on the protected area of a surface designated for aircraft landing and taking-off, it does not provide advance warning of an imminent runway incursion.

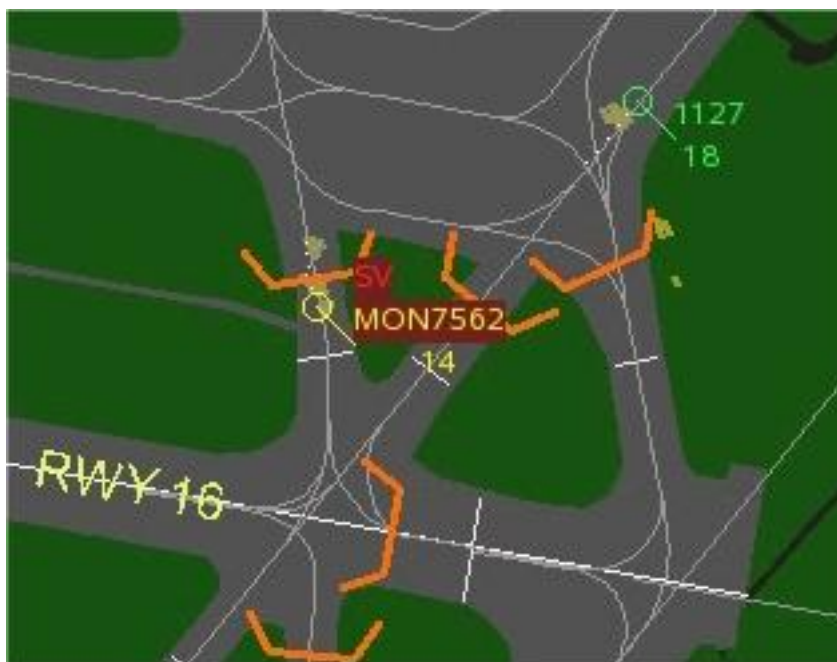
Figure No. 5: SVM Alert in Test Configuration

As SVM detects the incorrect presence of an aircraft, vehicle or person before it enters the protected area for aircraft landing and taking-off, it can provide advance warning of a potential runway incursion.
