Air Accident Investigation Unit Ireland

FORMAL REPORT

Reims-Cessna F150H, EI-AST

11 November 2012

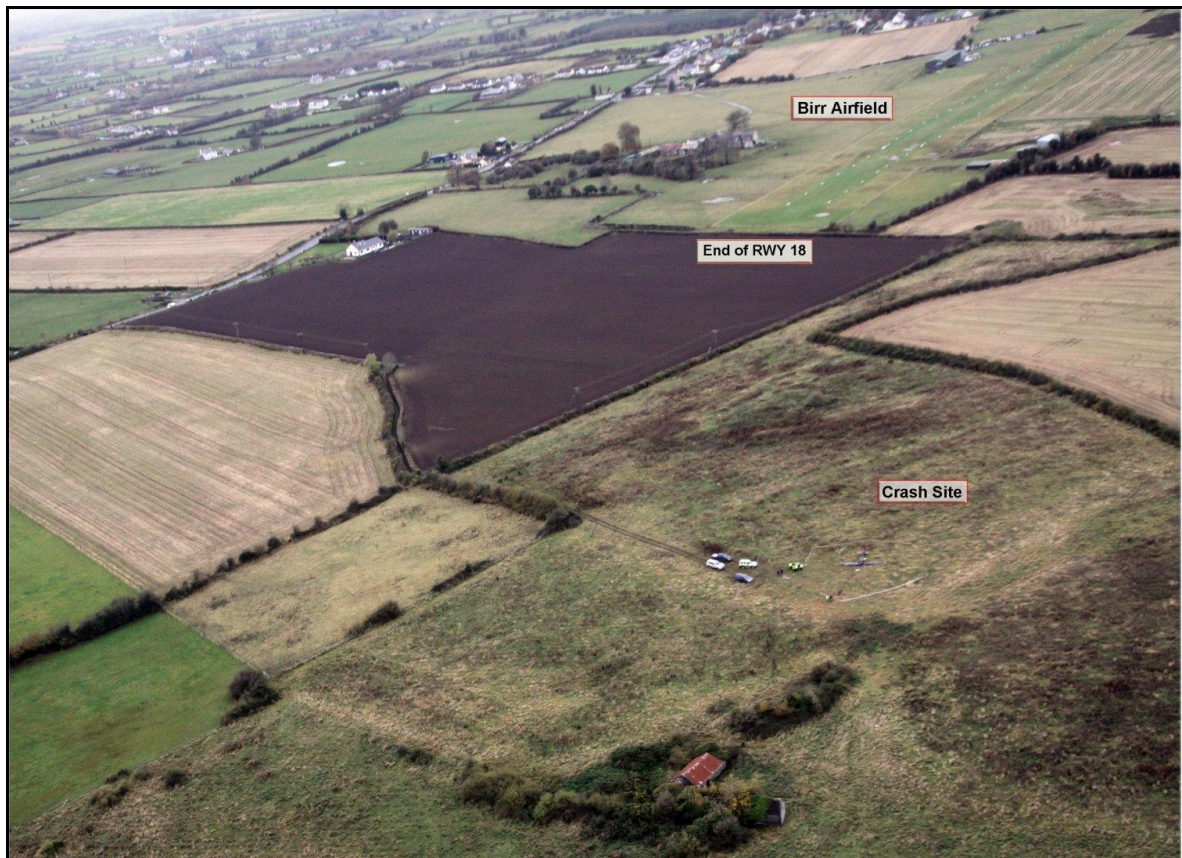
The accident site, (**Photo No.1**) which was located approximately 350 metres southeast of the end of RWY 18 at EIBR, was examined the morning after the accident. The site was in a small field that contained a plantation of immature saplings. The area of the field was approximately 1.5 hectares; the fields in the immediate vicinity were also small and irregular.

Photo No. 1: Accident site (photo courtesy of An Garda Síochána Air Support Unit).

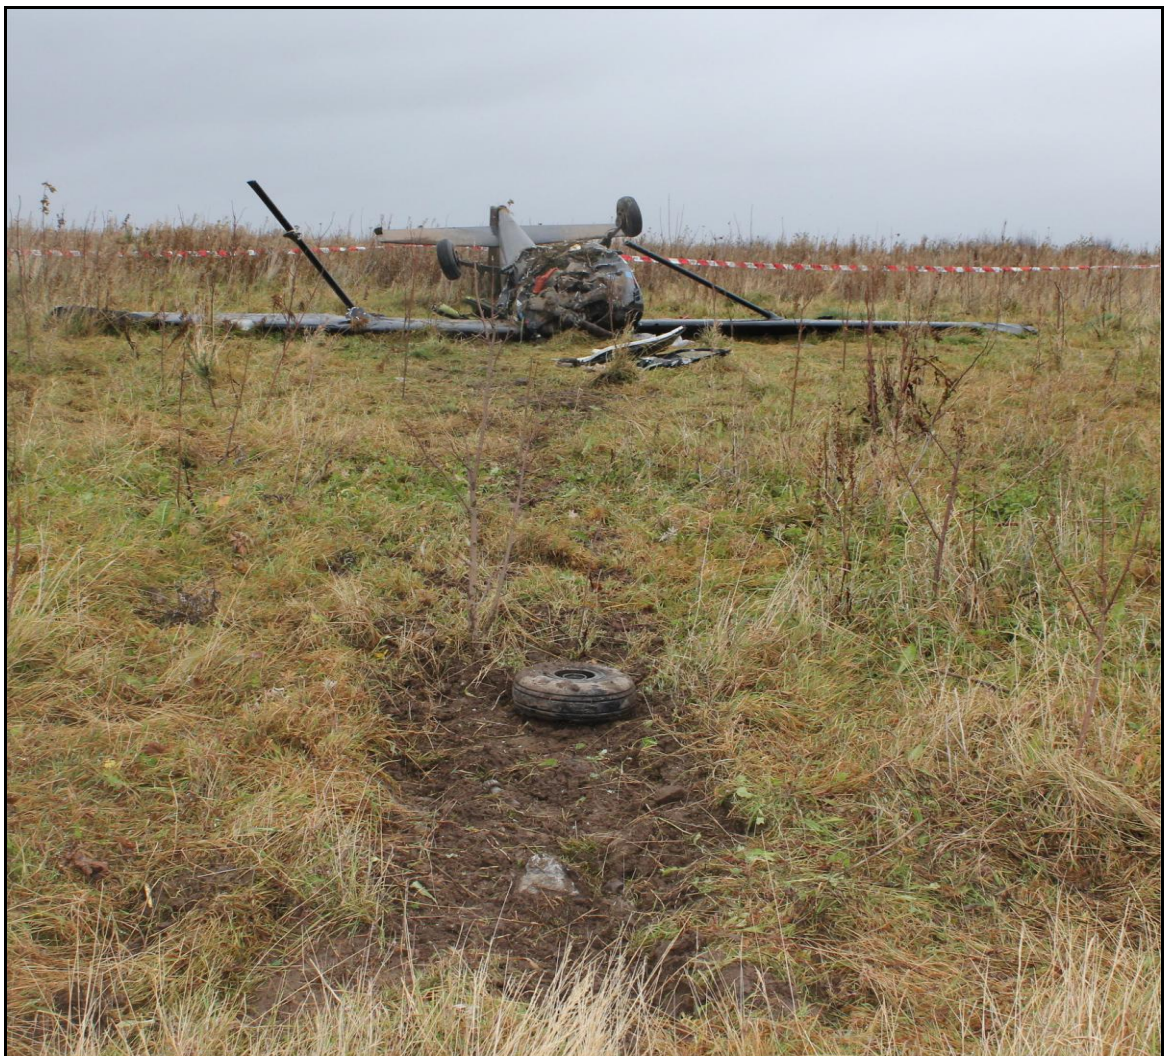
The nose wheel was found 2.3 metres from the initial impact point. The aircraft came to rest inverted 16 metres from the initial impact point. All major parts of the aircraft were accounted for at the accident site location.

The Investigation found no evidence of any substantial fuel deposit at the accident site although a small amount leaked from the inverted wreckage when raised during the recovery operation, this was insufficient for fuel analysis. A subsequent inspection of the accident site found no evidence of the grass staining that is symptomatic of fuel contamination.

Photo No. 2: Initial impact site and final resting position of wreckage.

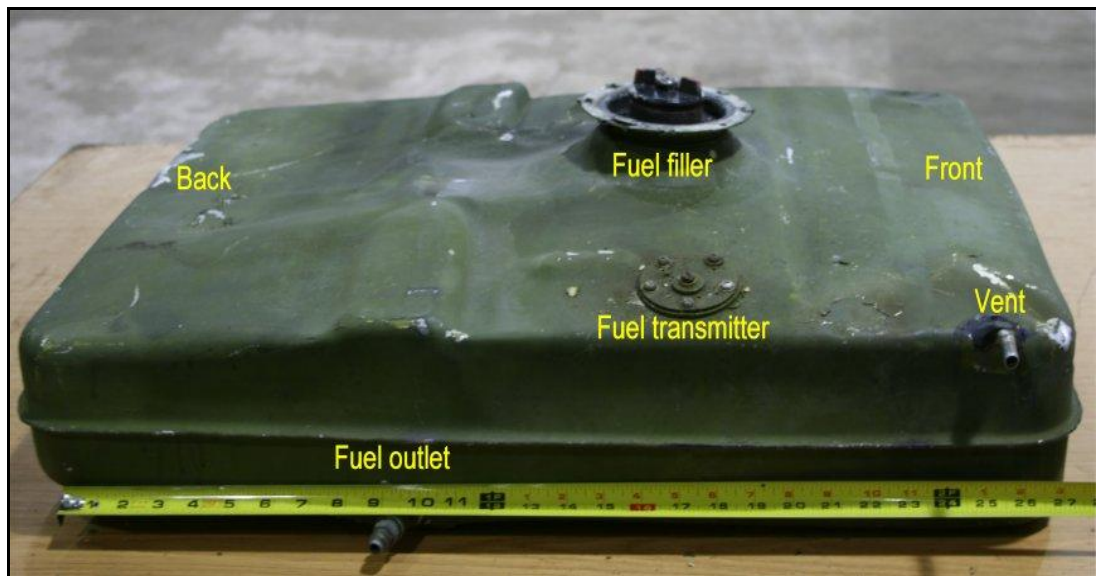
The float chamber of the carburettor had been severed during the impact. The fittings and connections attached to both fuel tanks were found intact during examination with the exception of the vent line from the port tank which had separated. Consequently, the port fuel tank (**Photo No. 3**) was removed and examined. It was adequately supported with all fittings intact, attached and connected. Other than a compression buckling on its outer side, the tank was relatively undamaged. The fuel quantity float transmitter was undamaged and clean with full and free movement.

Photo No. 3: Port fuel tank EI-AST

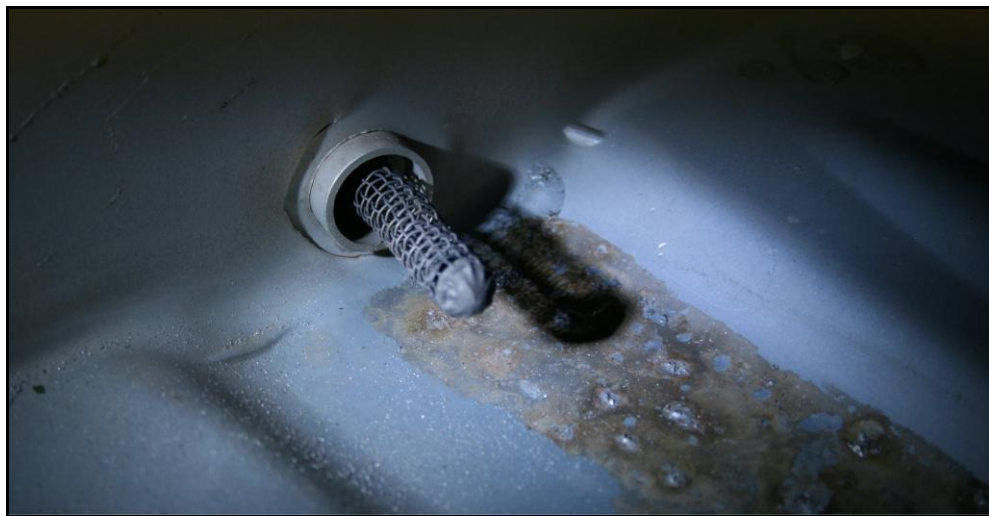
The coarse filter (**Photo No. 4**) attached to the fuel tank outlet was clean. The outlet was located on the inboard wall slightly above a manufactured recess in the floor of the tank, approximately 1/3 of the tank length forward from the rear wall.

Photo No. 4: Internal filter in fuel tank outlet

Other than some minor surface staining on the bottom of this recessed area the internal surfaces of the tank were clean. As the tank was recovered from the still inverted wing, this staining predated the accident flight.
