Air Accident Investigation Unit Ireland

SYNOPTIC REPORT

SERIOUS INCIDENT

**Involving
Diamond Twin Star DA42, G-COBS
& Piper PA 31-350, G-FCSL
5 NM east of Ireland West Airport
Knock, Co. Mayo
22 April 2013**

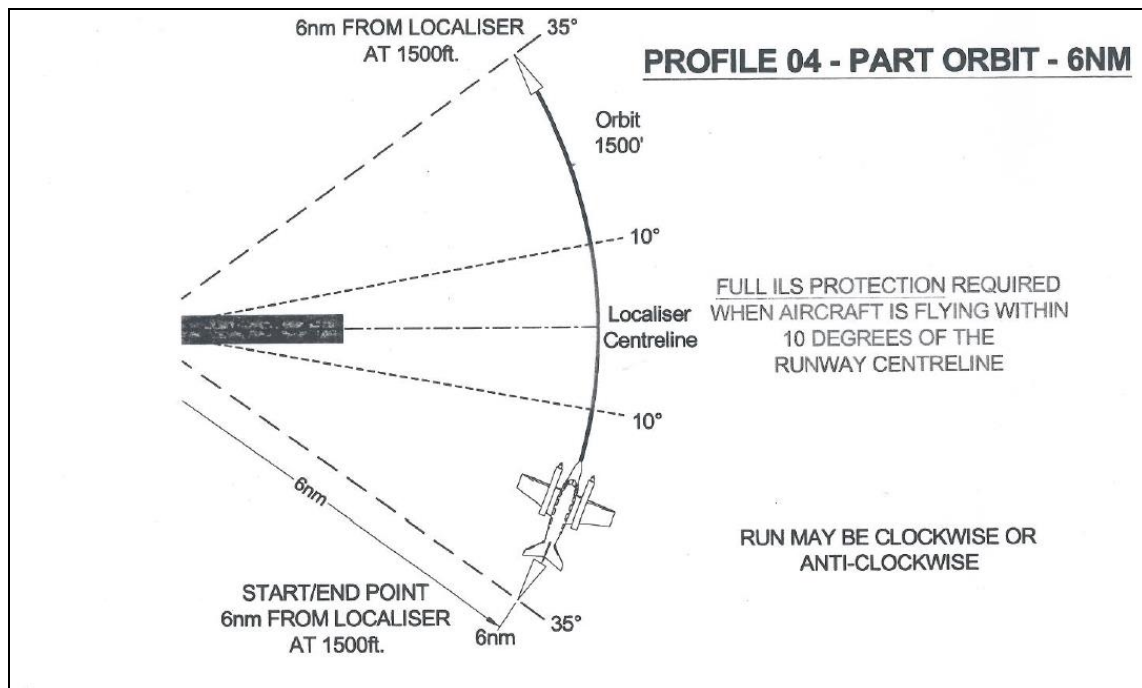
Twenty four seconds later at 12.15:18 hrs, CAL01 reported at the start point of the Profile 04 and requested to the AMC that "if you are happy we would like to continue out passing behind the other calibrator". The AMC acknowledged this and instructed CAL01, "you can report the profile complete". The AMC did not refer to CLB205 being on the approach to RWY 27 at that time. Profile 04, involves the aircraft performing a south to north arc at a height of 1,500 ft QFE⁵/2,100 ft QNH⁶ at right angles across the approach path of RWY 27 at a distance of approximately 5 NM from the threshold of the runway and approximately 6 NM from the localiser (**Graphic No. 1**).

Graphic No. 1: Profile 04 being performed by CAL01

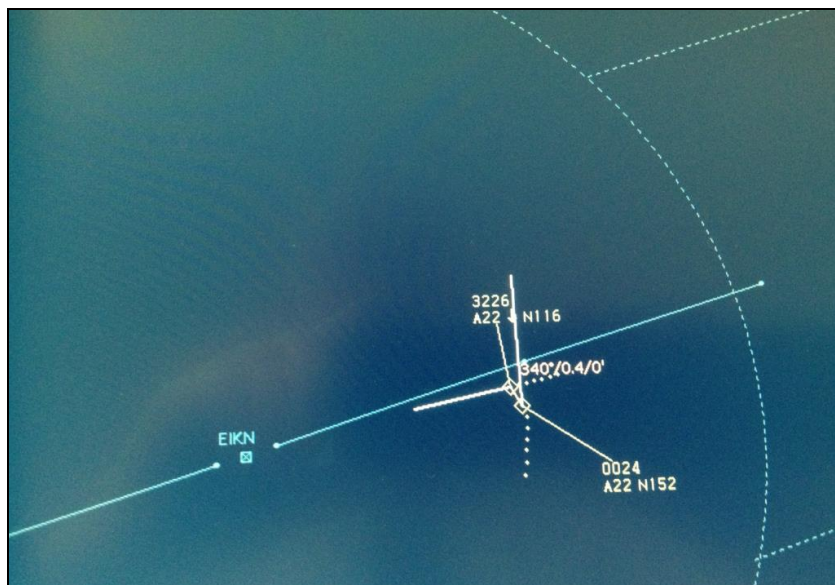
At the point of minimum separation, the uncorrelated radar trace from the Shannon ACC (**Graphic No. 1**) showed that CLB205 (squawk 3226) was at 2,200 ft (A22) descending, while CAL01 (squawk 0024) was level at 2,200 ft (A22) and the two aircraft were 0.4 NM apart.

More detailed analysis of the radar data determined that the minimum separation was 0.42 NM laterally with zero vertical separation.

Graphic No. 1: Radar return at minimum separation

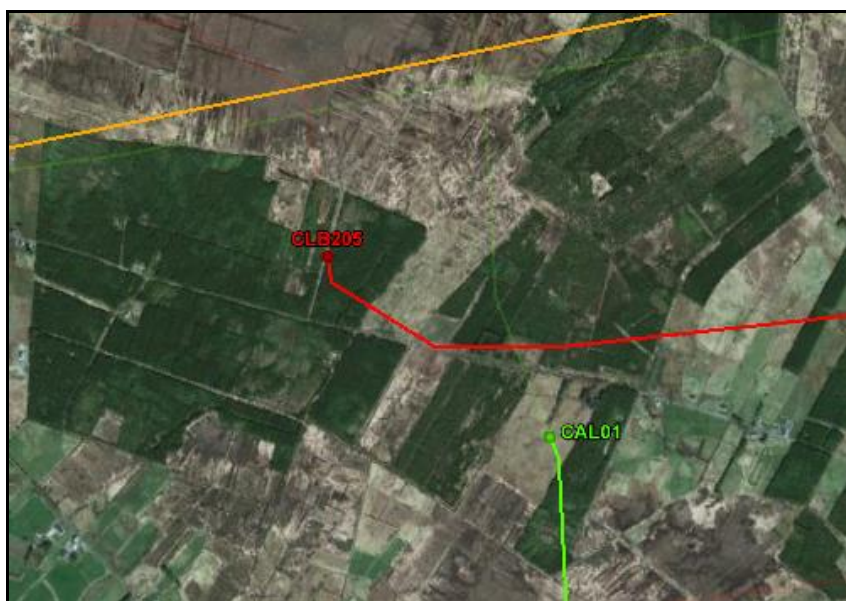
Following the completion of the evasive manoeuvre by CLB205, the projected flight path of CAL01 identifies that the aircraft would cross and pass behind CLB205 (**Graphic No. 2**).

Graphic No. 2: Projected flight path of CAL01 (Green) to cross and pass behind CLB205 (Red)
(The amber line indicates the extended centreline for RWY 27)

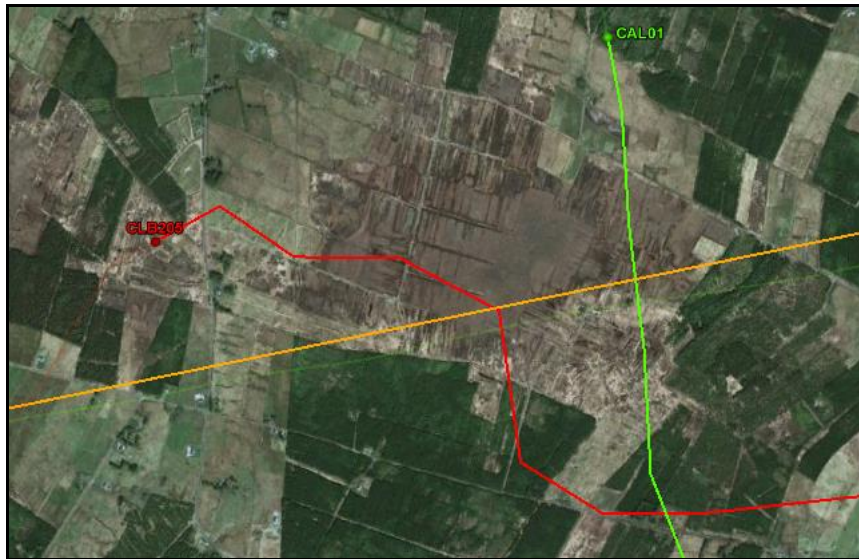
In calculating an approximate point at which CAL01 reported observing the CLB205 in their 8 o'clock position, the Investigation determined that CLB205 was commencing a left turn back to the runway, while CAL01 was approximately 0.4 NM north of the extended centreline for RWY 27 and continuing on the Profile 04 arc (**Graphic No. 3**).

Graphic No. 3: Approximate point where CAL01 would have observed CLB205 in the 7- 8 o'clock position
