# **Air Accident Investigation Unit Ireland**

## **SYNOPTIC REPORT**

**Cessna TU206G Stationair 6, G-SKYE  
Near Abbeyshrule, Co. Longford  
21 June 2014**

AAIU Report No: 2015-017  
 State File No: IRL00914045  
 Report Format: Synoptic Report  
 Published: 21 September 2015

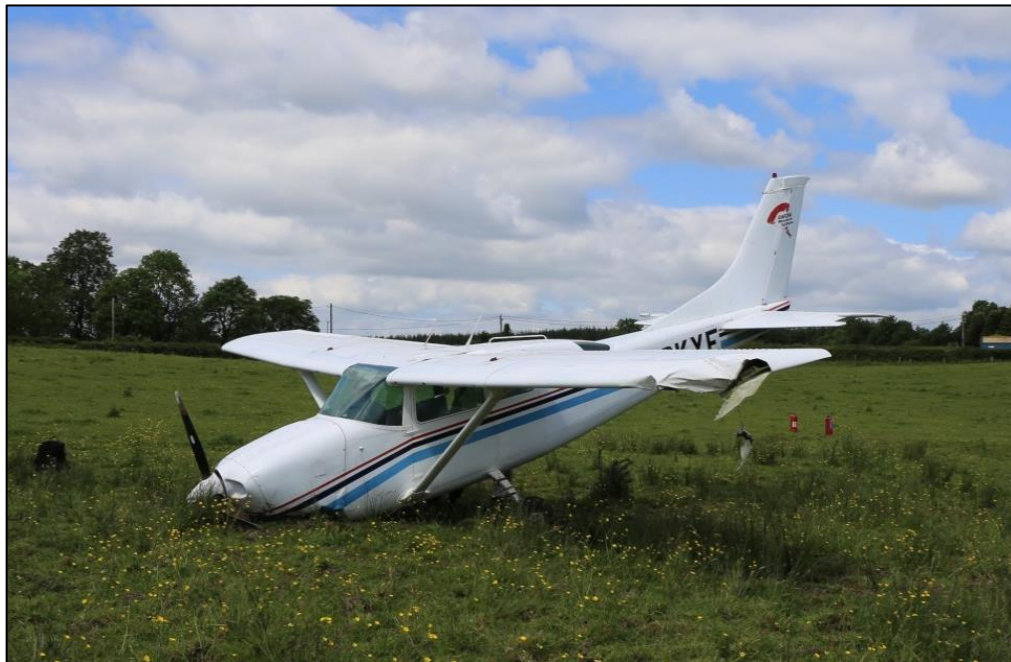
He made a 'Pan'<sup>6</sup> call to EIAB and selected a field to his right in which to land. He commented that at this stage the "engine note" was "up and down" and he was losing altitude but he didn't shut the engine down as he thought that it may have been providing some power. He realised that he was not going to make the chosen field and noticed another field to his left. He made a turn to the left, but then saw livestock in the upper right hand corner of the field. The Pilot reported that he adjusted the aircraft's approach path accordingly and picked his landing spot. He said that he was aware of trees on the approach, but knew he could clear them. He flared the aircraft and felt it sink for "maybe six feet", before it made contact with the surface of the field and bounced. When the aircraft contacted the ground for the second time, the nose landing gear collapsed, however the aircraft continued in a straight line. The left hand wing tip then contacted the ground following which the aircraft returned to wings level and came to rest a short distance later (**Photo No. 1**).

**Photo No. 1:** Final resting position of G-SKYE, with nose 'dug-in' and damage to left hand wing.

The aircraft was substantially damaged as a result of the accident. When the aircraft touched down following the bounce, the nose landing gear collapsed, which resulted in damage to the nose area of the aircraft. Two of the three propeller blades were bent and the engine bulkhead was distorted. Some damage was also sustained to the lower fuselage skin. The left wing tip was damaged when it contacted the ground, which resulted in damage to the upper fuselage between the wings.

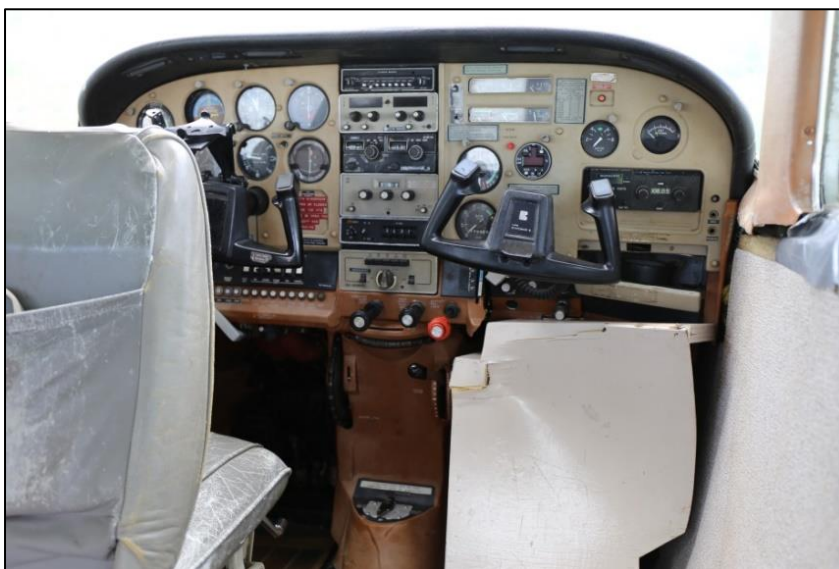
The aircraft, a Cessna TU206G Stationair 6, registration G-SKYE, was manufactured in 1978 and was fitted with a Continental TSIO-520-M (7) engine. It was owned and registered in the United Kingdom (UK) and was normally based there, but had been leased on 30 May 2014 by a skydiving club operating in Ireland. The aircraft had a maximum take-off weight of 1,633 kgs (3,600 lbs.). The cockpit had seating on the left hand side for one pilot which was fitted with a restraint harness. To facilitate parachute operations, there was no right hand cockpit seat installed. The rudder pedals and foot well area on the right hand side of the cockpit were blocked off with a wooden structure. The right hand control column/wheel remained in-situ and was not blocked off (**Photo No. 2**).

**Photo No. 2:** Cockpit of G-SKYE showing wooden structure at right hand foot well area.

**Figure No. 1** below illustrates how the skydivers, all of whom were facing rearwards, were carried on the aircraft during the accident flight. One of the Tandem Masters was seated with his back/parachute pack against the wooden structure used to block off the right hand foot well area, leading to damage to this structure during the forced landing (**Photo No. 2**).

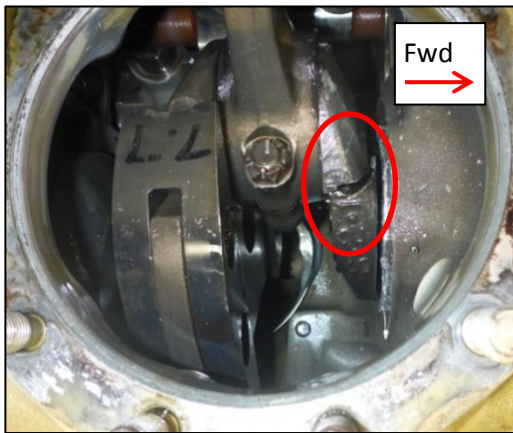
It was confirmed that the crankshaft was broken between the number three main bearing journal and number six cheek, aft of cylinders five and six (**Photo No. 3** and **No. 4**). Mechanical deformation and heat tinting were present on the cheek and journal.

**Photo No. 3:** Broken crankshaft as seen with the number four cylinder removed.

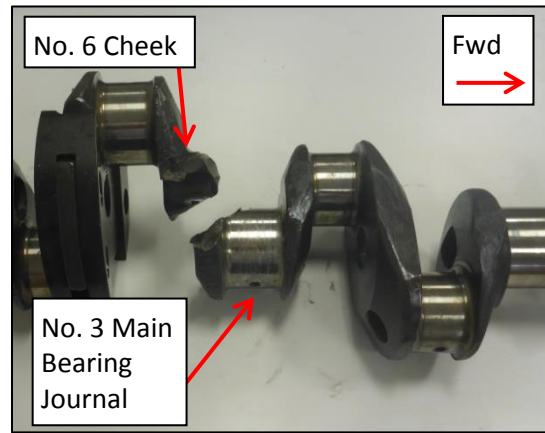
**Photo No. 4:** Crankshaft fracture between the number 3 main bearing journal and the number six cheek (web).

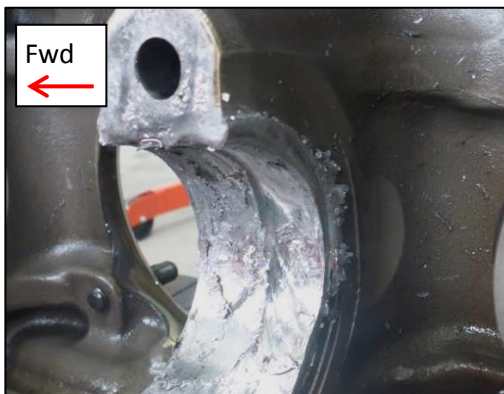
**Photo No. 5:** Damage to the number three bearing housing/saddle on the 1, 3, 5 crankcase half (viewed from the crankshaft side).

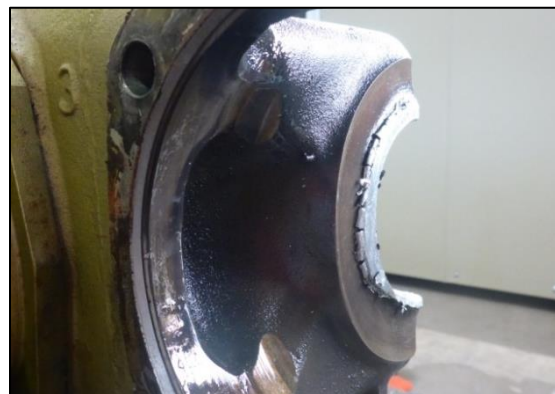
**Photo No. 6:** Damage to the forward face of the number three bearing housing on the 1, 3, 5 crankcase half (viewed from the cylinder side).

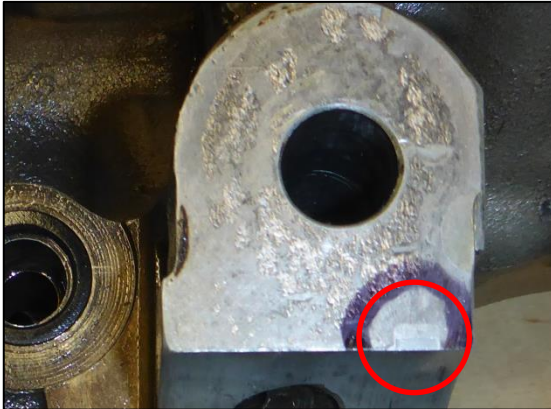
Evidence of fretting<sup>16</sup> was found on the mating faces of the main bearing housings/saddles. In addition, indentations caused by the bearing tangs on the main bearings fitted to the opposite crankcase were noted on some of these faces (**Photo No. 7**). There was also evidence of fretting on the crankcase parting surfaces (**Photo No. 8**).

**Photo No. 7:** Fretting on the number four main bearing housing/saddle face and indentation (circled) caused by the tang on the opposite bearing.

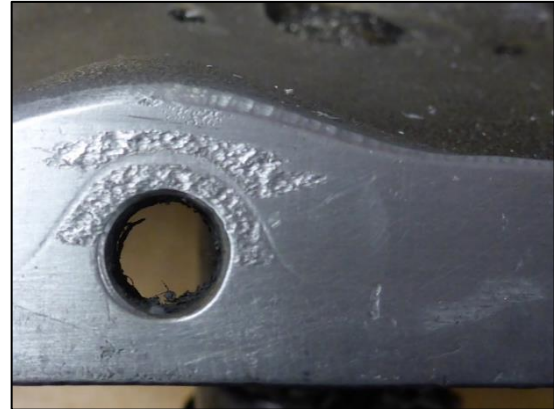
**Photo No. 8:** Fretting on the crankcase parting surface.

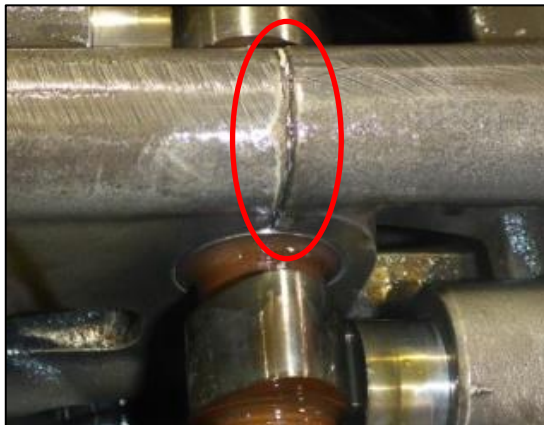
Before the crankcase halves had been separated during engine disassembly, a white-coloured sealant was evident at the crankcase parting surfaces adjacent to the camshaft (**Photo No. 9**). When the crankcase halves were separated, the white-coloured sealant was found on the parting faces of each crankcase half (**Photo No. 10**).

**Photo No. 9:** Sealant visible on crankcase parting surface adjacent to camshaft, before engine disassembly.

Following the disassembly of the engine, a photographic report on the engine condition and associated findings was provided to the Manufacturer which included photographs of the sealant found. In response, the Manufacturer stated that the sealant material shown in the photographs *“would be more than enough to cause the damage”*.

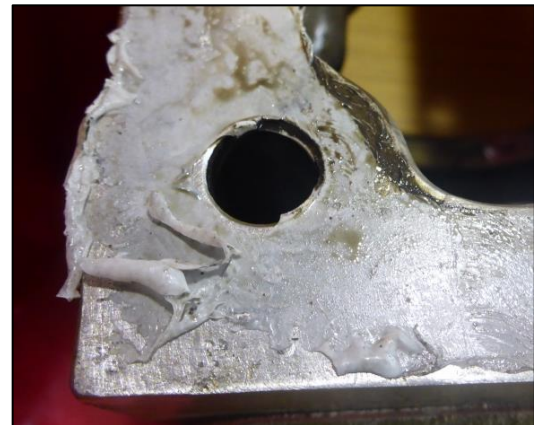
**Photo No. 10:** Sealant visible on crankcase parting surface following separation of crankcase halves.

The Manufacturer specifies the use of silk thread to perform the sealing function on the crankcase parting surfaces. Silk thread was not found to be present during engine disassembly.

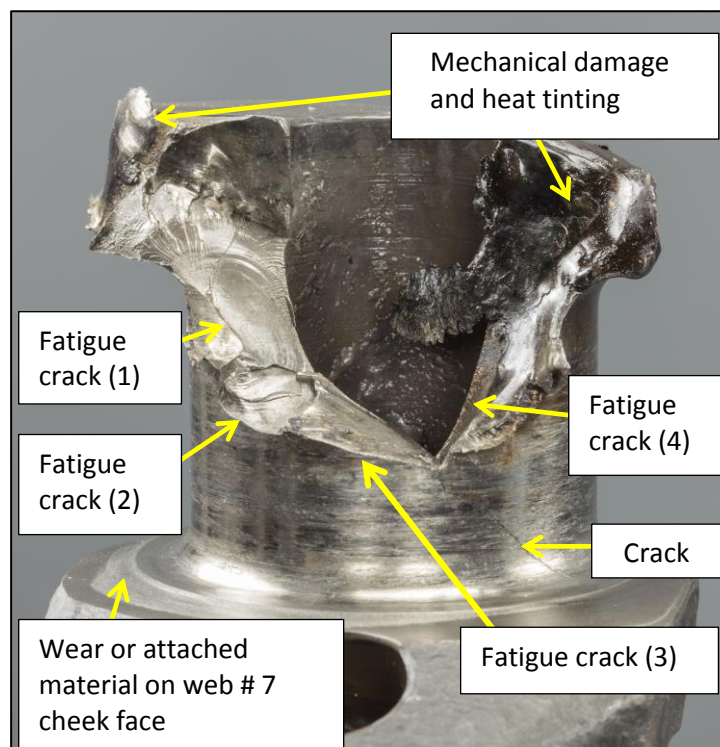
The crankshaft was sent to a specialist laboratory for detailed metallurgical analysis. The resulting report highlighted that the crankshaft fractured due to the initiation and propagation of multiple fatigue cracks through the wall thickness of the number three main journal (**Photo No. 11**).

**Photo No. 11:** Forward section of fractured number three main journal.

In conclusion, the report stated, *inter-alia*, that *“It is suspected that localised thermal expansion of the [number three] journal has resulted in the formation of longitudinal cracks in the brittle surface layer of the journal, these surface cracks have initiated a number of fatigue cracks that have propagated through the wall thickness of the journal resulting in final fracture of the crankshaft”*.

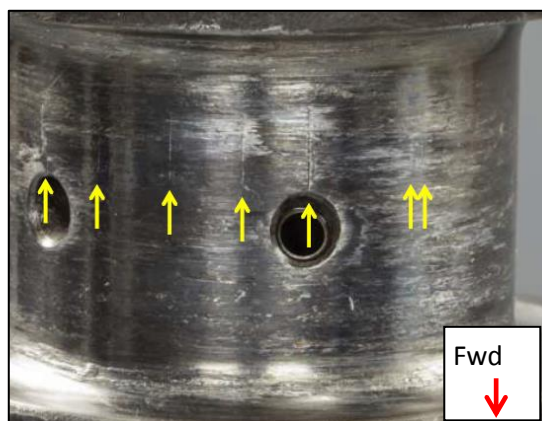
A number of longitudinal surface-breaking cracks were also observed on the surface of the fractured journal (**Photo No. 12**). Examination of fatigue crack (2) on the forward section of the crankshaft and the opening of one of the longitudinal cracks indicated that the origin of the fatigue cracks could be associated with the longitudinal cracks (**Photo No. 13**).

**Photo No. 12:** Longitudinal cracks present on fractured number three main journal.

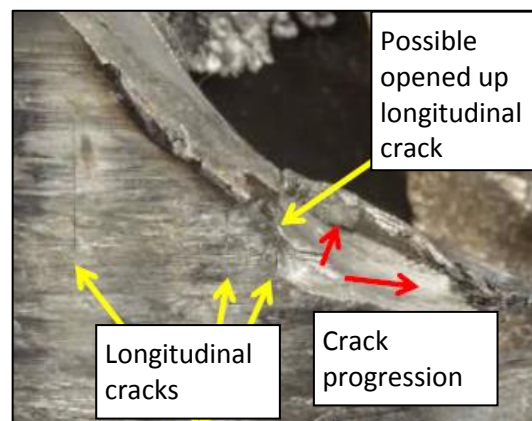
**Photo No. 13:** Origin of fatigue crack (2) from what appears to be one of the longitudinal cracks.
