Air Accident Investigation Unit Ireland

SYNOPTIC REPORT

**Cessna 208B, N208B
Ballyart, Co. Limerick
13 December 2014**

AAIU Report No: 2015-020**State File No: IRL00914106****Report Format: Synoptic Report****Published: 12 November 2015**

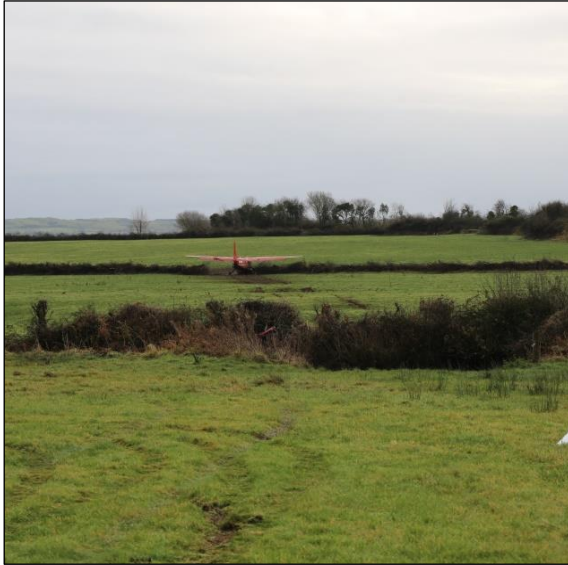
The ditch situated at the end of the runway had steeply sloping sides and contained water to a depth of approximately 0.5 m. The outer section of the left elevator had detached due to contact with a fence post and was found on the far side of the ditch embedded in the hedgerow (**Photo No. 1** and **Photo No. 2**).

Photo No. 1: End of runway and ditch

The Investigation suggested to the airfield owner that he should consider back-filling the entire ditch where it crosses the end of the runway to provide a safe over-run should a subsequent over-run event ever occur. The Airfield Owner agreed to this suggestion and as a result, no Safety Recommendation is made regarding this.

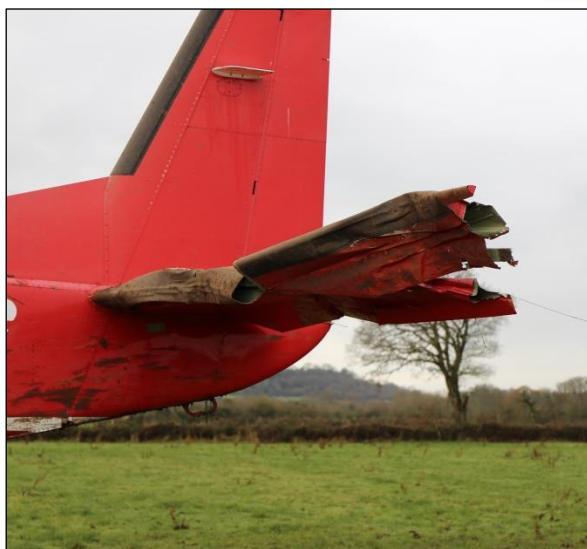
The aircraft sustained substantial damage. The aircraft made contact with several wooden posts and a section of pruned hedgerow which was situated at the end of the runway. The most severe damage was caused to the left tailplane (**Photo No. 3**), with compression buckling evident on the fuselage underneath the tailplane carry-through structure. The skin on the aft underside of the fuselage was torn with some damage to the lower fuselage frames. The propeller blades were bent at the tips due to contact with a piece of concrete at the entrance to the field where the aircraft came to halt (**Photo No. 4**).

Photo No. 3: Damage to left tailplane

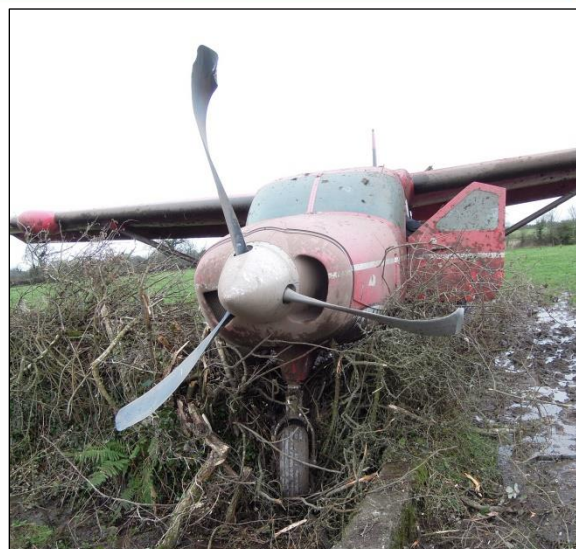
Photo No. 4: Damage to propeller blades

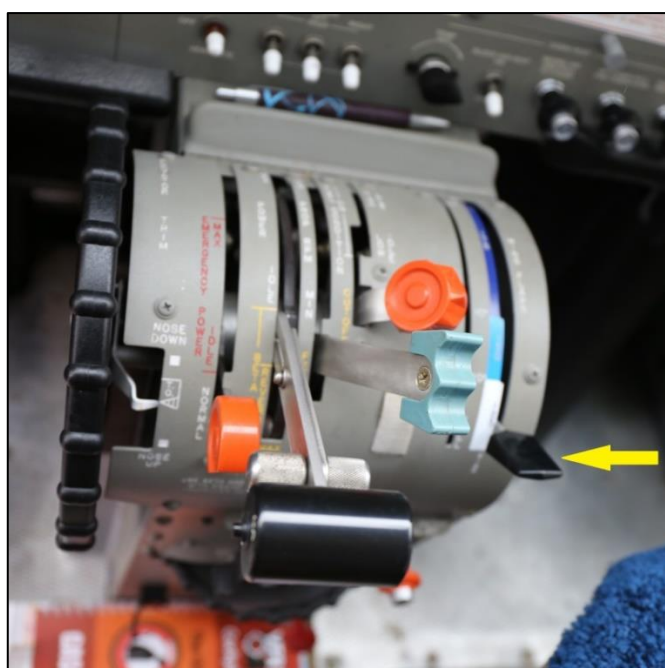
The Pilot recounted that he had set the wing flap selector to the FULL detent as part of his pre-flight inspection. During the inspection by the AAIU, the Pilot informed the Investigation that he had omitted to re-position the flap selection lever to the 20 degree detent following engine-start, the normal setting for take-off. This was consistent with the position that the flap selector was found during the cockpit examination by the AAIU (**Photo No. 5**).

Photo No. 5: Flap lever as found, set to FULL (indicated)

The flaps remaining selected in the FULL position following pre-flight checks, which resulted in increased drag and reduced aircraft acceleration during the take-off roll.

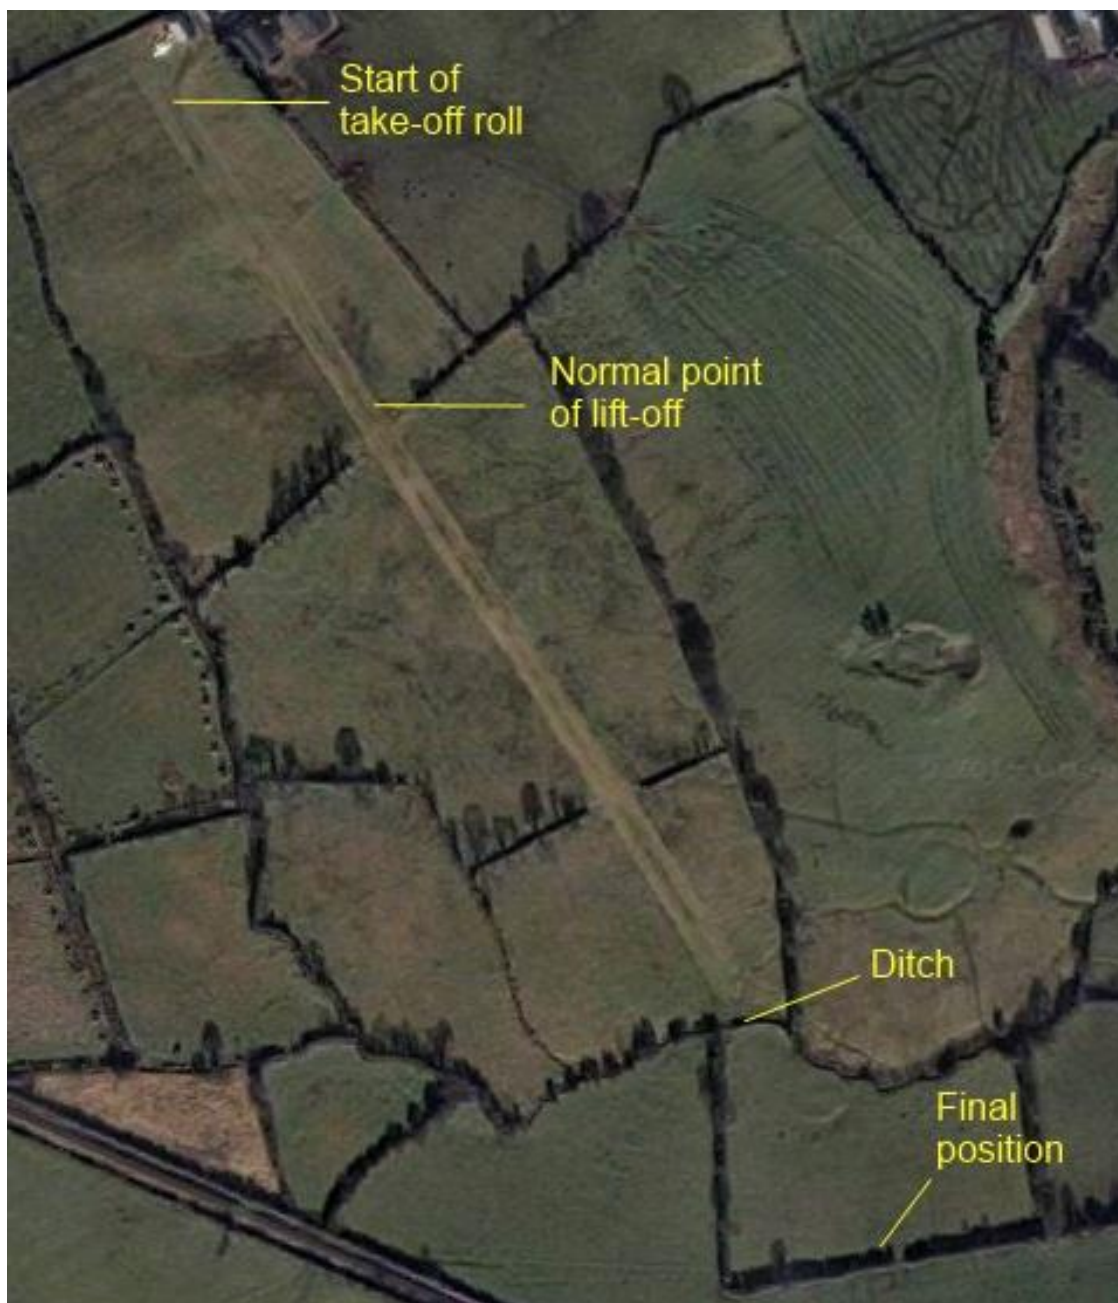
Position at start of take-off, normal lift-off point at 300 m, ditch and final position of aircraft *(based on Google Maps 2015)*
