Air Accident Investigation Unit Ireland

SYNOPTIC REPORT

**Serious Incident
Piper PA 32, G-OCTI
Lorrha, Co. Tipperary
24 December 2014**

AAIU Report No: 2016-001
 State File No: IRL00914109
 Report Format: Synoptic Report
 Published: 3 February 2016

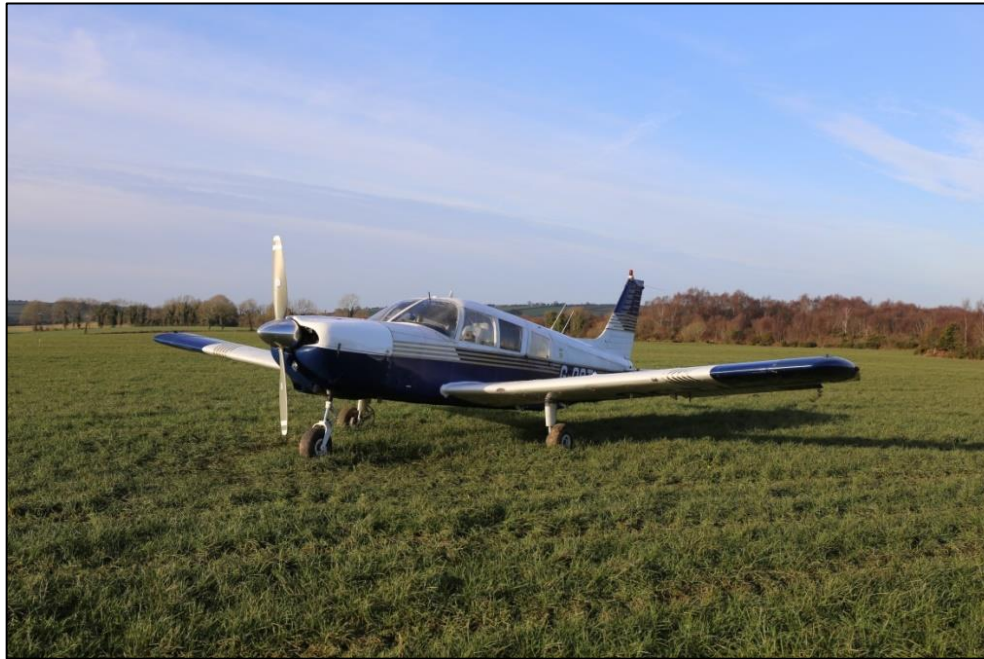
Except for minor damage to the engine cowling caused by the engine failure, the aircraft was undamaged and there was no fire. There were no injuries and all occupants were able to disembark the aircraft normally.

Photo No. 1: Final resting position of G-OCTI (post event date in daylight conditions)

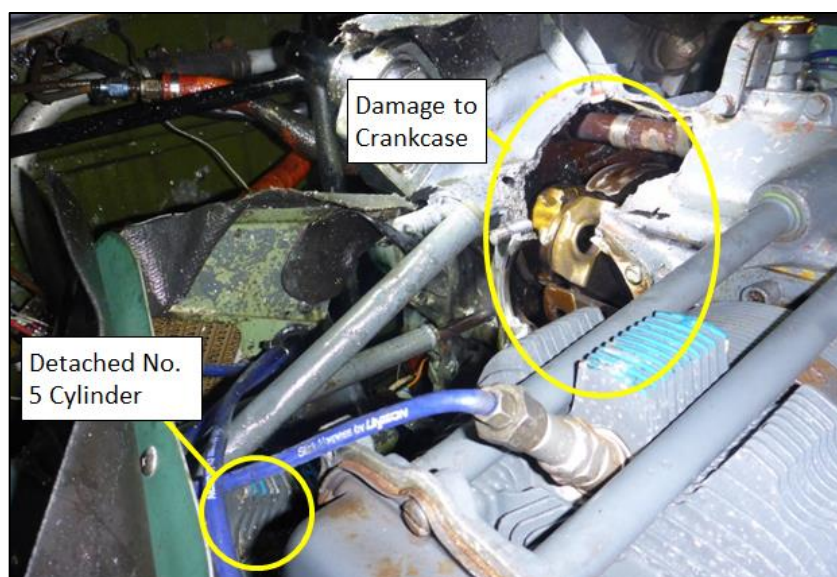
The engine was examined by the Investigation shortly after the forced landing. It was found that the number five cylinder had completely detached from the crankcase (**Photo No. 2**).

Photo No. 2: Engine damage

The number five piston was broken into three pieces and the number five connecting rod was detached from the crankshaft big end (rod) journal. The crankcase was found to be severely damaged above and below the number five cylinder mounting pad, with large sections having been broken off.

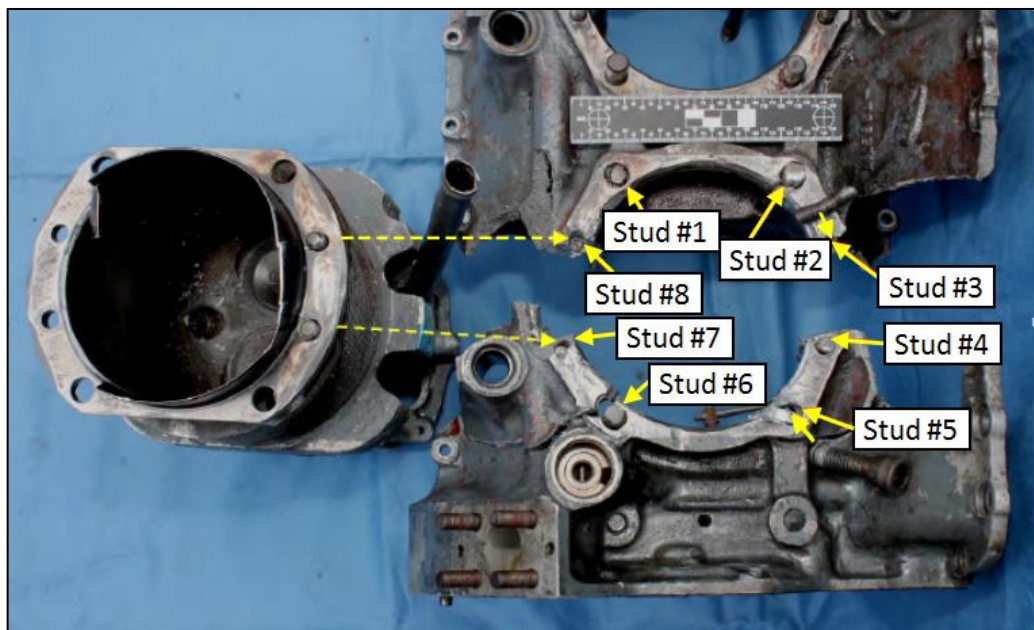
The detached number five cylinder, the engine crankcase and the failed cylinder retention studs were sent to a specialist facility for detailed metallurgical examination and analysis. Four of the failed studs were still in place in the crankcase (#1, #2, #4 and #6), two were still attached to the cylinder (#7 and #8) and the remaining two (#3 and #5) had completely separated (**Photo No. 3**).

Photo No. 3: Components sent for metallurgical analysis with stud numbers identified

Regarding the damage to the cylinder skirt, fatigue¹³ arrest marks¹⁴ were visible on the fracture surface. Ratchet marks¹⁵ were also present along the edge of the fracture surface, on the outer diameter of the cylinder. The metallurgical examination report stated that *“there was no evidence of pre-existing material defects at the crack initiation sites”* and that it was considered that this fracture was *“consequential to the bolt [stud] failures”*.

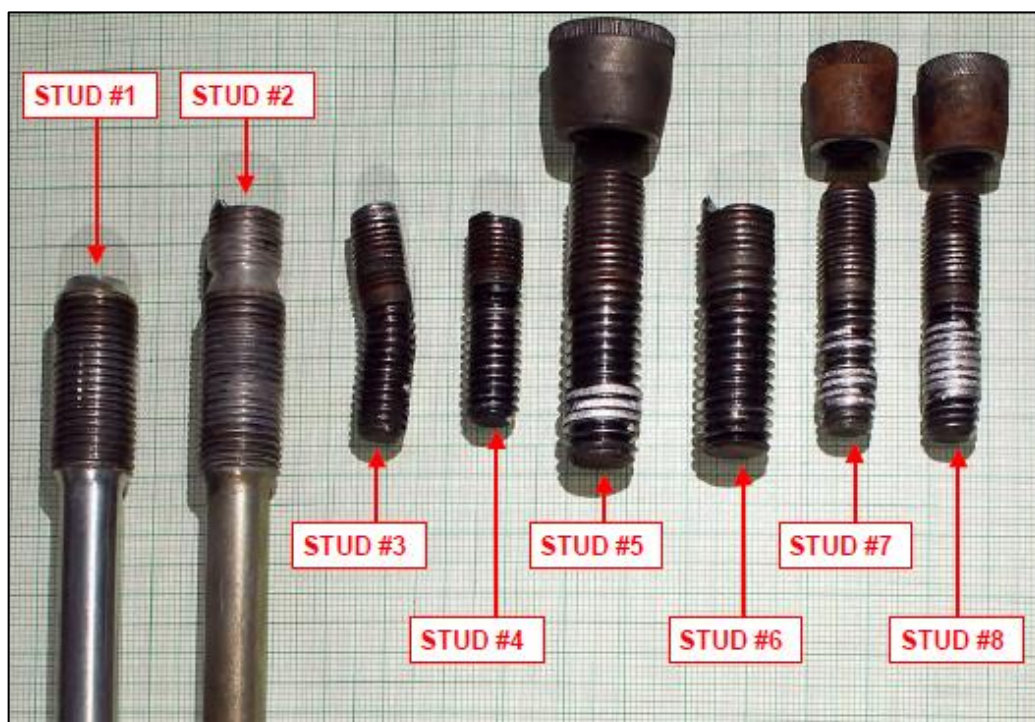
The damaged studs are shown in **Photo No. 4** below. Studs #1, #2, #3, #4 and #6 had fractured (studs #1 and #2 are thru-studs). Studs #5, #7 and #8 had not fractured, but coils of aluminium were found to be present in the thread roots. Metallurgical analysis deemed the coils of aluminium to be “clean and fresh looking with no significant evidence of heat exposure”, indicating that studs #5, #7 and #8 had been forcibly stripped from the crankcase when the cylinder became detached.

Photo No. 4: Damaged studs

Visual examination identified that the cadmium plating¹⁶ was absent from large areas on all of the studs. This was confirmed by Energy Dispersive X-Ray¹⁷ (EDX) analysis of the flanks of the threads, adjacent to the fracture surfaces. A dusting of red rust was observed on the thread flanks, but it was noted that there was “no evidence of corrosion pitting”.

The fatigue fractures on studs #1, 2, 3, 4 and 6 did not initiate from corrosion pitting or any other pre-existing material defects. Having discounted abnormal loading conditions and material defects or deficiencies, the most likely root cause of the stud failures was insufficient torque. This could have been due either to insufficient torque being applied to the nuts on assembly or to the nuts backing off in service.
