Air Accident Investigation Unit Ireland

SYNOPTIC REPORT

ATR 72-212A, EI-FAX

30 September 2015

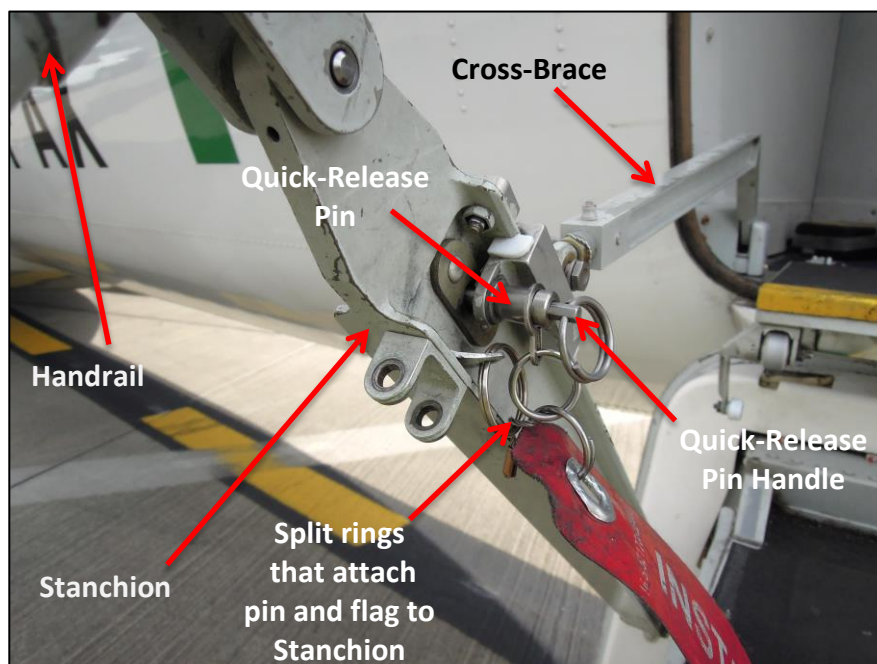
Photo No. 3: Close-up of collapsible handrail in deployed position

The cross-brace, stanchion, and handrail were examined by the Investigation and no anomalies were noted.

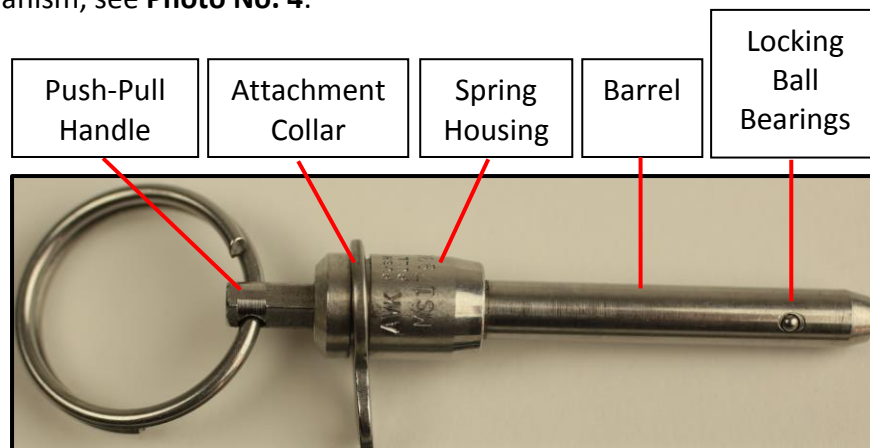
Photo No. 4: Push-Pull Quick-Release Pin

The Investigation obtained the quick release pin that was in use at the time of the accident. The handle and plunger were found to operate only partially in the pull direction and the locking ball bearings were found retracted and could not be pushed out into the locking position using the plunger. Inspection revealed that whilst the pin would fit correctly into the locating holes of the cross-brace and stanchion, the pin could not be locked in position. **Graphic No. 1** above shows the plunger in the condition as found by the Investigation, with the locking balls retracted.

‘CABIN CREW MUST CHECK THE PIN LOCKING MECHANISM IS SERVICEABLE FOLLOWING EACH INSTALLATION OF THE PIN; crew must grip the pin head by the external rim and try to pull it out. It should not be possible to remove the pin by pulling the external rim’.

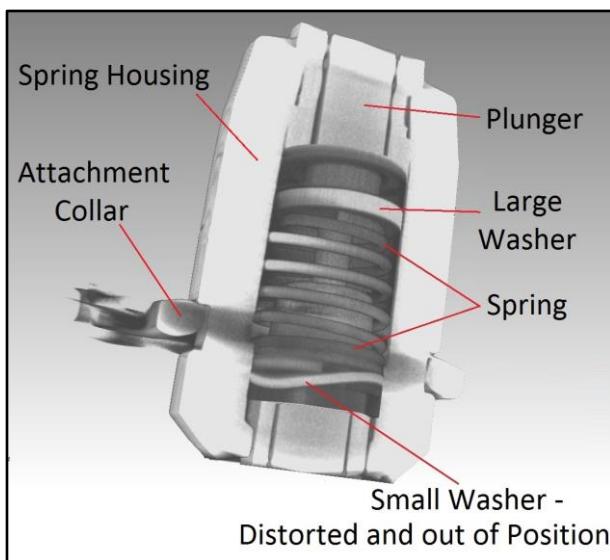
Photo No. 6: 3D X-Ray of Spring Housing.

The pin was sent to the French *Bureau d'Enquêtes et d'Analyses pour la Sécurité de l'Aviation Civile* (BEA) for X-Ray examination. This revealed that the small washer of the internal spring mechanism had become displaced and had migrated down the shaft of the plunger, restricting its movement and leaving the plunger positioned such that the locking ball bearings were permanently retracted (unlocked). The X-Ray images below, **Photo Nos. 6 and 7**, show the internal spring mechanism of the quick release pin.

Examination of the X-Ray photographs revealed that the shoulders of the spring housing, intended for seating the small washer, showed signs of damage and wear, with the shoulders becoming worn and rounded, allowing the small washer to migrate out of position, jamming the plunger.

X-Ray photography of the pin revealed damage or wear to an area of the spring mechanism which allowed the small spring retaining washer to migrate between the plunger and the sidewalls of the spring housing, thus impeding the movement of the plunger, eventually preventing the plunger from returning to the locking position. The exact nature/cause of this damage or wear was not determined by the Investigation.
