Air Accident Investigation Unit Ireland

FORMAL REPORT

**Bede Aircraft Corp BD-5GR, EI-DNN
Garranbaun, Co. Waterford, Ireland
25 July 2015**

AAIU Report No: 2016 - 014
State File No: IRL00915044
Report Format: Formal Report
Published: 06 October 2016

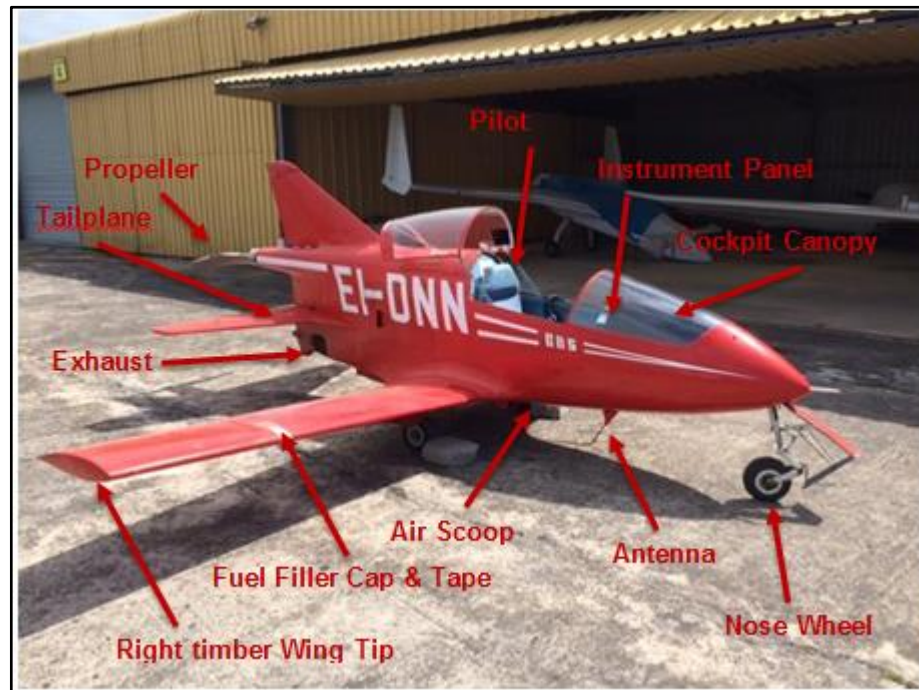
Photo No. 1: annotated photograph of the accident aircraft

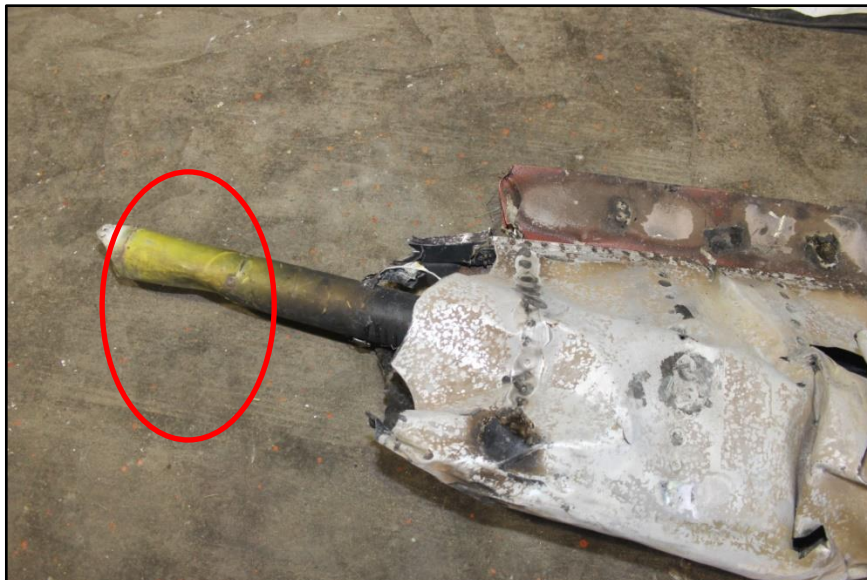
The aircraft impacted into agricultural land at Garranbaun, Co. Waterford, Ireland. Site observations suggest that the aircraft was upright when it impacted. The wreckage trail (see **Appendix A**) was approximately 63 m long and had a general orientation of 050° magnetic, from the point of first contact to the final resting place of the main wreckage. The first impact was between the left wing tip and a tree in a boundary hedgerow; the left main spar shows a significant impact mark (**Photo No. 2**).

Photo No. 2: Left wing viewed from below with impact mark on main spar

The wing tip separated at this point. As the aircraft travelled onwards it lost the left aileron and then the entire left wing. The remainder of the aircraft then impacted a second boundary hedgerow and tumbled before coming to rest, inverted, in the hedgerow between two fields.

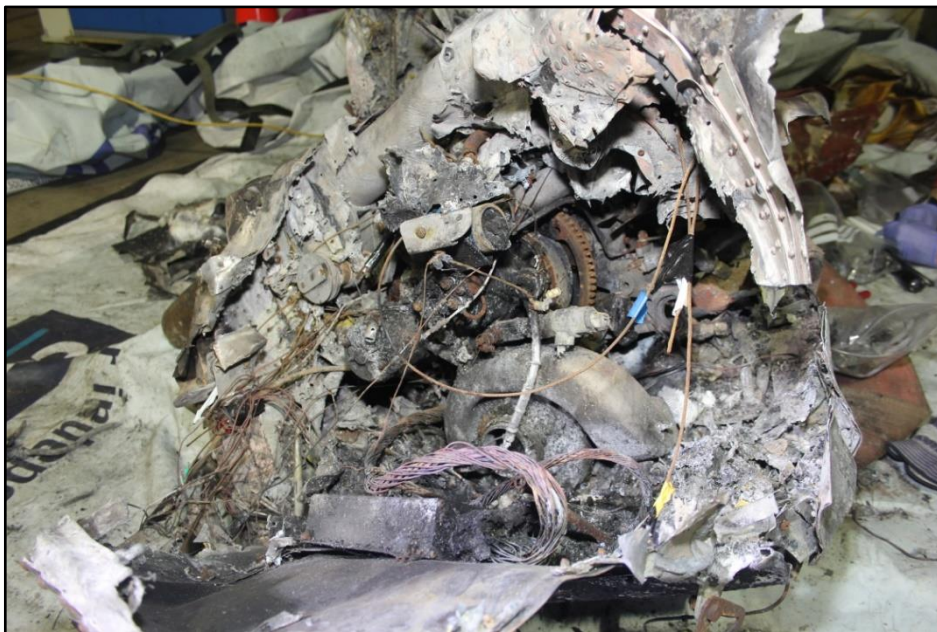
The aircraft wreckage was dis-assembled in an attempt to identify the source of the in-flight fire. Due to the intensity of the post-accident fire, there were significant deposits of molten and fractured metal located within and throughout the engine compartment. The engine and its accessories had suffered significant mechanical disruption and fire damage (**Photo No. 3**). It was not possible to distinguish in-flight fire damage from post-impact fire damage, nor was it possible to determine the precise seat or cause of the in-flight fire. Engine dis-assembly did not reveal any evidence of mechanical failure within the engine nor was there any evidence of fire within the core of the engine.

Photo No. 3: Engine bay showing engine disruption and extent of fire damage

When the main wreckage came to rest, inverted, it was exposed to intense fire and suffered significant damage which included widespread melting of metal components within the engine bay. The seat harness retained the Pilot in the aircraft cockpit throughout the impact sequence which involved at least four different impacts of varying intensities. The accident was not survivable.

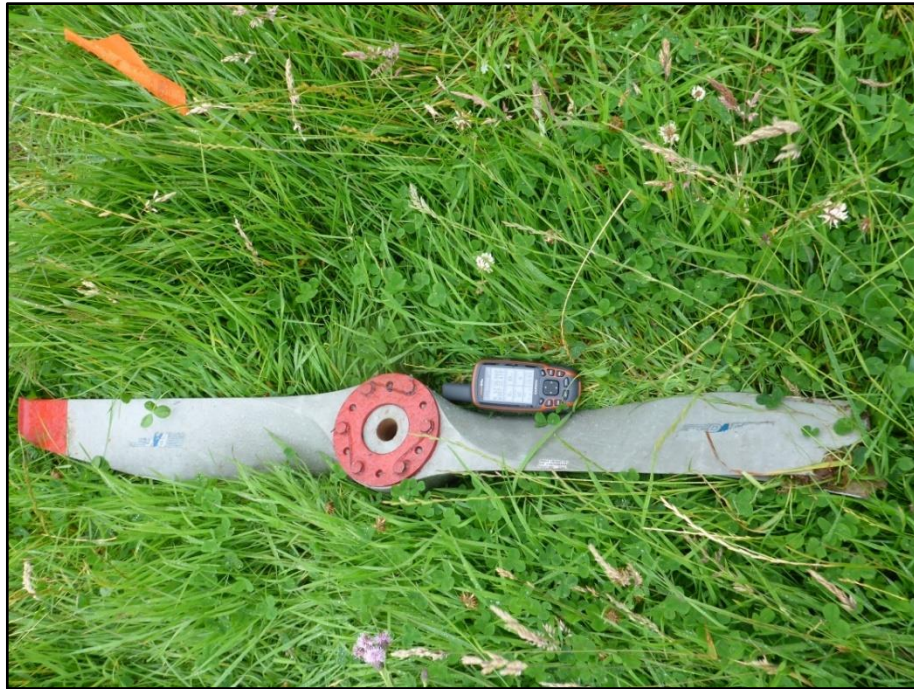
The propeller had separated from its mounting shaft and was found approximately 51 m further on from the initial impact point. The tip of one propeller blade was broken off (**Photo No. 4**); the other blade tip was intact.

Photo No. 4: Propeller with fractured tip (GPS added by the Investigation)

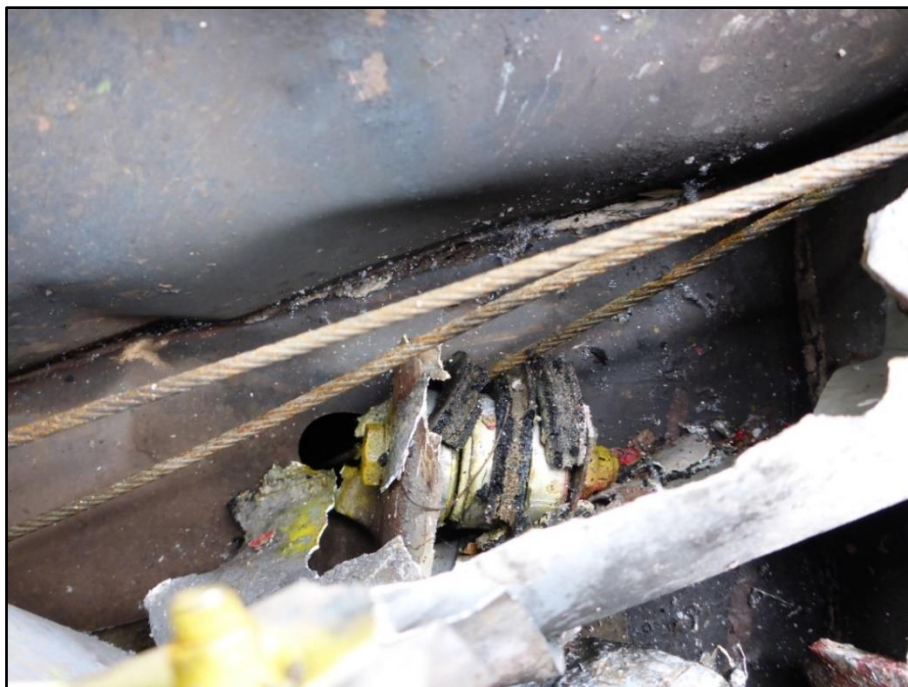
In addition to seeking to determine the source and origin of the in-flight fire, the Investigation also sought to determine the reason for the loss of elevator authority which the Pilot reported to ATC. During the initial wreckage examination at the accident site, the Investigation confirmed the continuity of the elevator control circuit. The control circuit involves two cables which pass through the engine bay, running through a twin pulley block. The Investigation noted that the pulley block had suffered significant heat damage and that rubberised rollers had been melted away (**Photo No. 5**).

Photo No. 5: Damaged elevator pulley block

The Pilot was an accomplished engineer and an experienced pilot who had completed all assembly and maintenance work on the aircraft. The Investigation is satisfied from his two reports to ATC that the aircraft had suffered an in-flight fire which the Pilot described as an *“engine fire”*. The Pilot’s associated comment that *“he had lost elevator authority”*, was probably due to heat/fire damage to the elevator cable dual pulley which was located in the engine compartment.

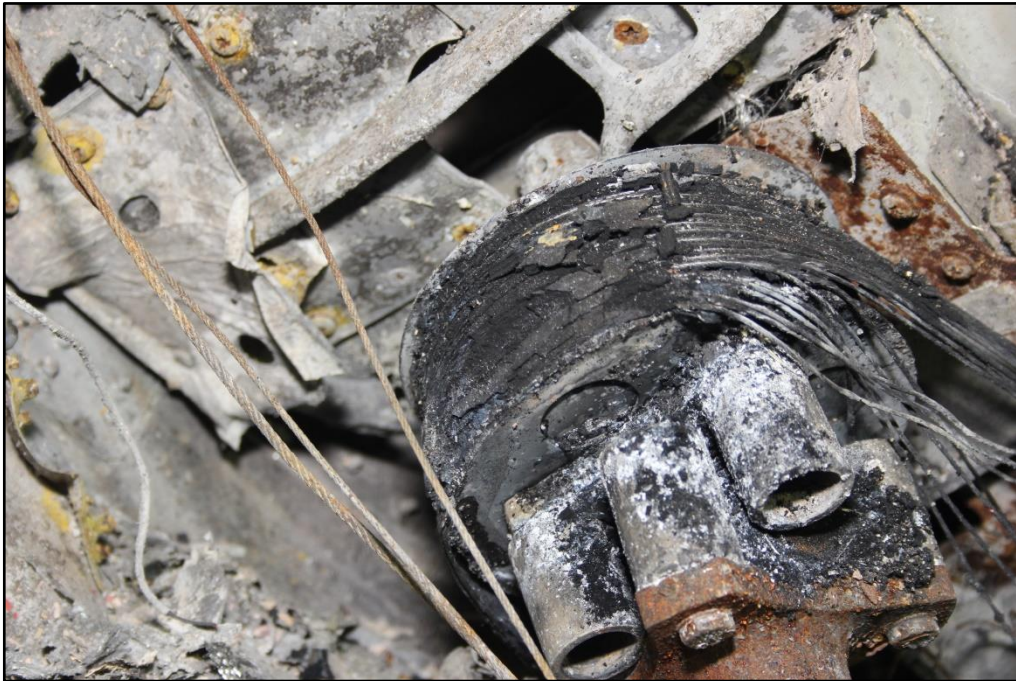
The Propeller Drive belt was of steel wire and rubber construction. This exhibited a high degree of fire damage with much of the rubber burnt away and the steel wires exposed and separated (**Photo No. 6**).

Photo No. 6: Fire-damaged Propeller Drive belt

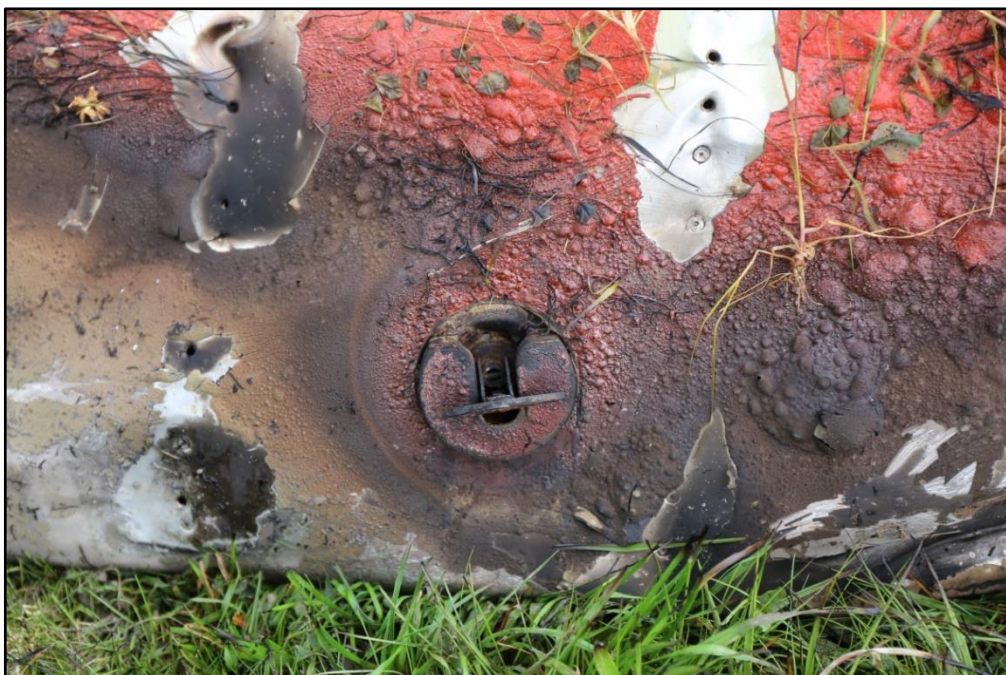
Examination of the separated left hand wing revealed that the fuel tank filler cap was loosely positioned within the neck of the fuel tank. The locking lever on the cap had popped up and there was no evidence of any tape securing the filler cap in position (**Photo No. 7**).

Photo No. 7: Left-hand wing fuel cap (as found)

The fuel tank cap from the left hand wing was loose and its locking lever had popped up. The fuel cap from the right hand wing was missing and not recovered. The Pilot's notes warned *"Fuel caps do need to be taped down after filling as the locking method is not reliable and can be sucked off the plane to be FOD at lift off."* No evidence was found that such tape had been installed; however, due to the extensive fire damage suffered by both wings it is possible that the tape and adhesive residue had burned away. Although the right hand fuel cap was not recovered at the accident site (or elsewhere) this was not conclusive evidence that the cap was not installed, or that it departed the aircraft in-flight. Thus, it was not possible to definitively say if both fuel caps were installed and properly taped down when the aircraft took off.

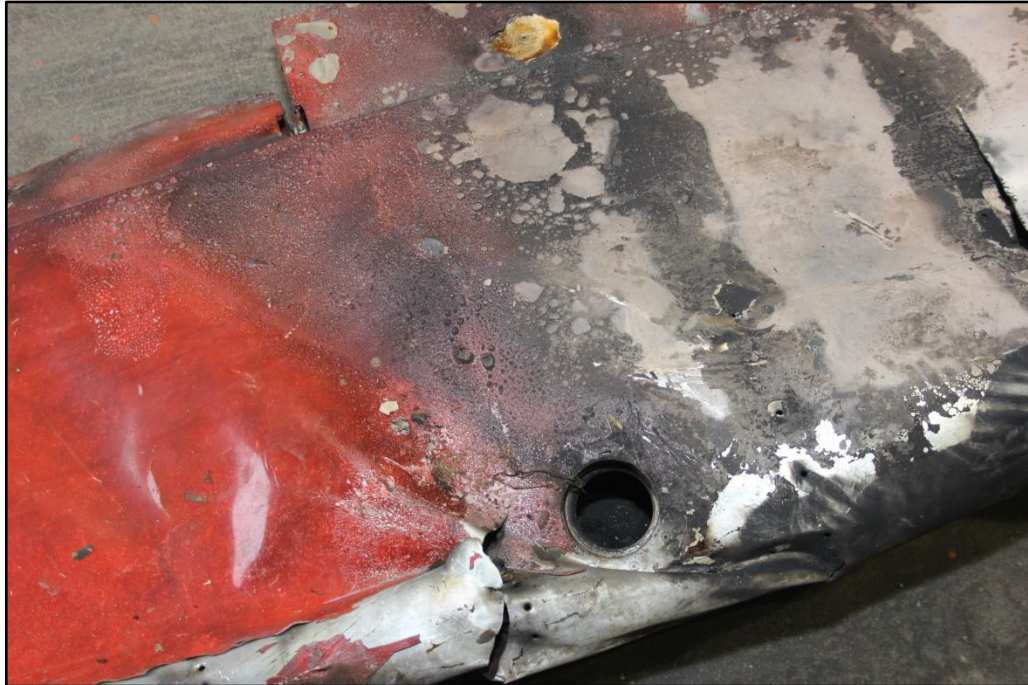
Examination of the still-attached right hand wing revealed that the fuel tank filler cap was missing (**Photo No. 8**). There was no evidence of any tape that may have been used to secure the cap in position. The missing fuel cap was not recovered by the Investigation.

Photo No. 8: Right-hand wing without fuel cap (as found)

- Leaking fuel from the right hand wing tank entered the engine compartment and ignited within the engine compartment.
 - The fuel filler orifices were located on the upper surface of each wing. The fuel filler caps were reported to have a tendency to ‘pop’ open and the Pilot had adopted a practice of securing them with tape. The right hand fuel filler cap was not recovered at the accident site.

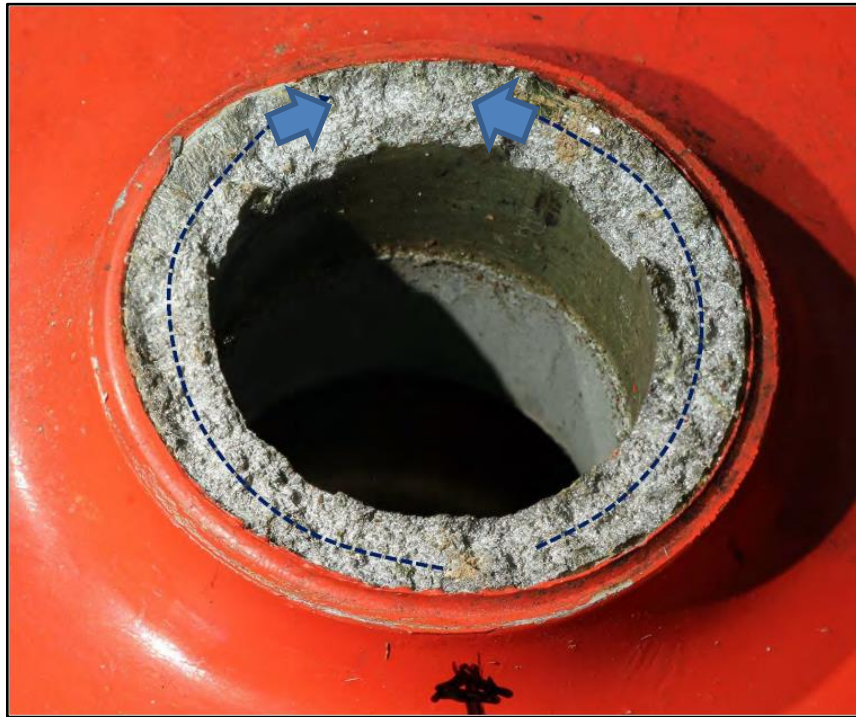
The propeller was attached to the engine output shaft by a cast aluminium flange/spigot. The propeller had separated from the aircraft due to a fracture through the spigot detail, at the radius with the flange. The propeller was examined by a metallurgist to attempt to determine if it was under engine power when the aircraft impacted.

The metallurgist's report states that *"There was no visible evidence of pre-existing material defects or stable crack growth mechanisms, such as fatigue"*.

The metallurgist found that on one side of the diameter, the fracture surface was perpendicular to the major axis of the spigot. This was consistent with the region of fracture initiation. On the opposite side, it was inclined on shear planes. This was consistent with the final region to separate. These features indicated that the fracture had progressed circumferentially around the spigot in two directions (indicated by blue arrows in **Photo No. 9**).

This was consistent with failure in bending, with no significant contribution from torsional loading.

Photo No. 9: Fractured propeller attachment spigot

The metallurgist was not able to positively determine whether or not the propeller was being driven at the time of impact. However, the metallurgist considered that on the balance of probabilities, it was considered more likely that it was not being driven at that time.
