Air Accident Investigation Unit Ireland

SYNOPTIC REPORT

SERIOUS INCIDENT Sikorsky S-92A, EI-ICG Hook Head, Co. Wexford

6 December 2015

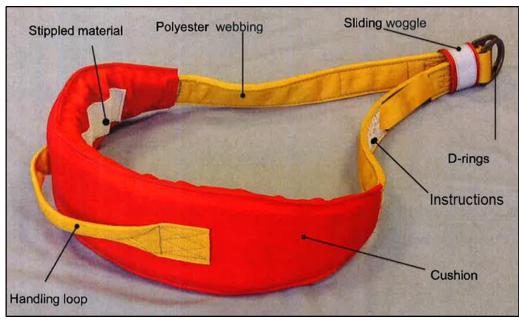
Photo No. 2: Helicopter Rescue Strop (*Manufacturer*).

The function of the Helicopter Rescue Strop (**Photo No. 2**) during a SAR mission is to facilitate the lifting of a casualty via the hoist hook during winching into the helicopter from a vessel, the sea or the ground. The strop consists of a length of heavy polyester webbing, folded in four and stitched along each edge throughout its length. A D-ring is enclosed in the folds at each end and the centre portion is cushioned with a double thickness of expanded rubber, tapered at each end and covered with orange-coloured fabric. A strip of stippled material made from white webbing is sewn onto the inside face of the cushioned portion to aid grip.

The two ends of the strop pass through a sliding woggle which allows the strop to be drawn close to the torso of the wearer. Instructions for the correct use of the strop are attached to the webbing in the form of a pictorial guide (Photo No. 3). Prior to ascent, the strop is positioned around the casualty's torso and under the arms with the pad at the back and the sliding woggle at the front.

Step four of the instructions requires the casualty to keep their hands beside their body. A handling loop on the outside of the strop enables the winch operator to draw the casualty into the cabin after they are winched up to the helicopter door.

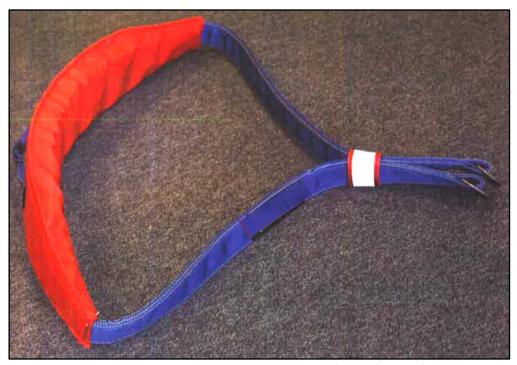
Photo No. 4: Hypothermic Rescue Strop (Manufacturer)

The Hypothermic Rescue Strop (**Photo No. 4**) was designed to mitigate these long term immersion effects when used in conjunction with the Helicopter Rescue Strop by enabling a more horizontal body position for the casualty being winched (Hypothermic Lift Technique). When winching persons in distress, a horizontal body position improves the chances of survival by avoiding the effects of vasoconstriction and the redistribution of blood during lifting. It can also reduce the effect of the removal of hydrostatic compression from the lower extremities of the body. Rescue crews carry a Hypothermic Rescue Strop on SAR missions as a standard equipment fit.

The Hypothermic Rescue Strop is slightly larger than the Helicopter Rescue Strop and is positioned under a casualty's thigh area to mitigate the effect of gravity and cold shock on the body. The Hypothermic Rescue Strop does not have any stippled material on the inside of the cushioned area. This is to allow the winchman to more easily slide the strop under the casualty's legs.

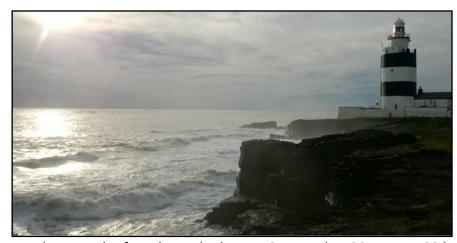
Photo No. 5: Photograph of Hook Head taken on 6 December 2015 at 14.00 hrs approx.

Although Photo No. 5 showed that the sea around Hook Head did not appear to be significantly rough or turbulent in the light northerly winds, Photo No. 6 and Photo No. 7 provided to the Investigation show images of the same area of rocks at Hook Head taken five minutes apart and 15-20 minutes prior to the occurrence. These photographs illustrate the volatile nature of the coastal sea conditions at the time.

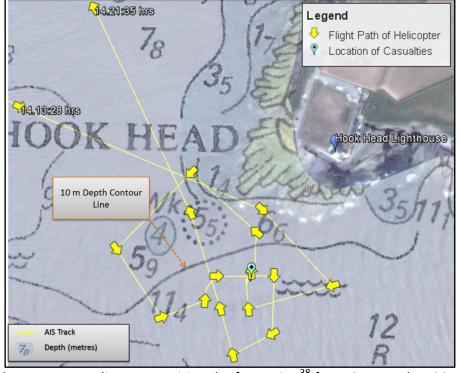
Figure No. 4: Helicopter Positional Information ³⁸ from 6 December 2015

The Investigation overlaid the positional information from the AIS on to a maritime navigation chart to reconstruct the flight path of the helicopter (**Figure No. 4**). The maritime navigation chart legend stated that "Depths are shown in metres (m) and are reduced to Chart datum which is approximately the level of Lowest Astronomical Tide". The SAR was conducted within one hour of High Tide, which at Dunmore East (approx. 5 km NW of Hook Head) was at 13.42 hrs on 6 December 2015.

The data indicated that the helicopter transited from Waterford Airport to Hook Head at a height of approximately 500 ft above the ground. Upon reaching the Hook Head area and commencing search operations, the helicopter descended to approximately 50 ft above the surface. During the winching operation, the helicopter remained at approximately 45 ft above the water. Since these heights were measured by radio-altimeter from the surface, the measurement would include height variations of up to 2.5 metres due to the sea swell (as noted in **Section 1.5 Meteorological Information**).

The location of the winching operations was approximately 110 m from where the casualties entered the water at Hook Head and approximately 30 m south of the 10 m depth contour line (See **Figure 4**). This contour line joins sea areas with a common depth of 10 m below the surface as measured at low tide. The post mortem noted that there was "no evidence of any primary brain injury" and "no evidence of any traumatic brain injury". Given the available information, the Investigation has concluded that the unconscious female casualty fell from the strop into open water of at least 10 m depth.
