Air Accident Investigation Unit Ireland

FORMAL REPORT

**Laser Z200, PH-LSR
Abbeyshrule, Co. Longford
20 March 2016**

AAIU Report No: 2017 - 012
 State File No: IRL00916016
 Report Format: Synoptic Report
 Published: 13 November 2017

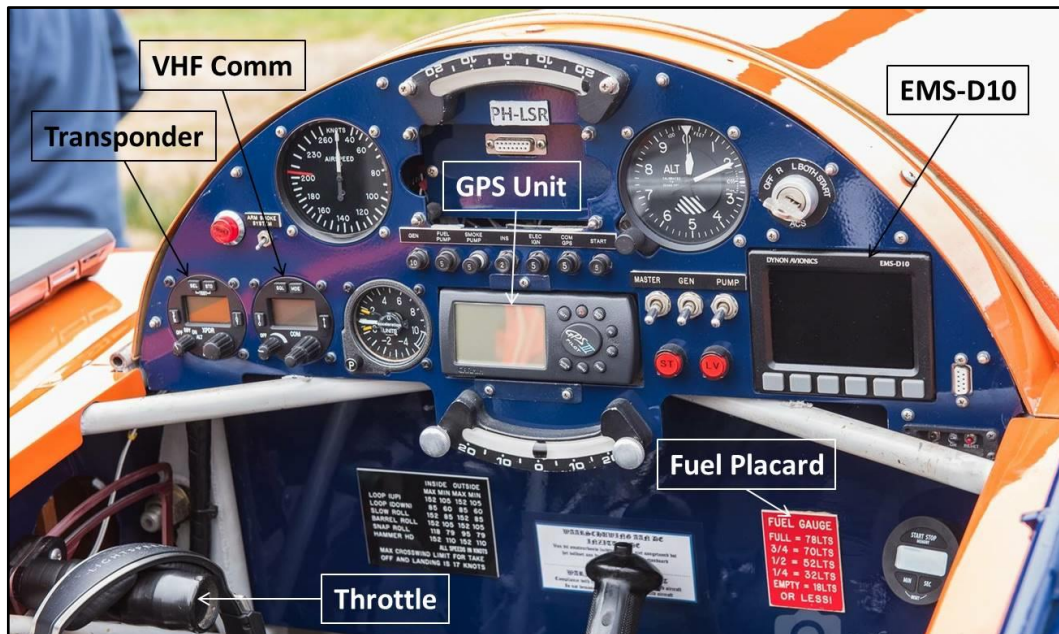
The Flight Manual stated that the maximum fuel capacity was 72 litres (L), with a maximum usable fuel of 68 L. There was no fuel quantity gauge in the cockpit. Fuel quantity was measured through an externally accessible sighting gauge. A placard mounted on the inside of the cockpit instrument panel (**Photo No. 3**) listed the total fuel quantity as 78 L.

Photo No. 3: Laser Z200 cockpit instrument panel including Fuel Placard (K. Donoghoe)

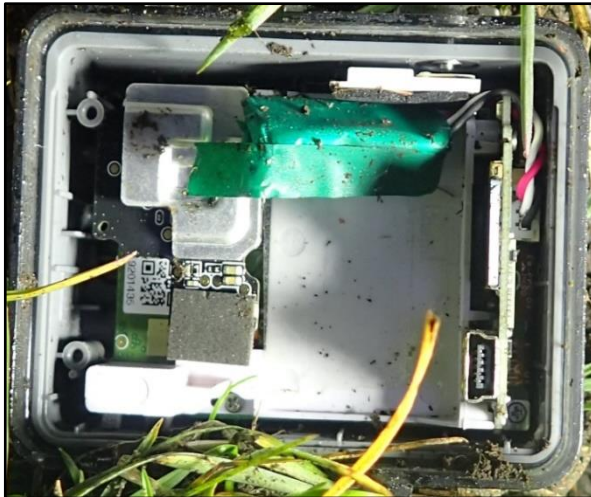
Photo No. 6: *GoPro Camera 1*

The Investigation recovered both cameras at the accident site. The first camera recovered (*Camera 1*) was substantially damaged (**Photo No. 6**). The rear cover assembly consisted of two main parts; a grey plastic inner cover to protect the components and an outer clear plastic cover to provide a waterproof casing for the camera. Both parts had separated from the camera, along with the retaining clip for the rear cover. The outer clear plastic casing had sheared from the camera at the point where it was attached to the mounting on the aircraft cowling. The internal battery pack and connecting wires had been torn from the unit.

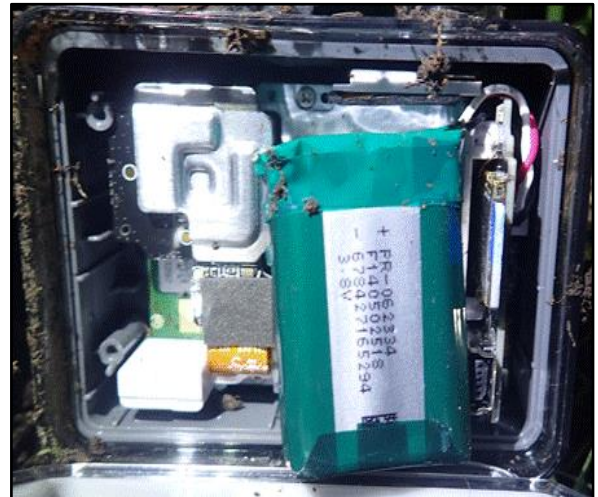
Photo No. 7: *GoPro Camera 2*

A second camera (*Camera 2*) was also recovered at the accident site (**Photo No. 7**). It was damaged but was still powered upon recovery. The retaining clip for the rear cover assembly was missing. The rear cover assembly, the grey plastic inner cover and the outer clear plastic cover were attached to the camera, but were open, leaving the camera's internal components exposed to the elements.

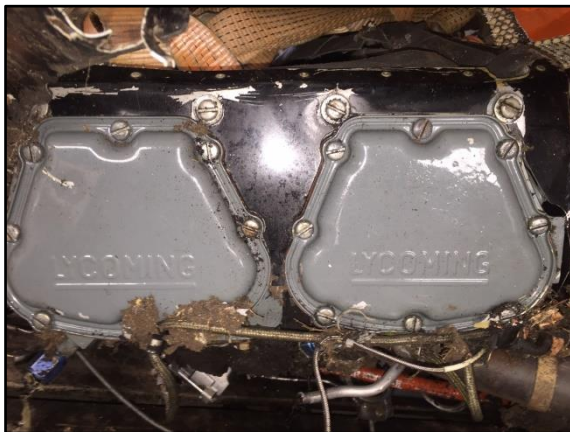
Photo No. 13: Left cylinder rocker covers

The front main wing spar was still attached to the engine and forward cockpit area, and had rotated rearward laterally on the right side of the aircraft by approximately 20° from its original alignment. Most of the remaining wooden components of the wing structure had shattered and were scattered around the main wreckage site. The engine was substantially damaged. The throttle, propeller and fuel mixture levers were found to be in the full forward, high power position. It was noted that there was significantly less impact damage and soil contamination to the left side of the engine (**Photo No. 13**) when compared to the right (**Photo No. 14**).

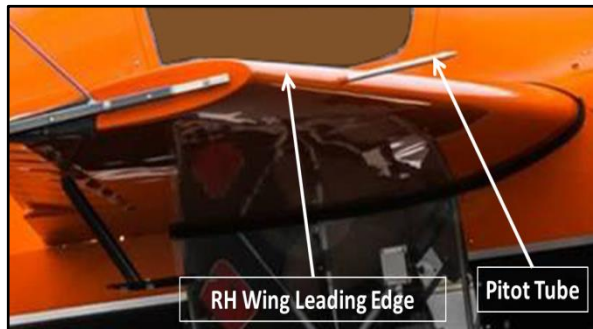
Photo 15: Right wing and pitot tube

The pitot tube, located on the right wing leading edge (**Photo No. 15**), which senses dynamic air pressure in order to provide airspeed indications to the Pilot, was found under the right main wing spar. It had been torn from the main spar mounting point (**Photo No. 16**). The bending of the tube indicated that it had suffered a lateral impact from the right.

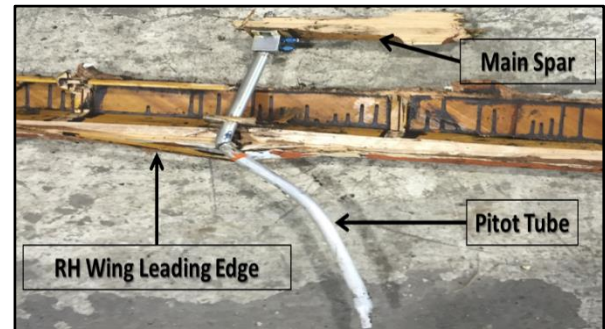
Photo No. 16: Impact damage to pitot tube

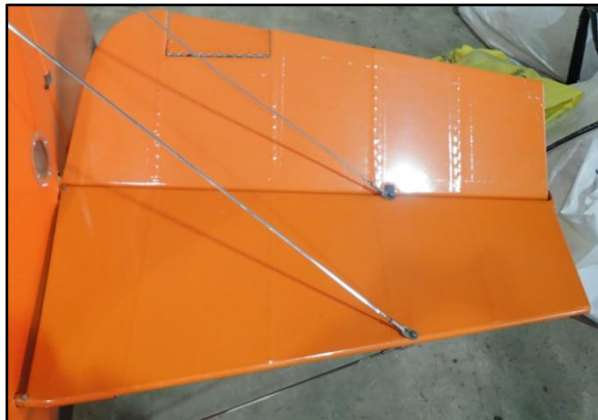
Photo No. 17: Left elevator (facing rearward)

The rear cockpit and tail section was located eight metres north east of the engine and forward cockpit. It had completely separated from the forward section and was pointing in a north easterly direction. There was evidence of compression damage on the left side of the fuselage behind the cockpit area. The left elevator (**Photo No. 17**) was intact while the right elevator showed damage consistent with a ground impact (**Photo No. 18**). The damage pattern indicated that the tail section struck the ground in a right elevator down orientation and was travelling tail first in a north easterly direction.

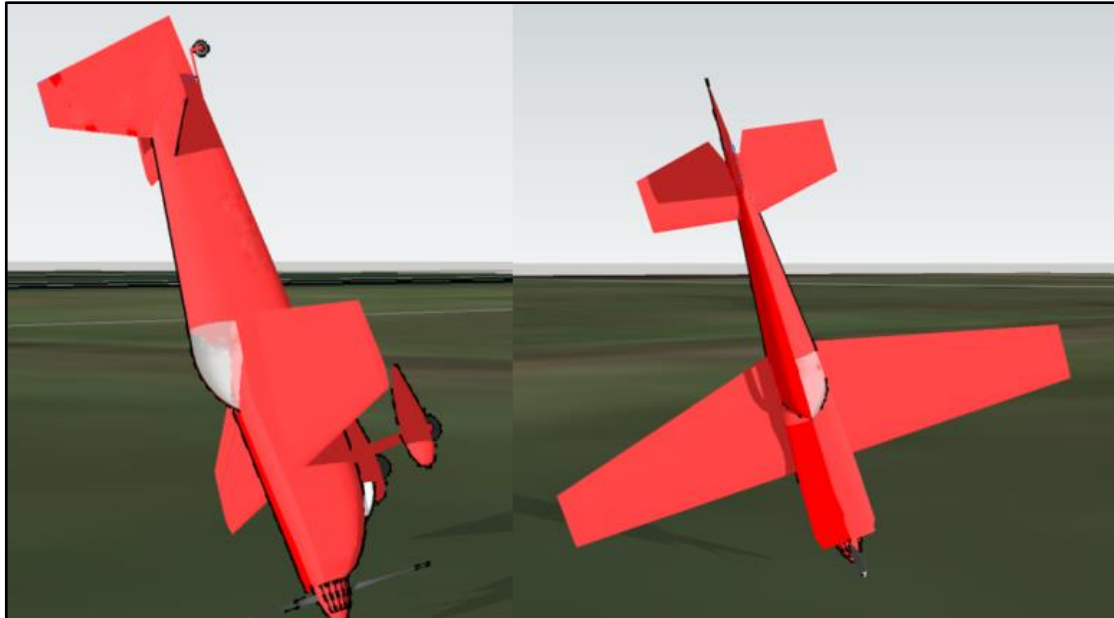
Figure No. 8: Graphic of aircraft's probable final orientation viewed from different angles

This wreckage orientation combined with the footage from the *GoPro* cameras indicated that the aircraft, in addition to being in a steep nose down attitude, was inverted while still travelling in a general easterly direction (**Figure No. 8**).

Evidence indicated that the combination of pitch attitude, speed and orientation caused the aircraft to pitch over into a westward facing, upright orientation, upon impact with the ground. The force of the impact caused the rear fuselage and tail section to separate and continue travelling eastwards for an additional 10 m approximately, resulting in damage to the elevator consistent with this section travelling tail first at the moment that the elevator impacted the ground. The Investigation concluded from the analysis of the wreckage that it was probable that the aircraft entered the incipient phase of a spin.
