Air Accident Investigation Unit Ireland

SYNOPTIC REPORT

**BAe Avro 146-RJ85, EI-RJW
Near CDG Airport, Paris, France**

AAIU Report No: 2018-005
 State File No: IRL00916048
 Report Format: Synoptic Report
 Published: 4 April 2018

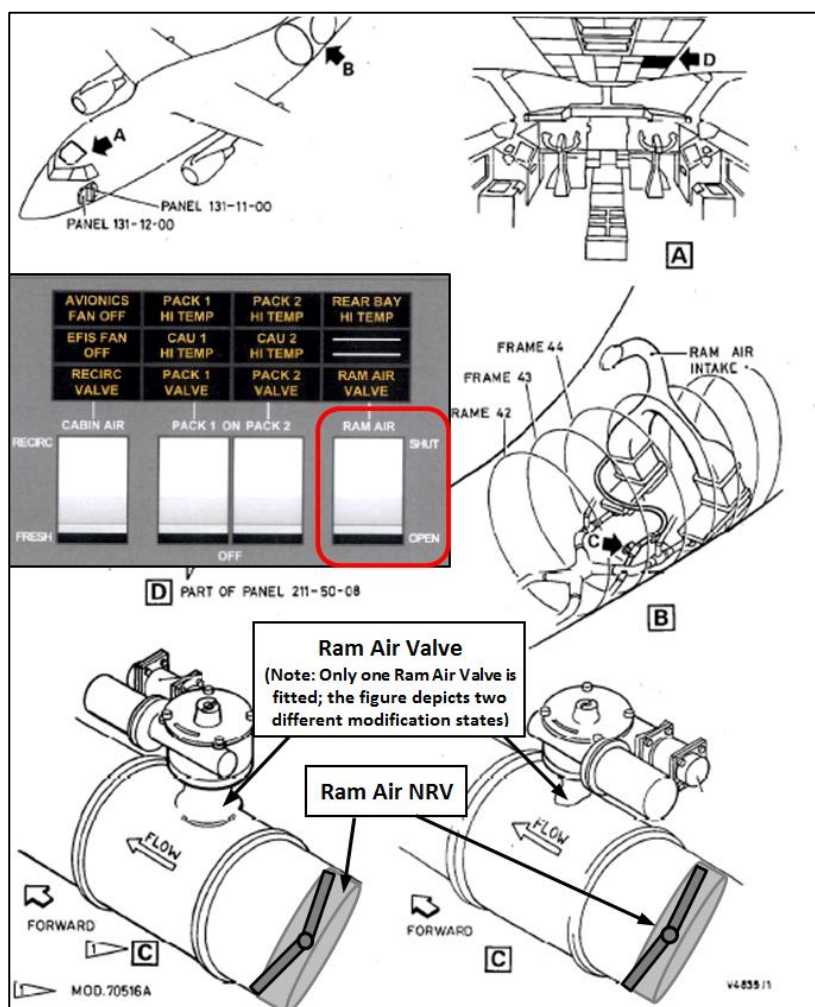
Figure No. 3: The ram air system (adapted from AMM 21-51-00). The direction of the airflow is embossed on the ram air valve's housing.

An optional ram air system (**Figure No. 3**) is fitted to all RJ aircraft in the Operator's fleet. When activated, it provides aircraft ventilation during unpressurised flight or when the air conditioning packs are off. It can also assist with the clearing of smoke or fumes from within the aircraft and its activation is included in the checklists to be followed for such events.

The NRV fitted to the ram air system ordinarily prevents a loss of pressurisation in the event of a failure of the ram air valve in the open position or its inadvertent opening. In the case of the subject aircraft, this protection was lost because the ram air NRV had been installed the wrong way round, and with the ram air switch inadvertently in the OPEN position on the occurrence flight, the aircraft did not pressurise correctly.

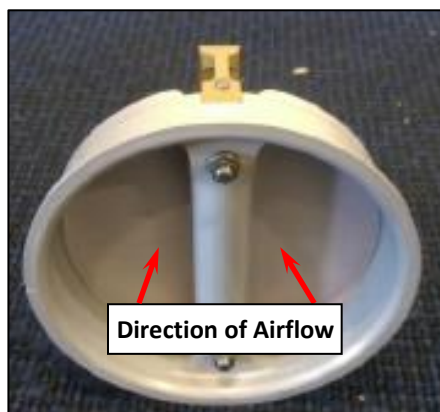
Photo No. 1: A removed ram air NRV (Source: *Aircraft Operator*)

It was subsequently found that a non-return valve in the aircraft's ram air system had been installed the wrong way round. This incorrectly installed valve, in combination with the ram air valve being in the open position on the occurrence flight, prevented the aircraft from pressurising correctly.

The ram air NRV consists of a circular housing (four inches in diameter), which contains two spring-loaded flaps and a spigot, about which the flaps hinge (**Photo No. 1**). The flaps are spring-loaded to the closed position. The purpose of the NRV is to ensure that when the ram air valve is open, air can only flow into the aircraft cabin from the ram air duct and not from the cabin to the duct and therefore to atmosphere.

It is Recommended that:		Recommendation Ref.
1.	BAE Systems should advise operators of 146-RJ aircraft equipped with ram air systems to verify that the ram air non-return valve is correctly installed.	IRLD2018004

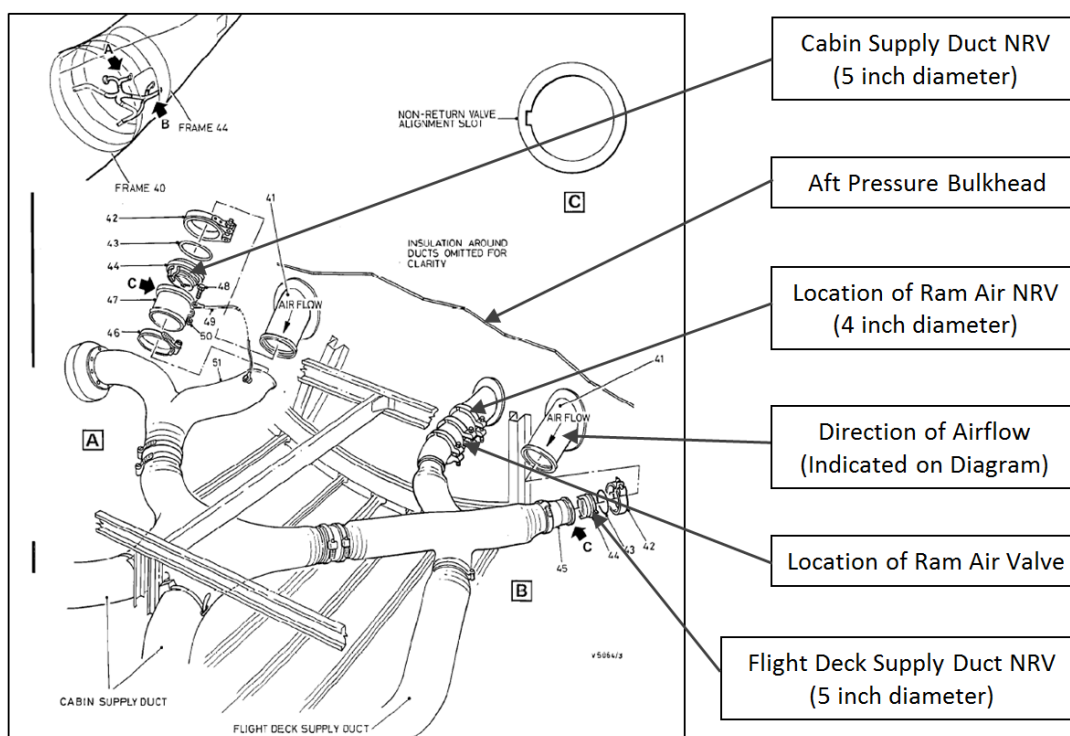
Figure No. 4: AMM 21-50-54 Fig. 201 (Cabin and Flight Deck Supply Ducts and NRVs)

The AMM procedure instructs to "align pin on non-return valve (valve) (44) with slot in flange of duct (47), with valve flaps operating in direction of airflow and insert valve in duct". This slot ensures that the NRV is fitted with the spindle in the vertical position; it does not ensure that the valve is installed the right way round.

No defects were recorded as a result of the maintenance inspection of the left hand recirculating NRV and the NRVs fitted to the cabin and flight deck supply ducts, indicating that the technician (who also installed the ram air NRV) correctly installed these valves. It is therefore equally possible that the technician correctly understood the direction of airflow at the ram air NRV, but unintentionally installed it the wrong way round.

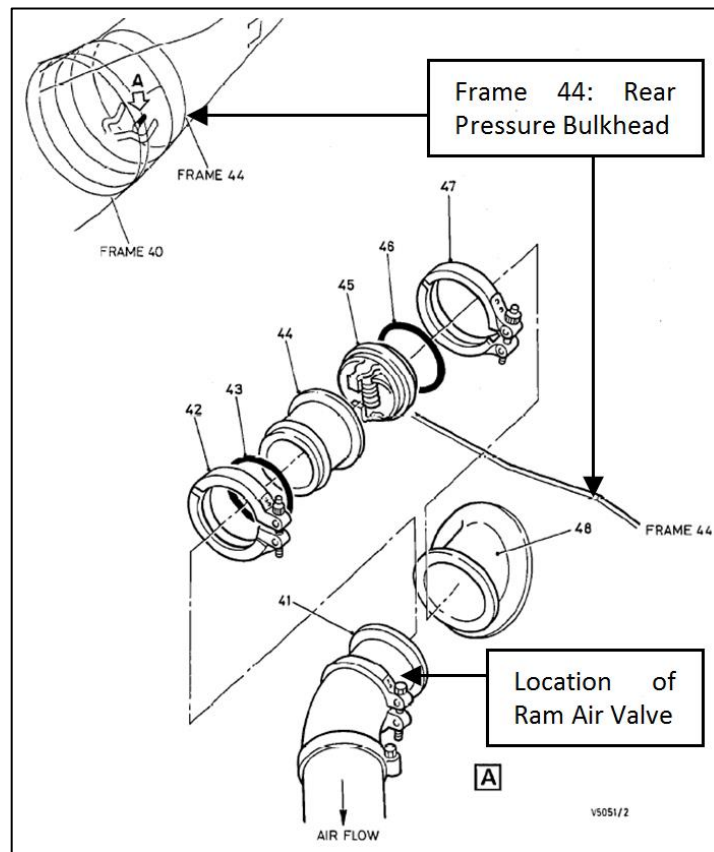
Figure No. 5: AMM 21-51-14 Fig.201
(Location of the ram air valve and rear pressure bulkhead added for clarity)

There are no design features that preclude an incorrect installation of the ram air NRV. The procedure states, *inter-alia*:
