# **Air Accident Investigation Unit Ireland**

**FACTUAL REPORT**

**Bolkow, Bo208, D-EKMY**

**17 June 2017**

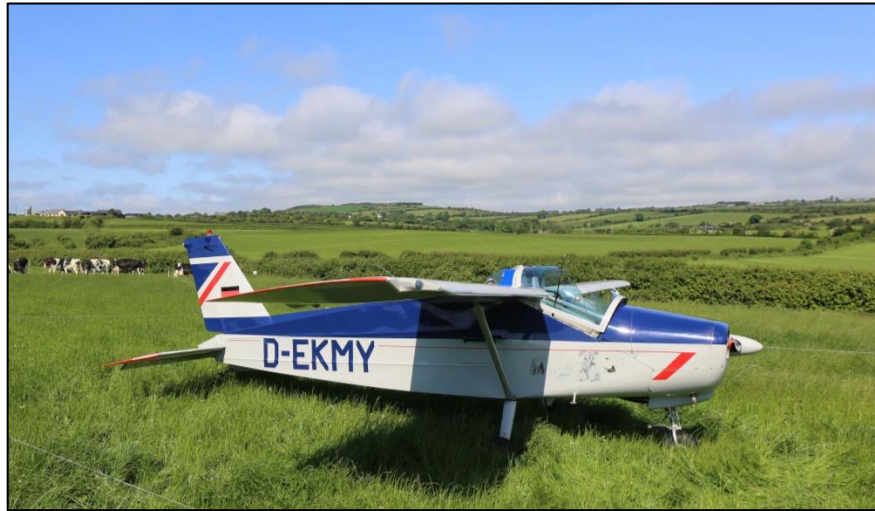
The landing site was an agricultural field at Carntown, Co. Louth. The field was approximately 340 metres (m) long and approximately 170 m wide. The site had a gentle slope and at the time of the occurrence was covered in long grass. The Pilot landed perpendicular to the slope. **Photo No. 1** shows the final position of the aircraft.

**Photo No. 1:** D-EKMY Final Position

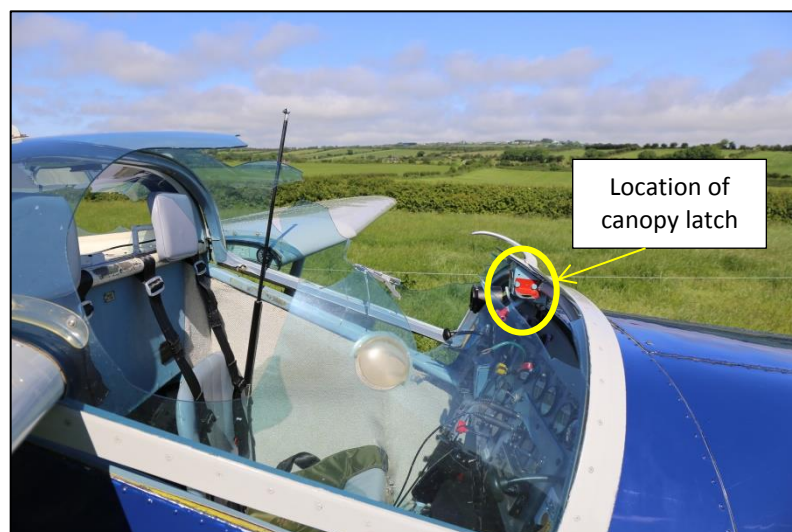
The aircraft forward and rear canopies were shattered and the aircraft suffered damage to the tailplane. **Photo No. 2, 3 and 4** shows the extent of the canopy damage.

**Photo No. 2:** Forward Canopy Damage in Closed Position

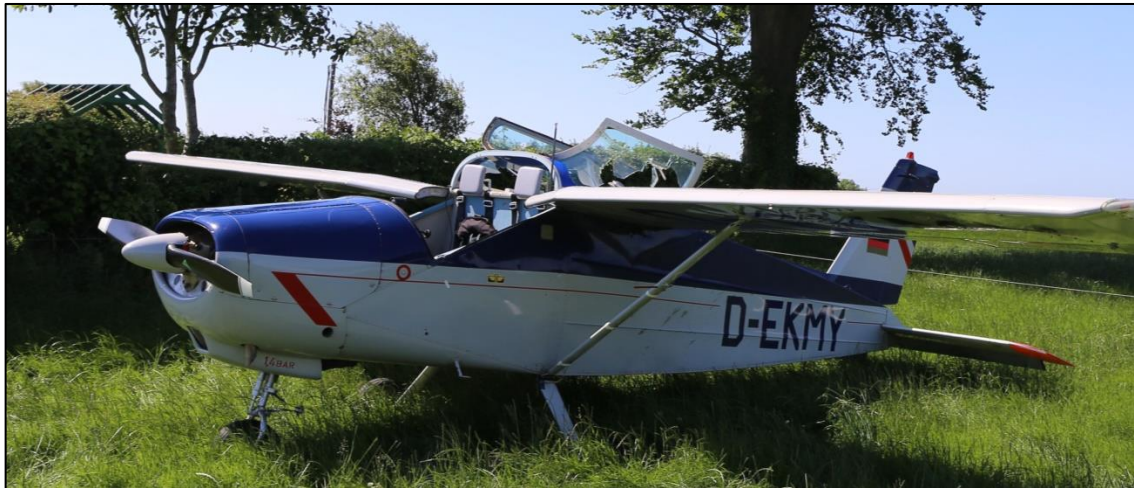
The aircraft departed Runway (Rwy) 27, EIHH at 06.35 hrs with the Pilot's stated intention to fly to EGKB. After take-off the aircraft climbed to 2,000 feet (ft) and proceeded east towards the Irish Sea. A short time later the aircraft forward canopy opened unexpectedly. The canopy was held briefly by a restraining cable and initially opened by approximately 25 millimetres (mm). The fastener at the end of the cable broke shortly afterwards, allowing the forward canopy to fully open and hit the rear canopy located behind the Pilot's head. The canopy Perspex shattered.

**Photo No. 3:** Forward Canopy Damage in Open Position

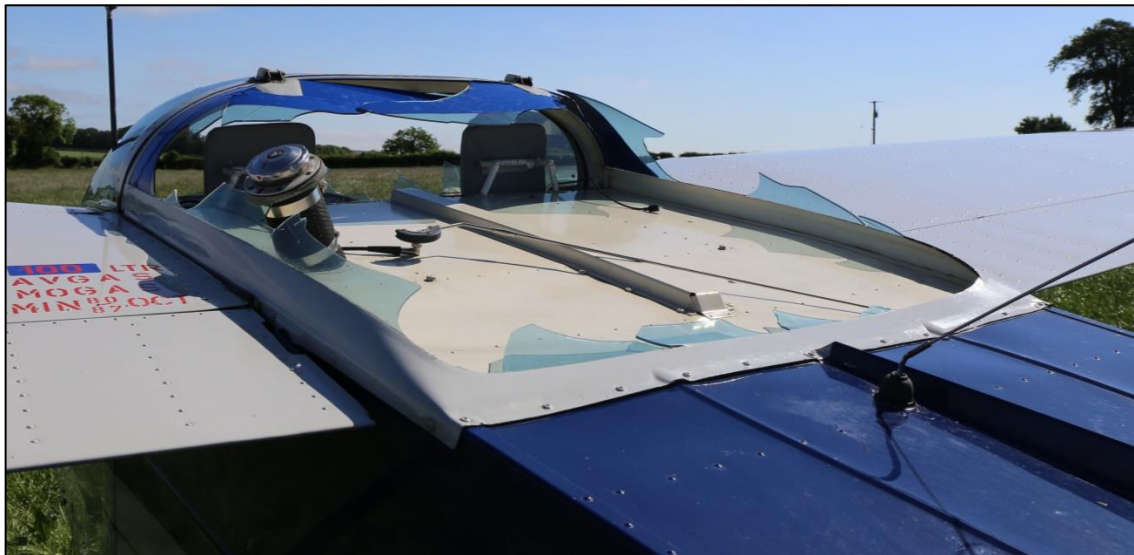
**Photo No. 4:** Rear Canopy Damage

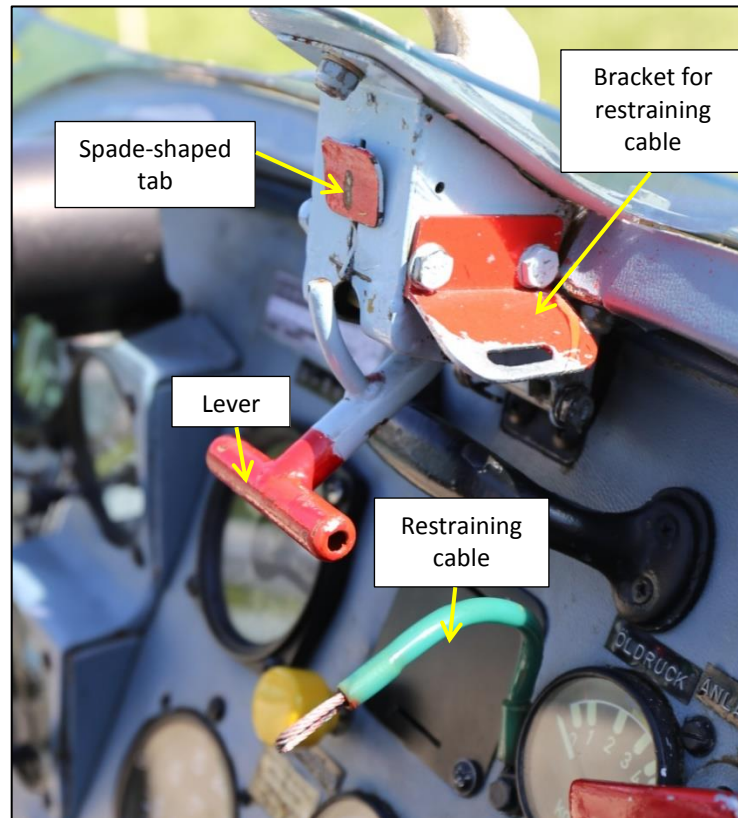
**Photo No. 5:** Canopy Latch

Subsequent to the recovery of the aircraft, two Inspectors of Air Accidents carried out a detailed examination of the canopy latch and the canopy, both of which had been removed from the aircraft. The canopy latch showed some signs of wear but the mechanism appeared to be operational.

In this aircraft a bracket had been attached to the right side of the latch mechanism (**Photo No. 5**). Once the canopy was locked into position a cable which was affixed to the aircraft firewall was hooked through the bracket, preventing the canopy from opening by more than 25 mm. The Pilot stated that it was his belief that the cable was a safety cable to prevent the canopy opening fully and noted that the fastener at the end of the cable may have been inadequate for that purpose. The Pilot also informed the Investigation that the restraining cable held for approximately 30 seconds and that this time allowed him to *'make a judgement and plan a return to airfield'*.

The Investigation contacted the type certificate holder for this aircraft and obtained an original drawing of the canopy latch. The bracket and cable do not appear in the original design, nor are they the subject of any subsequent Service Bulletins or Airworthiness Directives. Therefore, it is likely that the bracket and cable were added as an unapproved modification at a later date. The Pilot informed the Investigation that the restraining cable and bracket were installed on the aircraft when he purchased it.

Aircraft which are operated on a CofA can be modified. However, the modifications are subject to a European Aviation Safety Agency (EASA) design approval process known as 'Part 21'<sup>7</sup>. This process ensures that the modification is properly tested and integrated into the aircraft configuration. The design and manufacture of such modifications can only be carried out by EASA Part 21 approved organisations. A check of the historical records for the aircraft did not reveal any evidence that a Part 21 process relating to this modification had been undertaken.

In this occurrence the aircraft was fitted with a restraining cable. It was an unapproved modification to the aircraft and had not been engineered to withstand the combined forces caused by the airflow on the open canopy and the canopy strut. Although in this case the restraining cable did not contribute to the initial canopy opening, unapproved modifications can introduce unknown risks to an aircraft as their design and manufacture have not been through the rigorous approvals process which is required for aircraft components.

This occurrence serves to remind General Aviation Pilots of the importance of canopy locking mechanisms. They should be of robust design and maintained in good condition. If there is any doubt, a pilot should seek a second opinion from an approved maintenance organisation. In addition, a '*canopy locked check*' should be carried out prior to every flight.
