SYNOPTIC REPORT

ATR 42-300, EI-CBK

Carrickfinn, Donegal, Ireland

7 September 2016

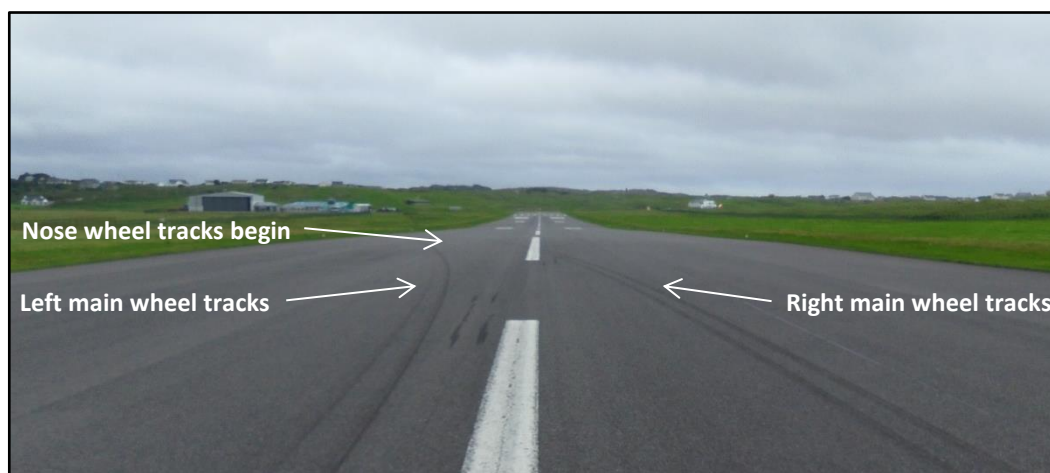
The Investigation received photographs of the runway from the Operator and measurements of the site from the Airport Manager. Tyre tracks indicated that the aircraft lost directional control¹⁴ at 660 m from the runway threshold, and departed the edge of the runway surface at approximately 700 m from the threshold. The tyre tracks on the runway indicated that the aircraft was on the centreline prior to the left turn (**Photo No. 2**). Nose wheel tyre tracks first appear on the runway after the excursion begins; between the runway centreline and the point at which the aircraft entered the grass. There was no scuffing visible on the aircraft nose wheel.

Photo No. 2: Tyre tracks indicating location of the excursion from the centreline

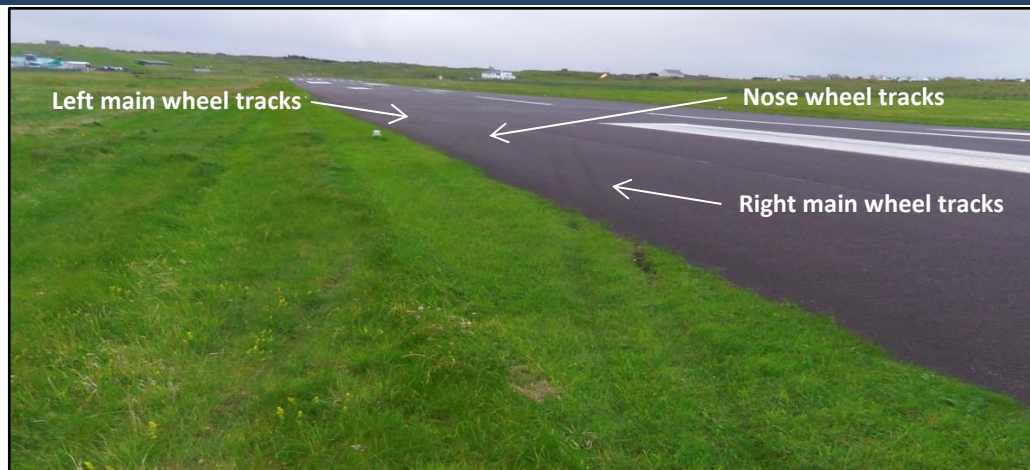
The aircraft returned to the paved surface 62 m beyond the exit point (**Photo No. 3**) and measurements of the tyre tracks indicated that the left main undercarriage wheel reached a maximum lateral displacement of 8 m beyond the edge of the 30 m wide runway. The lateral distance between the main wheels of the ATR42-300 is 4.1 m, and 2.05 m from nose wheel to each main wheel. This equated to a maximum displacement from the runway centreline of 23 m for the left wheel, and approximately 21 m for the nose wheel. There was no report of damage to any airport infrastructure or equipment as a result of the excursion.

Photo No. 3: Tyre tracks indicating point of re-entry to the runway
