Air Accident Investigation Unit Ireland

SYNOPTIC REPORT

Tecnam P2002-JF, EI-WAT

Cork Airport

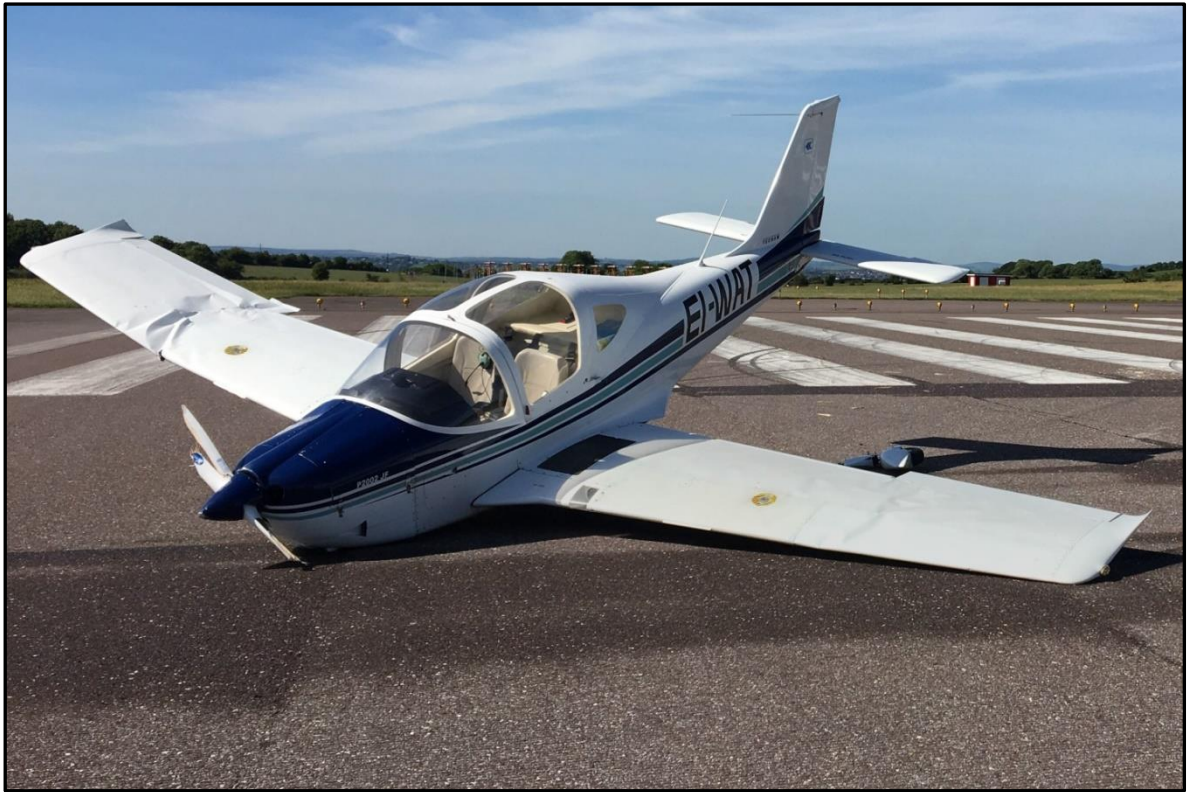
The aircraft came over the threshold of RWY 16 at 15.27 hrs, in level flight. Shortly after crossing the threshold, the nose-up pitch attitude of the aircraft increased and the aircraft rolled rapidly to the right. The aircraft impacted the runway, and came to rest on the runway, 46.8 m from the threshold and 16.5 m to the right of the centreline, (**Photo No. 1**).

Photo No. 1: Aircraft in its final position, post-accident.

The right wing sustained upward chord-wise folding and creasing, approximately 1.5 m inboard of the wingtip. The right wingtip sustained abrasive damage to the navigation light, wingtip leading edge fairing and the right aileron balance horn. There was also chord-wise abrasion to the outer 1.5 m of the underside leading edge skin panels of the right wing.

The left wing also sustained upward chord-wise folding and creasing, approximately 1.5 m inboard of the wingtip. There was span-wise scoring to the underside leading edge surface of the left wing. The left wing flap showed impact damage, span-wise folding, and creasing of the skin, due to contact with the runway surface. The aircraft flaps on both wings were found in the fully extended position.

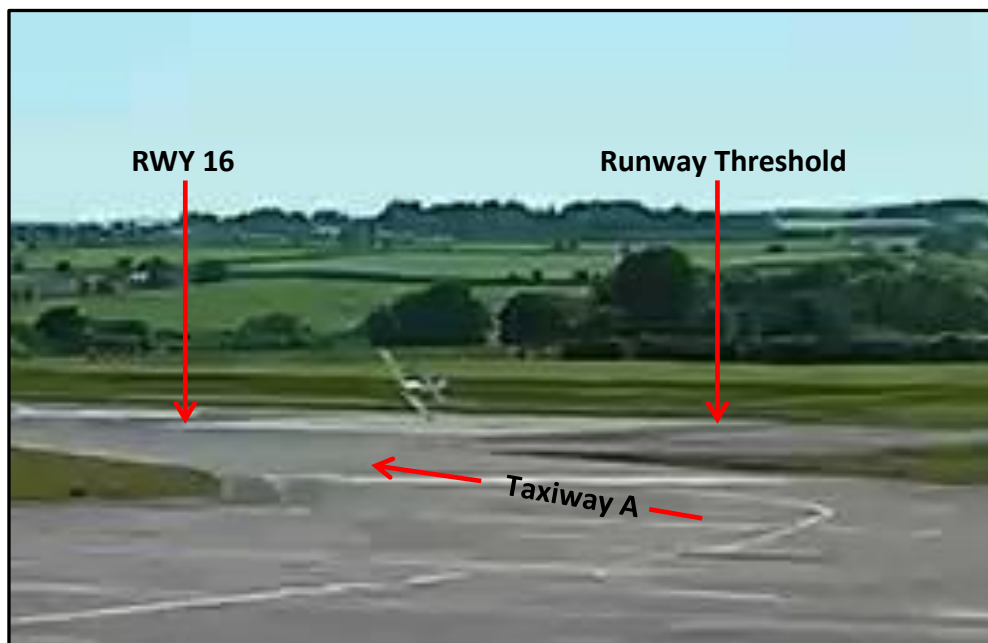
Photo No. 2: Screenshot from CCTV showing orientation of EI-WAT as the right wing contacted the runway.

The CCTV recording showed that, shortly after the pitch up manoeuvre, the aircraft rolled to the right and the right wing made contact with the runway.

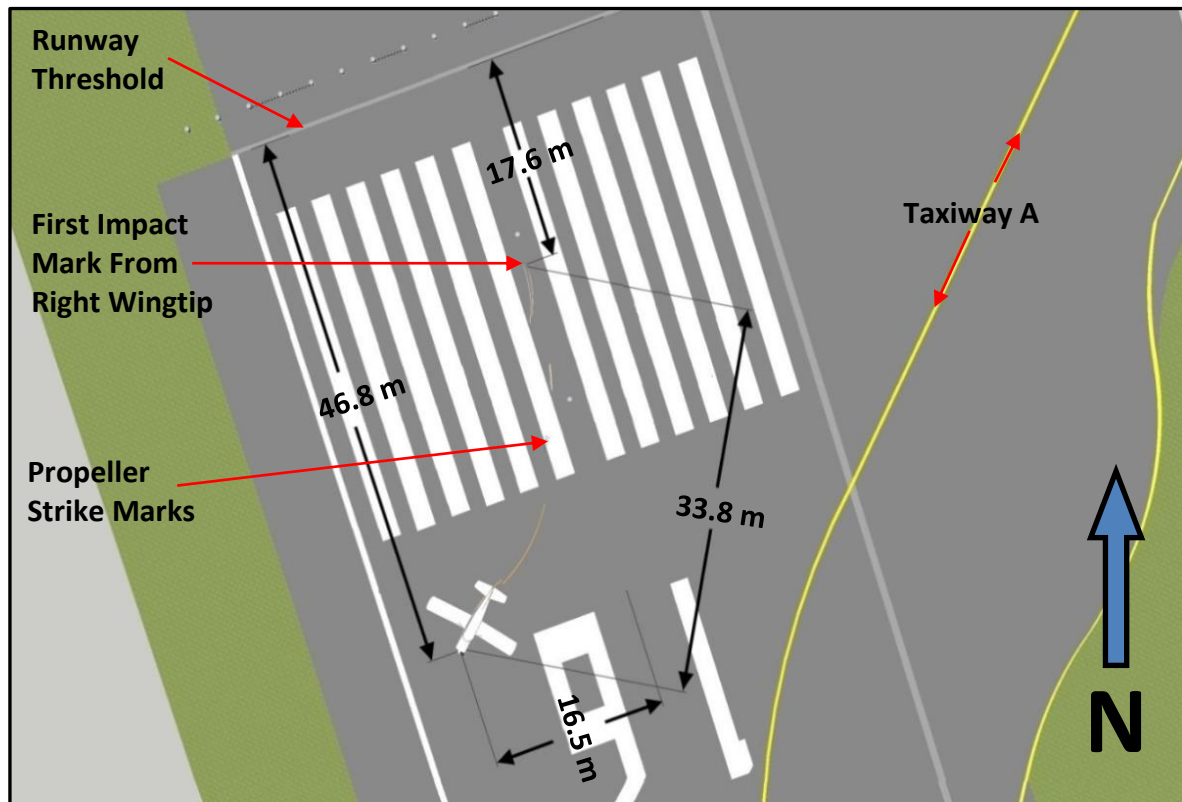
The witness marks found on the runway surface showed that the first contact with the runway was made with the right wingtip, 17.6 m from the runway threshold. This is consistent with images obtained from Closed Circuit Television (CCTV) recordings obtained by the Investigation, which show the aircraft in a 50° to 55° right bank just prior to impact, (**Photo No. 2**). The contact of the right wing with the runway caused the aircraft to rotate about its yaw axis, in a manner similar to a cartwheel motion, causing the aircraft nose to impact next.

During this second impact the aircraft righted itself and the nose gear and left main gear detached as they contacted the runway. The aircraft then slewed to the left and came to rest 33.8 m from the first point of contact, and 46.8 m from the runway threshold.

Figure No. 1: Witness marks on RWY 16

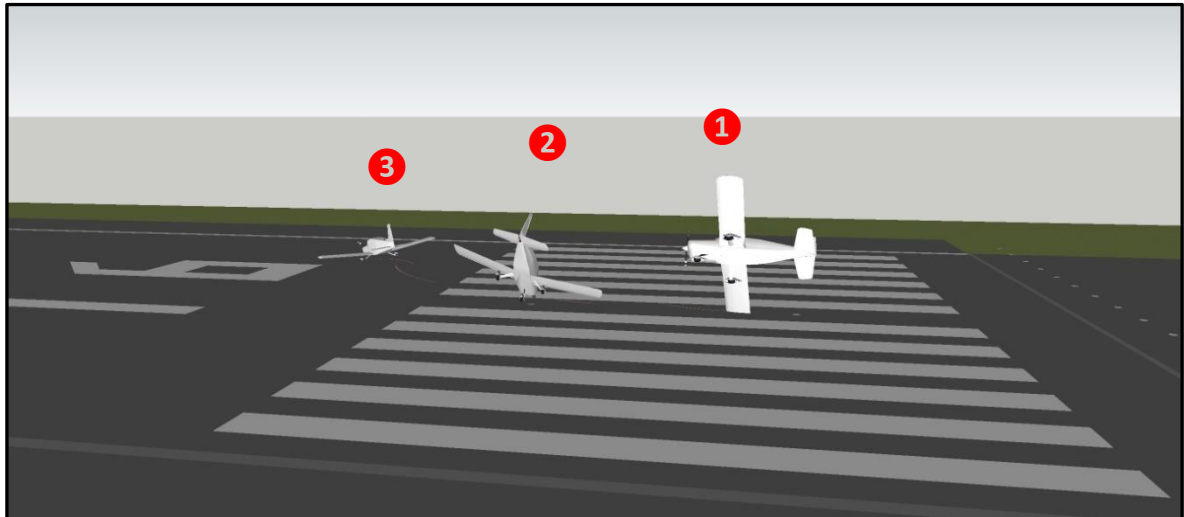
This height was maintained, with an increasing nose-up attitude, until the aircraft stalled (**Graphic No.1**). The right wing dropped during the stall, impacting the runway (1). The nose of the aircraft then contacted the runway during which the aircraft righted itself (2). The nose gear and left main gear then detached and the aircraft came to rest to the right of the runway centreline (3).

Graphic No. 1: Computer generated image of accident sequence.

1. The aircraft stalled in level flight, approximately 15 ft above the runway surface, resulting in a loss of control.
