Air Accident Investigation Unit Ireland

FORMAL REPORT

**BRM Aero, Bristell NG5, G-OJCS
Belan, Co. Kildare**

13 June 2019

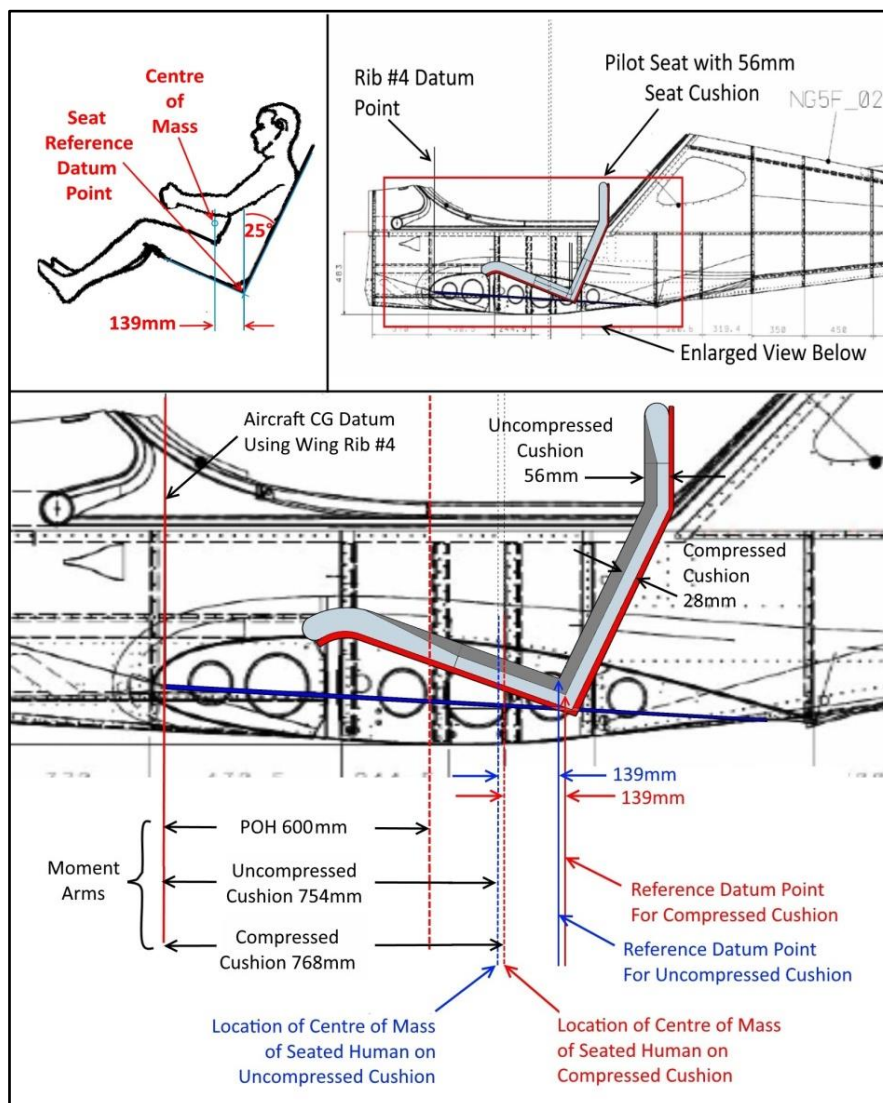
Based on measurements taken of the subject aircraft seats, an adjustment was made for seat cushioning material (which was 56 mm thick, and not 100 mm as advised by the Manufacturer), and its effect on the seated position of a pilot and passenger. Using these aircraft seat and seat cushion dimensions, the moment arm was calculated using the CAD program. If no allowance was made for any compression of the cushion material in the subject aircraft, the moment arm for a pilot and passenger was found to be 754 mm aft of the datum point. However, allowing for 50% compression of the seat cushion the moment arm was found to be 768 mm aft of the datum point, (**Figure No. 4**). (Note: If the seat cushion was to be compressed to the full extent found in **Section 1.6.8**, i.e. 11 mm, then the moment arm for a pilot and passenger would be 777 mm aft of aircraft datum.)

Figure No. 4: Diagram showing how the moment arm for a person seated in the NG5 was determined.

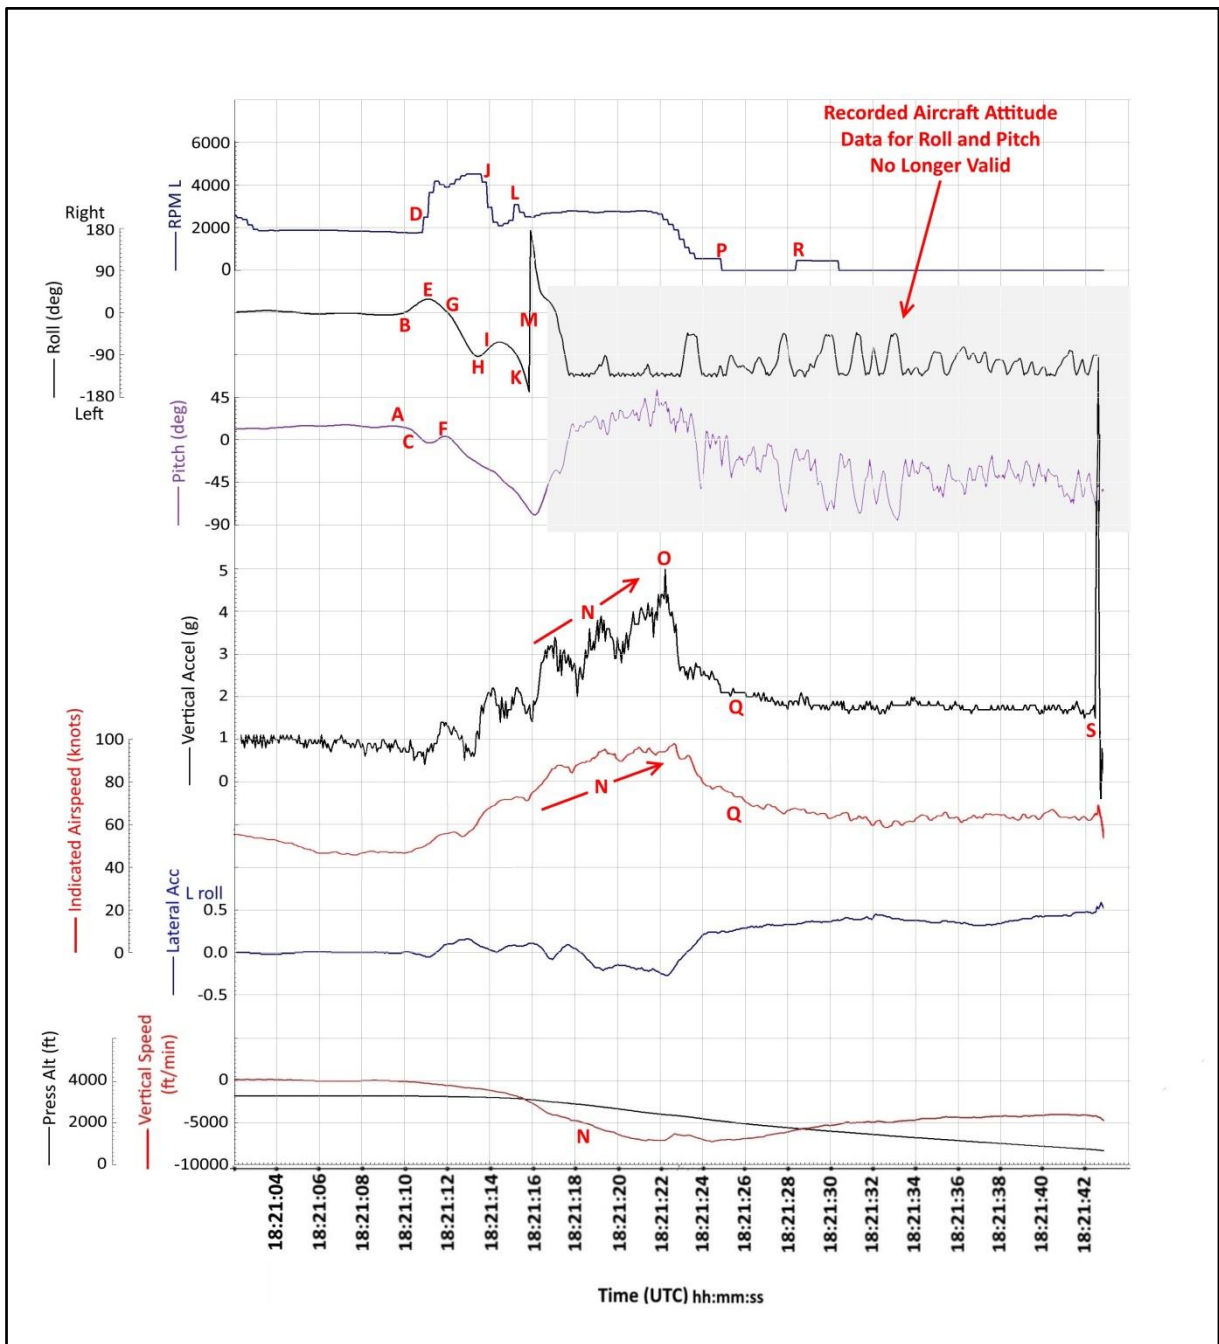
Figure No. 8: Graph of recorded user-accessible PFD data for the period 18:21:04 to 18:21:42, showing the manoeuvre at time 18:21:09. (Shaded area indicates the data that the OEM for the PFD considered to be invalid)

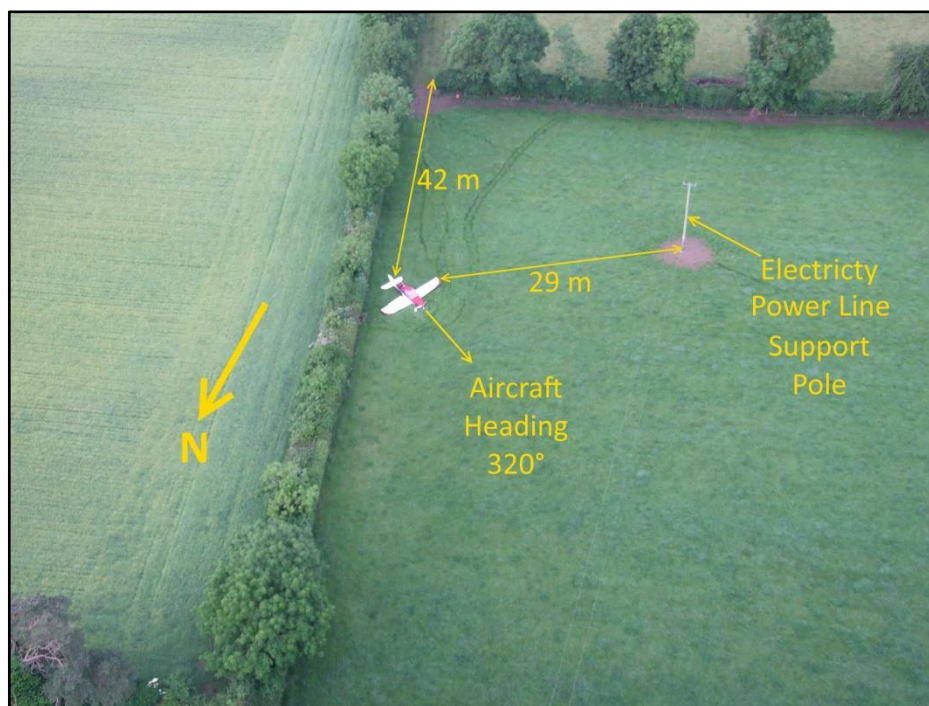
The accident site was located in a grass field, 5.2 NM south of EIKH. The site was compact, and the aircraft was found upright, with all parts of the aircraft structure and all components present at the accident site. The aircraft had come to rest oriented on a magnetic heading of 320°, approximately 29 m east of an electricity power line support pole, (**Photo No. 3**).

Photo No. 3: Aerial view of accident site (courtesy of Irish Coast Guard)

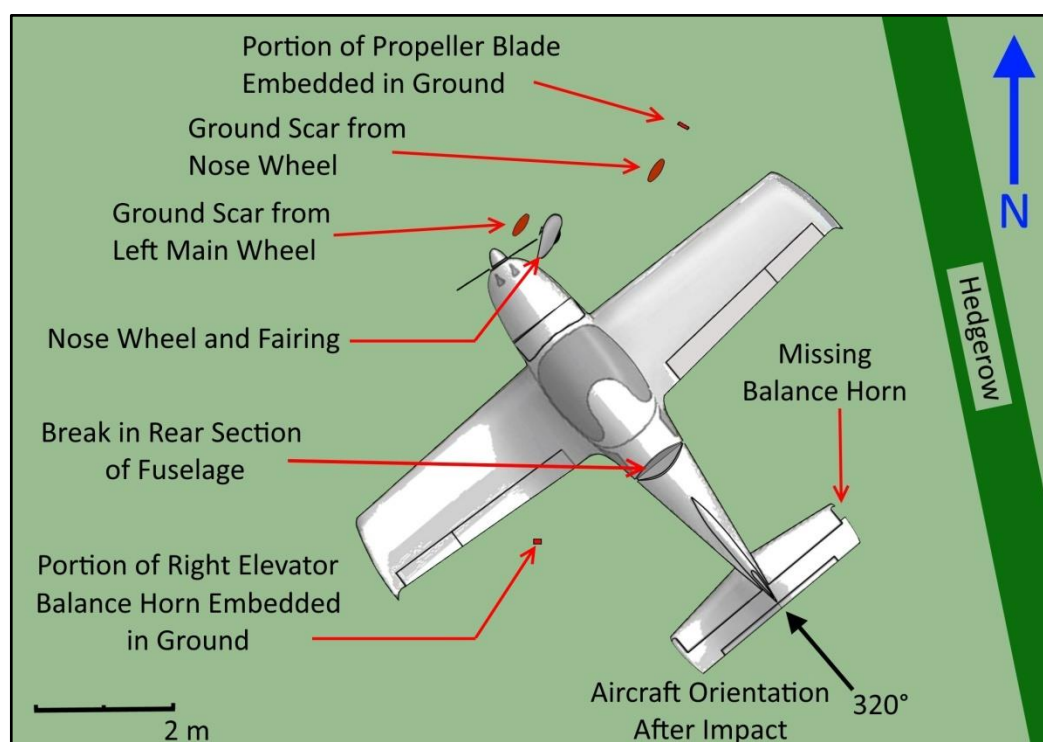
The aircraft was located less than 2 m west of a 4 m high boundary hedge. Examination of the hedge showed no evidence that the aircraft had made contact with it prior to impact. One propeller blade had been broken into four unequal lengths; one portion of the blade, approximately 150 mm in length, remained attached to the propeller mounting plate. The outermost portion, comprising the propeller tip and approximately 240 mm of propeller blade, was found completely embedded in soil, 1.2 m forward of the right wing. The aircraft nose-wheel, complete with its fairing, had separated from the aircraft. The nose-wheel and fairing had left an imprint in the ground. There was also an imprint in the ground from the left main-wheel. A section of the right elevator balance horn was found embedded in soil at a distance of 0.5 m behind the left wing (**Figure No. 9**).

Figure No. 9: Diagram of final orientation of aircraft and wreckage distribution

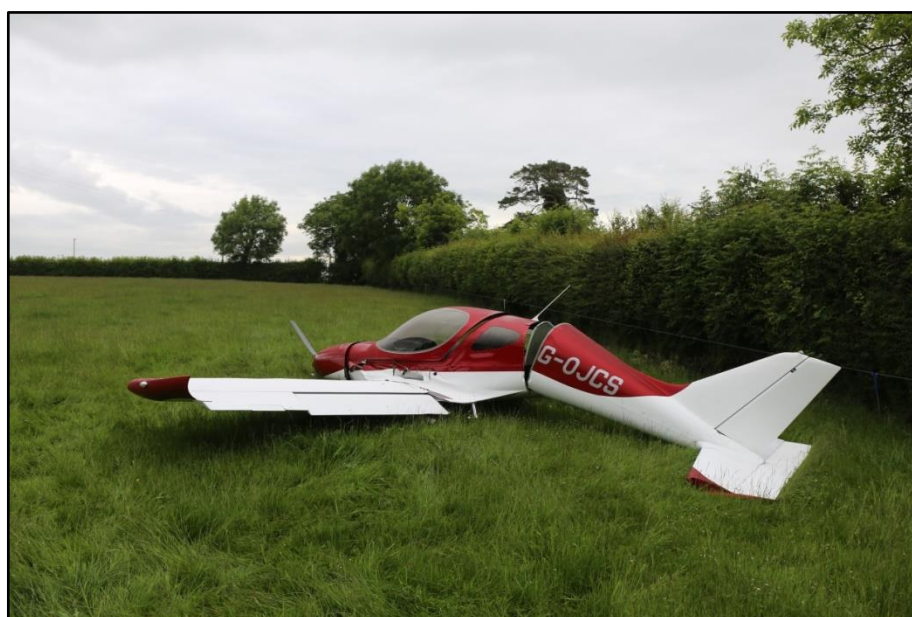
There was evidence of significant vertical compression damage to the metal skin of the fuselage and both wings, resulting in folding and creasing of these structures. The rear section of the fuselage had separated along the top and side portions of the bulkhead rivet line, aft of the cockpit rear bulkhead. However, it was still attached to the forward section of the fuselage along the lower rivet line (**Photo No. 4**).

Photo No. 4: Aircraft at accident site

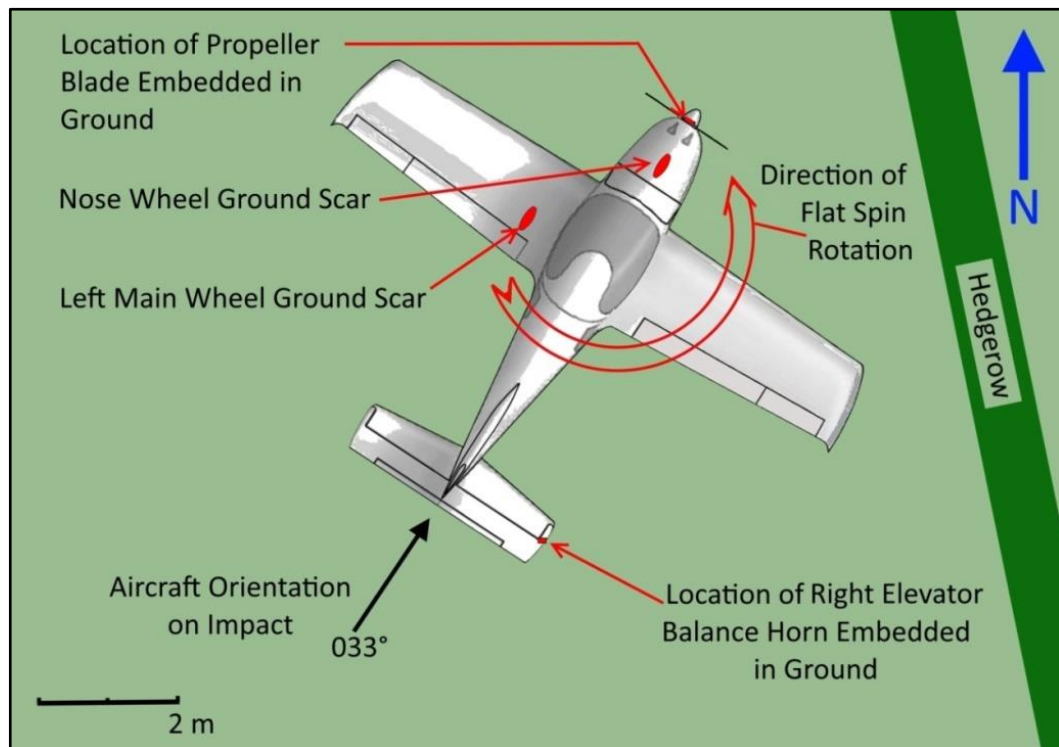
This aligned very closely with the witness marks and showed that the aircraft initially impacted the ground on a magnetic heading of 033°. This indicates that the aircraft impacted the ground with a significant counter-clockwise rotational motion about the normal (Z) axis, before bouncing and coming to rest on a heading of 320° (**Figure No. 13**).

Figure No. 12: Orientation of Aircraft at Initial Impact

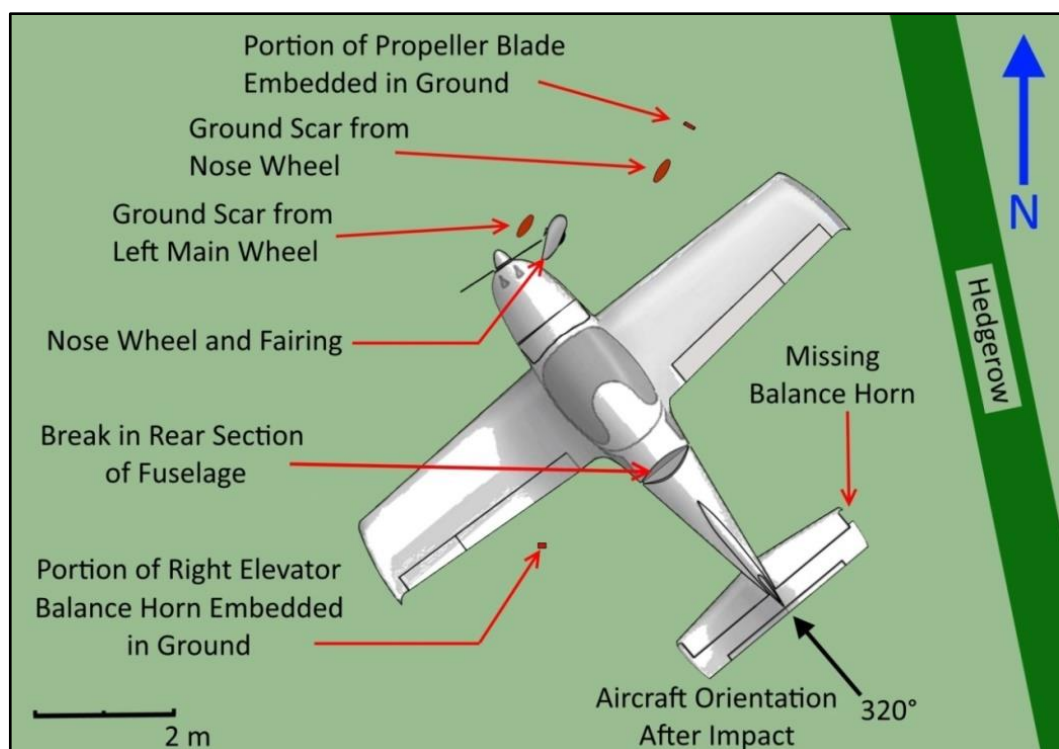
Figure No. 13: Final Orientation of Aircraft

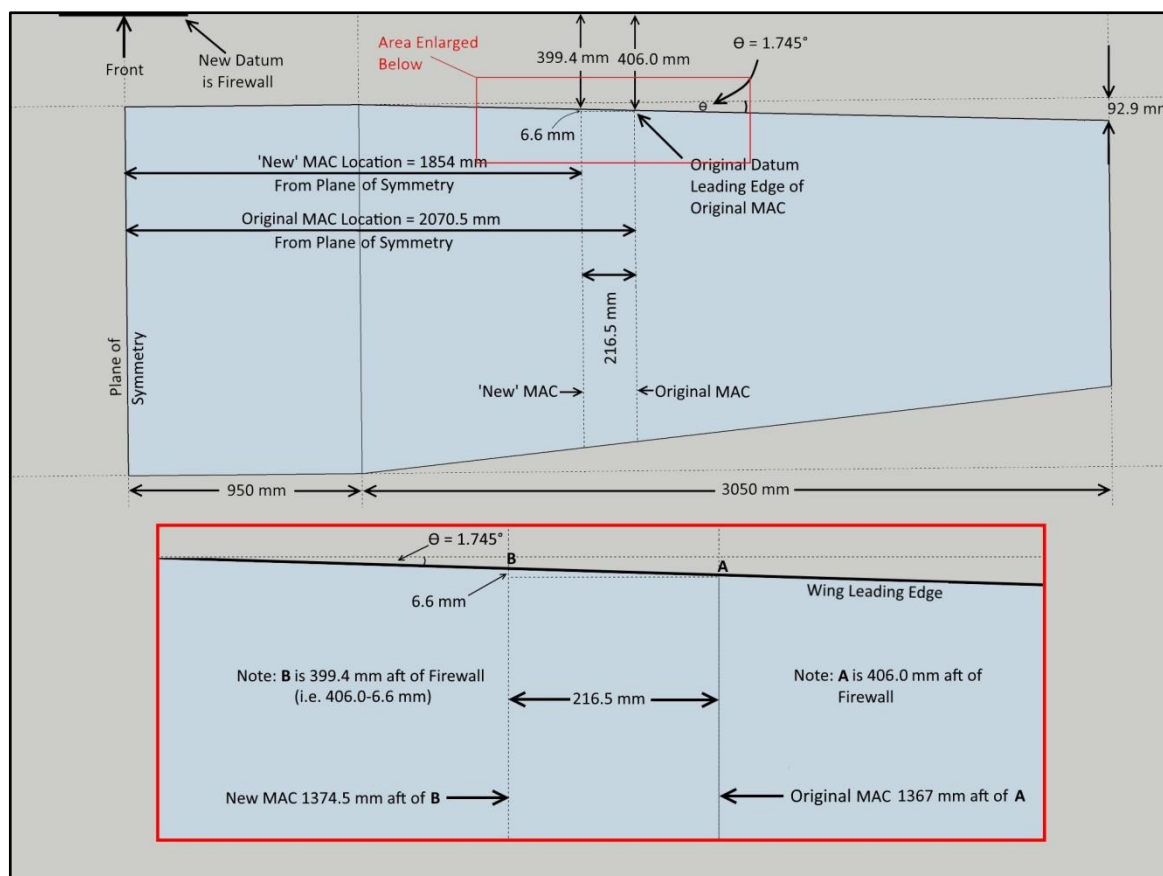
Both the original and 'new' aerodynamic data indicated that the sweep-back angle of the leading edge of the outer portion of the short wing was approximately 1.745° . Consequently, as the 'new' MAC is situated 216.5 mm inboard of the original MAC (2.0705 m minus 1.854 m), it follows that the leading edge of the 'new' MAC is 6.6 mm ahead of the leading edge of the original MAC, due to the sweep-back angle of the wing (**Figure No. 14**).

Figure No. 14: Diagram showing how wing sweep angle affects distance of MAC from Firewall Datum as calculated from the data in **Section 1.6.1**

Information from the Aircraft/Kit Manufacturer showed that the new datum (aircraft firewall) is situated 406 mm ahead of the original datum (old MAC leading edge position). From this it follows that the 'new' MAC lies 399.4 mm aft of the new datum (i.e. 406 mm minus 6.6 mm). The Investigation notes that the Aircraft/Kit Manufacturer issued an amended Weight and Balance document for the short wing variant (BRSW-AOI-AU_Ra, dated August 2020), which stated that the 'new' MAC for the short wing, of 1.3745 m lay 406.1 mm aft of the new Firewall datum. From the information above, the Investigation believes that the location of the MAC relative to datum is incorrect in the amended Weight and Balance documentation issued by the Aircraft/Kit Manufacturer in August 2020, and that the Weight and Balance document should show the 'new' MAC as lying 399.4 mm aft of the Firewall. The Investigation therefore makes the following Safety Recommendation to the Aircraft/Kit Manufacturer:
