Air Accident Investigation Unit Ireland

SYNOPTIC REPORT

ATR 72-212A, EI-FCY

24 August 2016

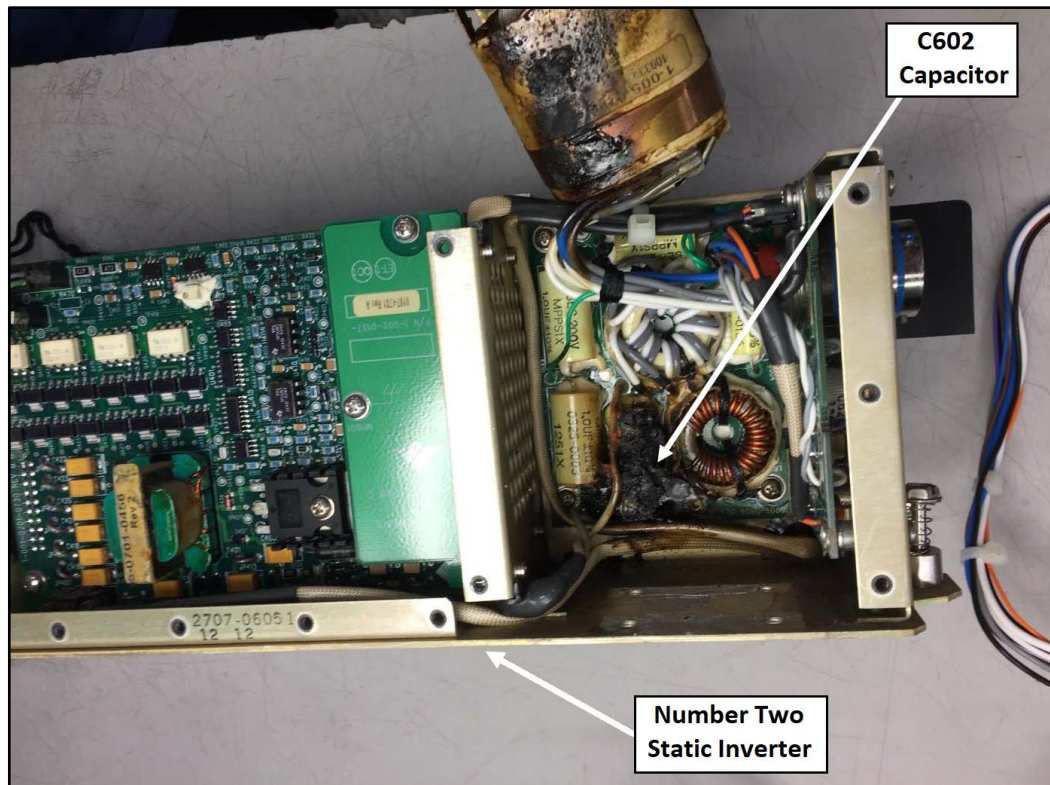
The OEM conducted an engineering examination of the failed static inverter. The OEM produced a Failure Analysis Report which found that the failure of the number two static inverter and associated smoke and odour was caused by a failure of the C602 (1-001-0306-0136) capacitor within the number two static inverter (**Photo No. 1**).

Photo No. 1: Static Inverter showing location of failed capacitor (C602).

Workshop examination of the number 2 static inverter showed that a C602 capacitor within the unit had failed in a manner that resulted in electrical smoke being emitted from the unit.

Failure of the C602 (1-001-0306-0136) capacitor within the number two static inverter.

'Product improvement to the Static Inverter upgrades the unit from "MOD E" to "MOD F" which replaces capacitors C601 through C605 with new capacitors that have had additional quality screening (i.e. burn-in).'
