Air Accident Investigation Unit Ireland

FACTUAL REPORT

BRM Land Africa, CS-UTN

Letterkenny Airfield, Co. Donegal

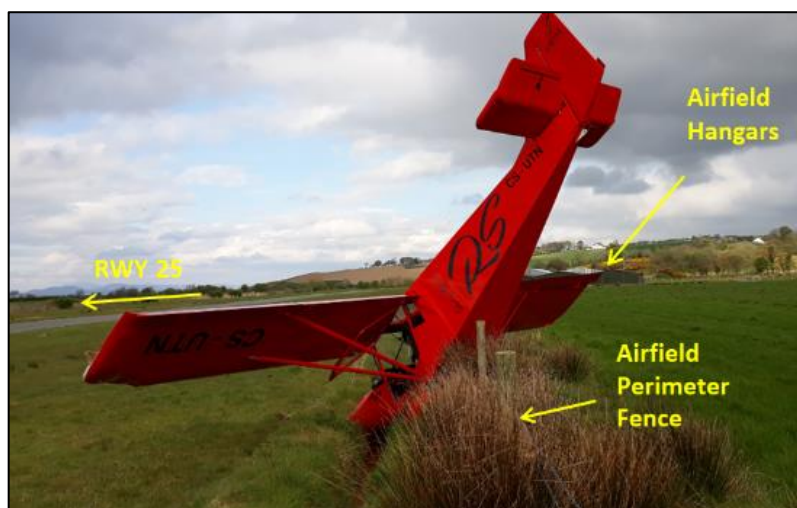
The Pilot informed the Investigation that due to the speed of the occurrence he was uncertain as to the exact sequence of events. He stated that he was unsure *'if it was the left wing tip or the left wheel that caught the fence and spun [the aircraft] around 180 degrees into a ditch/drain nose first'*. The aircraft came to rest, nose down, in a drain, which runs adjacent to the airfield's perimeter fence (**Photo No. 1**). The Pilot was uninjured and exited the aircraft unaided.

Photo No. 1: Final Resting Position of CS-UTN

Following the impact, the aircraft came to rest approximately 250 metres (m) from the threshold of RWY 25 entangled in a barbed wire perimeter fence running parallel to the southern side of the runway. It had rotated approximately 220 degrees anti-clockwise from its original direction of travel onto a magnetic heading of approximately 030 degrees. The aircraft sustained substantial damage, as shown in **Photo No. 2**.

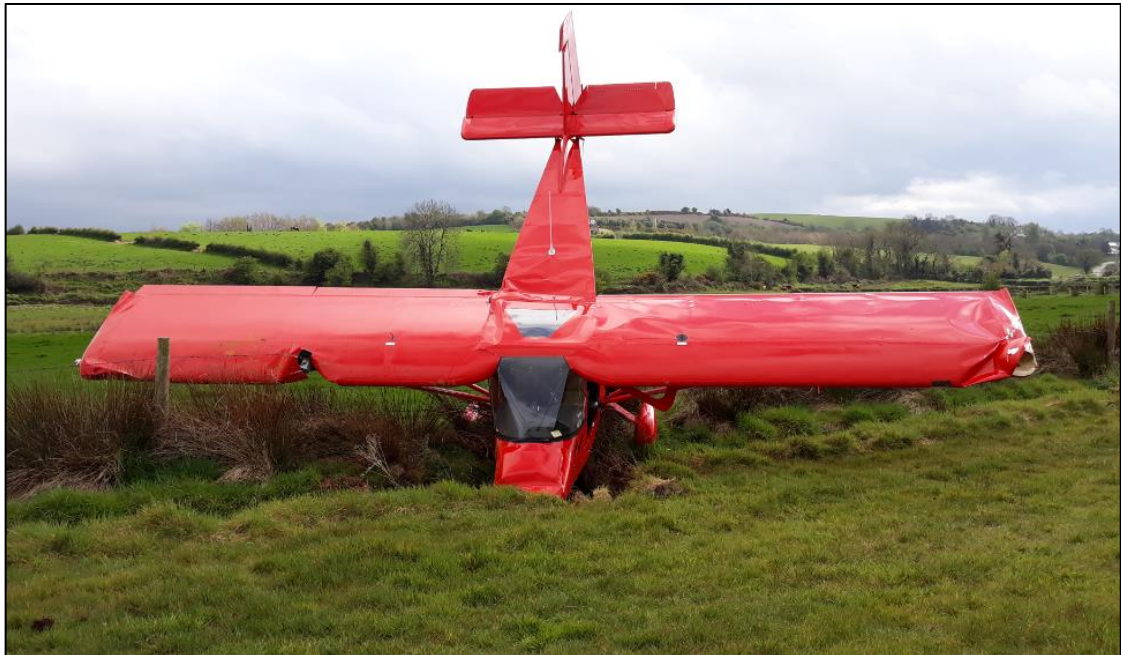
The left wing was buckled, split and creased along its wing tip and leading edge area. The wing tip area and leading edge of the right wing also suffered impact damage. The barbed wire fence pierced through the right wing's leading edge, tearing the wing's main rib structure.

The propeller, which was providing power at the time of the accident, was broken during the impact and accordingly the engine would have suffered shock loading. Significant damage and skin buckling to the engine cowlings and aircraft fuselage area was also evident.

Photo No. 2: Damage Sustained To Aircraft

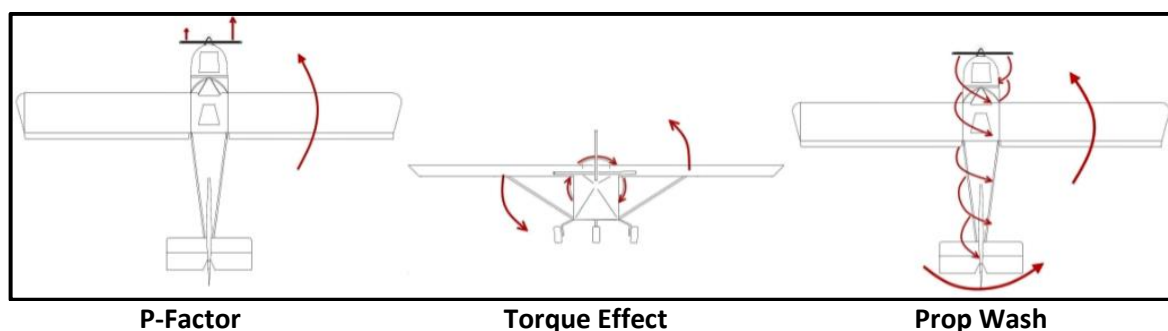
Figure No. 2: Effects of Propeller Rotation

P-Factor, as illustrated in **Figure No. 2**, is a condition of asymmetric or unequal loading of the propeller disc due to changes in an aircraft's angle of attack. The propeller blade moving downwards has a higher angle of attack and will consequently generate more thrust than the propeller blade moving upwards. In aircraft that have a clockwise rotating propeller (as viewed from the cockpit), the thrust imbalance on the propeller will cause an aircraft to yaw to the left. This is due to the propellers centre of thrust being located to the right of the centre of the propeller. The yaw to the left as a result of P-Factor is more pronounced during take-off and climb and is normally counteracted by the pilot inputting rudder as necessary to counteract the unwanted yaw.

In aircraft that have a clockwise rotating propeller (as viewed from the cockpit), the torque reaction from the propeller will cause the aircraft to rotate anticlockwise and roll the aircraft to the left (**Figure No. 2**). The left undercarriage will counteract this rolling reaction on the ground however, in the air the aircraft will roll to the left. The torque reaction is more prominent at high propeller speeds and low forward airspeed.

Aircraft that have a clockwise rotating propeller (as viewed from the cockpit) will induce a clockwise rotation on the slipstream as the air flows over the aircraft, (**Figure No. 2**). This causes asymmetric or unequal loading over the left-hand side of the aircraft's vertical fin and rudder. This slipstream effect imparts a force on the left-hand side of the tail area, pushing it to the right. The result is that the aircraft nose will yaw to the left.

During the attempted go-around manoeuvre, the combination of a strong gusting crosswind, rudder inputs, the effects of propeller aerodynamics at low aircraft speed and application of additional engine power, likely caused the aircraft to roll to the left. From eyewitness reports, and from the damage observed, the left wing tip impacted the ground first and the aircraft pivoted about this point. Once the left wing struck the ground, control of the aircraft was lost, and a recovery was no longer possible.
