Air Accident Investigation Unit Ireland

SYNOPTIC REPORT

**Boeing 737-800, EI-GXG
Frankfurt-Hahn Airport**

29 January 2019

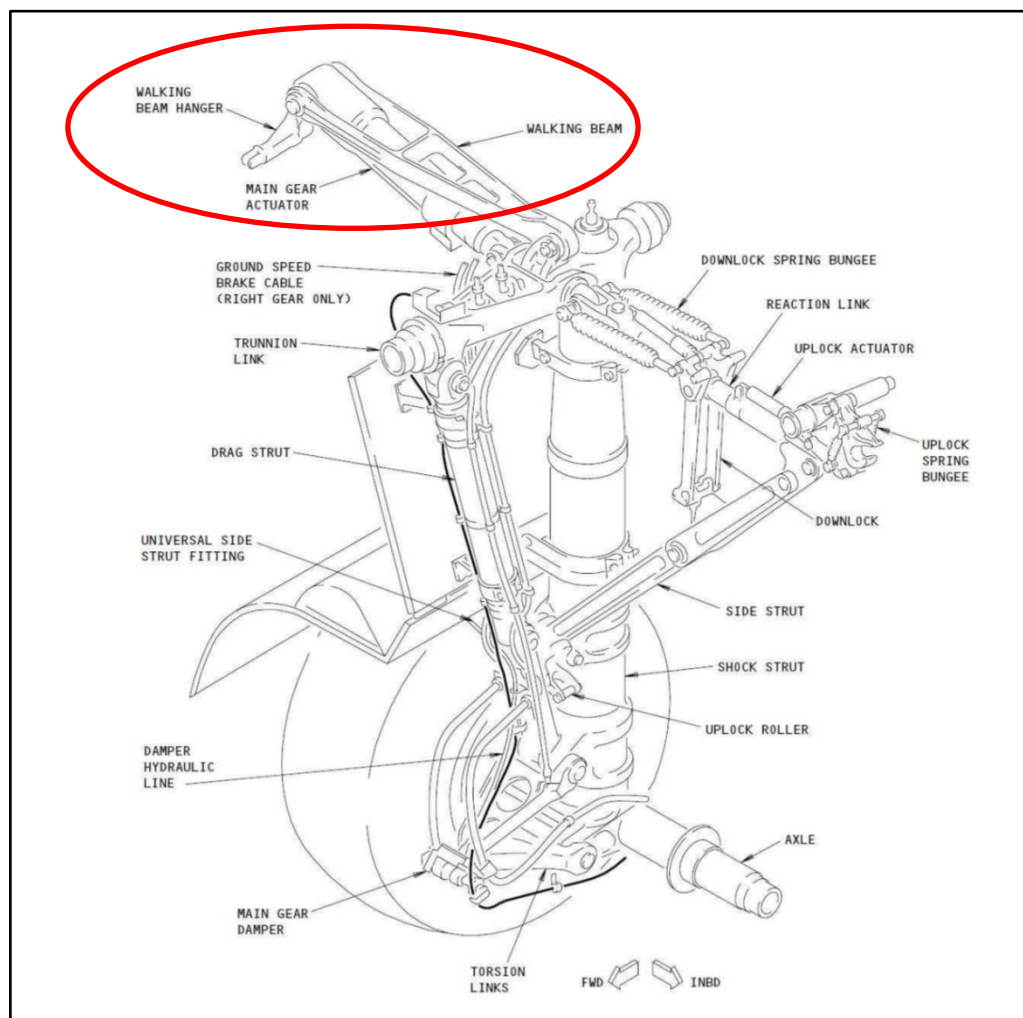
The general arrangement of the Main Landing Gear (MLG) on the subject aircraft type is shown in **Figure No. 1**. The area of interest in this occurrence is highlighted by the red oval marking. **Note: Figure No. 1** and **Photo No. 2** depict the right-hand gear which is the mirror image of the subject left-hand gear.

Figure No. 1: Main landing gear assembly with walking beam and walking beam hanger highlighted (Aircraft Manufacturer)

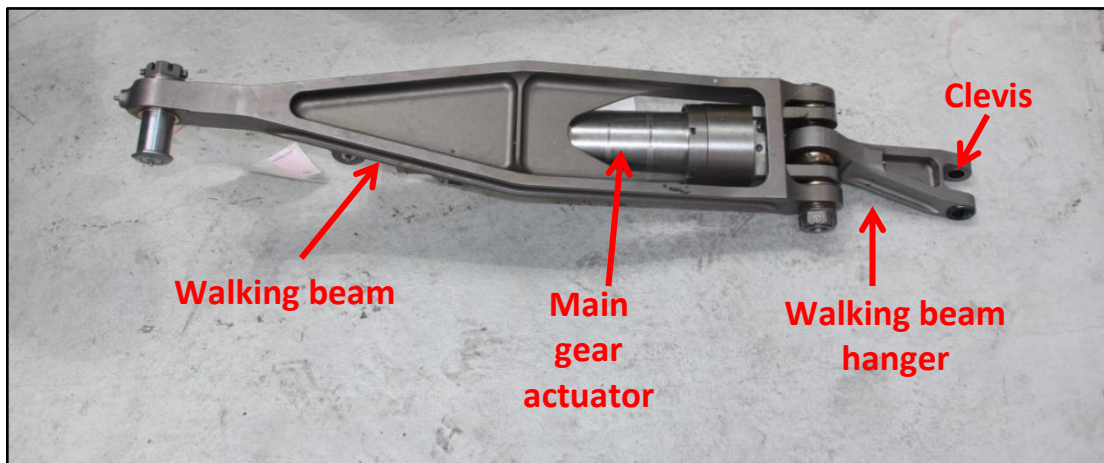
The MLG is extended and retracted by a hydraulic main gear actuator. A walking beam, attached to the actuator at one end, and to the upper part of the MLG at the other end, reacts against the force of the actuator when it is pressurised and extending, causing the MLG to retract into the main wheel well. The walking beam is connected to the aircraft structure by a walking beam hanger (**Photo No. 1**). Maintenance records did not indicate that any maintenance had been carried out on the walking beam attachment mechanism since delivery of the aircraft.

Photo No. 1: General layout of walking beam and walking beam hanger

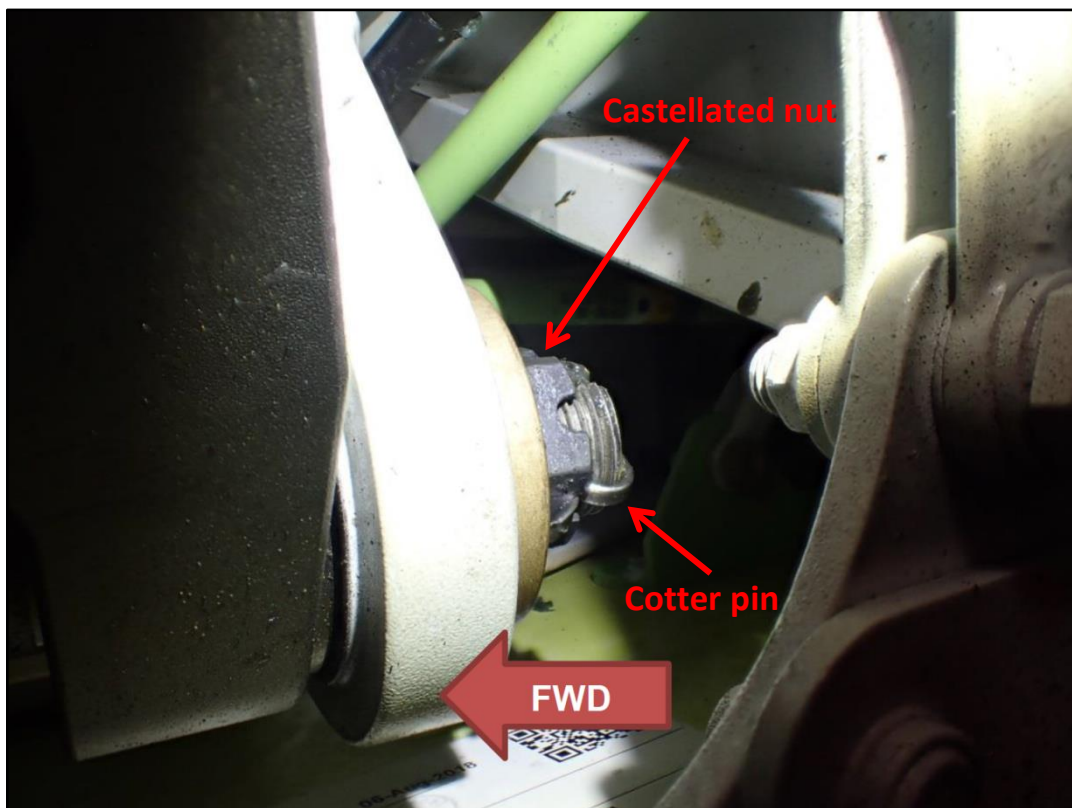
A pivot pin located in the clevis of the walking beam hanger connects the hanger to the aircraft structure and is secured by a castellated nut and cotter pin (split pin) (**Photo No. 2**). The castellated nut has a slightly deformed thread which acts as a self-locking feature. The Aircraft Manufacturer informed the Investigation that the '[Cotter] PIN, P/N BACP18BC04A14P, is considered to be a secondary means of preventing migration of PIN, P/N 161A7301-1, with NUT [self-locking], CASTELLATED, P/N BACN11N112CD, representing the primary means of retention.'

Photo No. 2: Castellated nut and cotter pin arrangement (in right wing of aircraft)

The BFU investigator also noted that the location of the installed castellated nut and cotter pin was difficult to access and inspect.

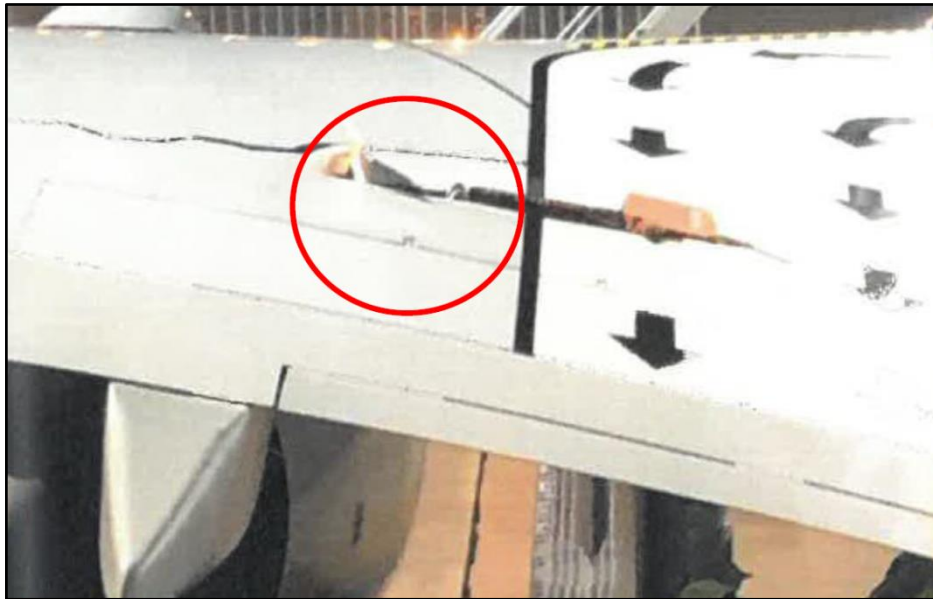
The left-hand main landing gear walking beam hanger was found detached and had punctured the upper surface of the wing in the area of the landing gear bay cover (**Photo No. 3**). The forward support position of the walking beam hanger clevis exhibited slight damage (**Photo No. 4**), which appeared to be an imprint of the threaded part of the pivot pin. The pivot pin and associated tang washer (**Photos No. 5 and 6**) were found separately in the landing gear wheel well. The thread of the pivot pin appeared to show some minor damage. The castellated nut and cotter pin were not found. In addition, one fractured hydraulic pipe was found and the rubber coating of two hydraulic hoses sustained damage.

Photo No. 3: Damage to upper surface of the left wing

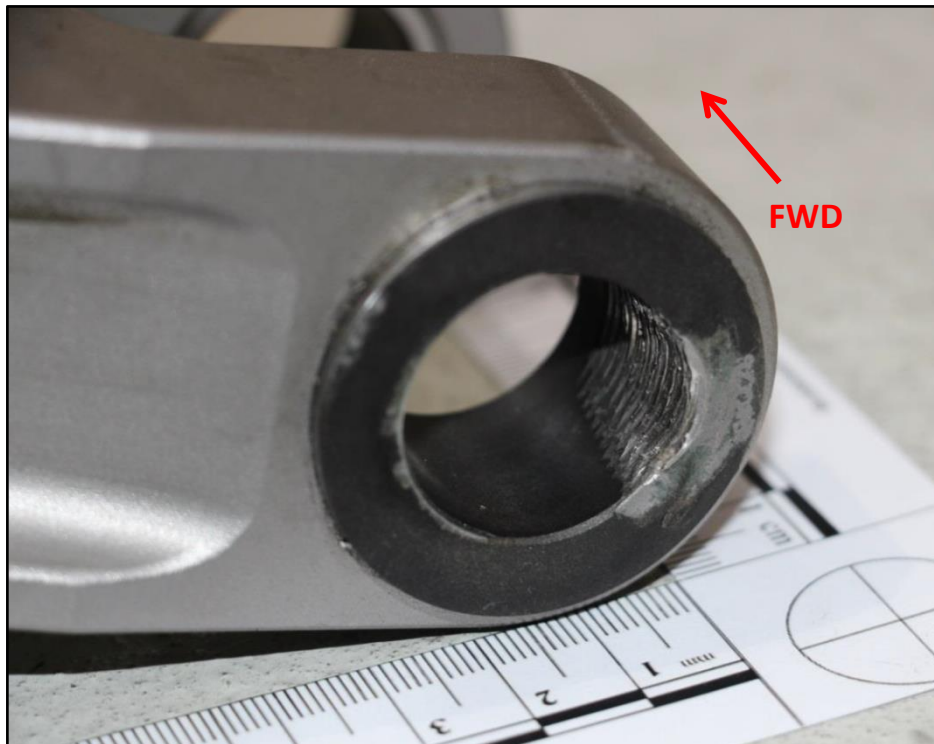
Photo No. 4: Damage to forward support position of walking beam hanger clevis

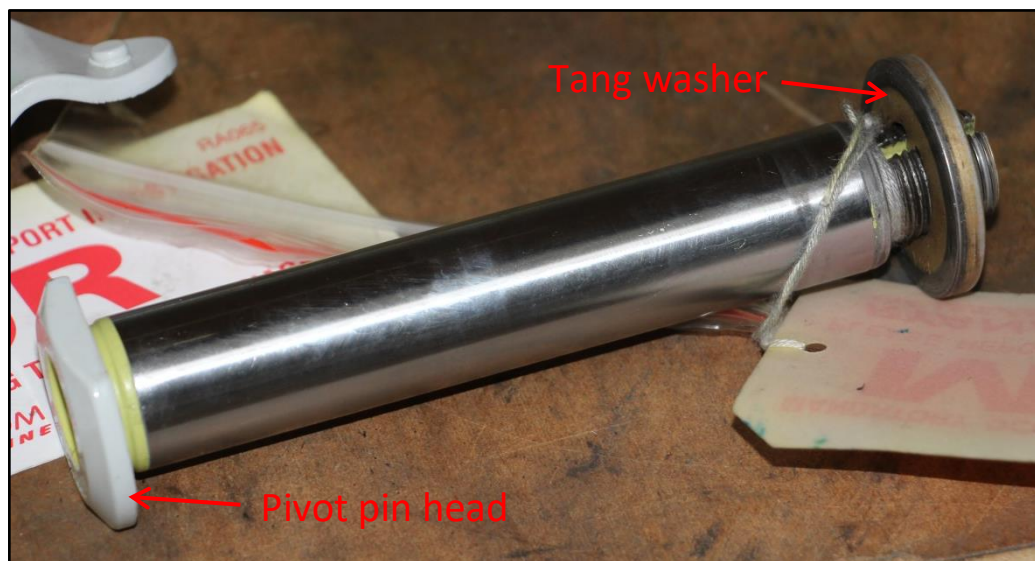
Photo No. 5: Pivot pin and tang washer with label attached

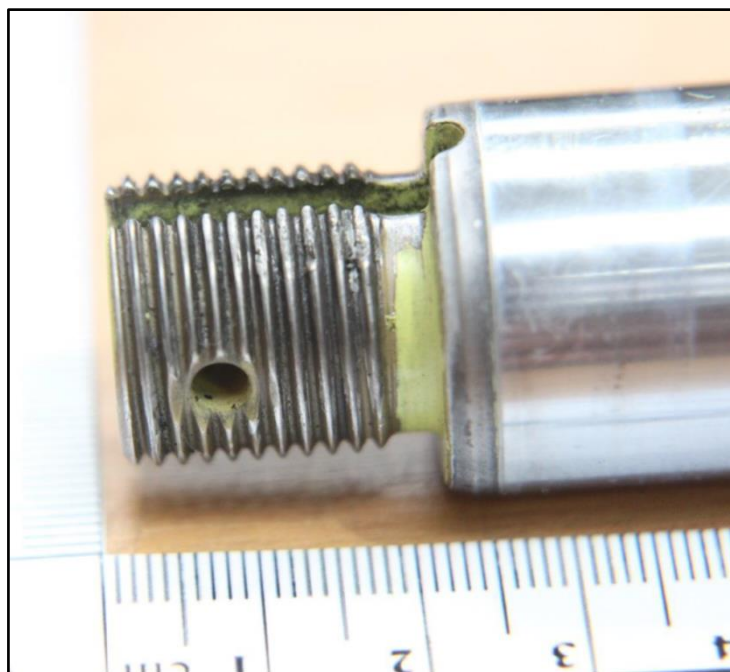
Photo No. 6: Threaded end of pivot pin showing machined hole for cotter pin and tang washer slot

An investigator from the BFU (Germany) examined the occurrence aircraft and the parts that had become separated. The investigator concluded that the pivot pin and tang washer had been correctly positioned in the walking beam hanger as there were witness marks on the clevis of the walking beam hanger. The BFU investigator concluded that it was most likely that the castellated nut and cotter pin had been incorrectly installed, or not installed at all. The BFU investigator noted that the condition of the cotter pin hole on the screw thread supported this hypothesis.

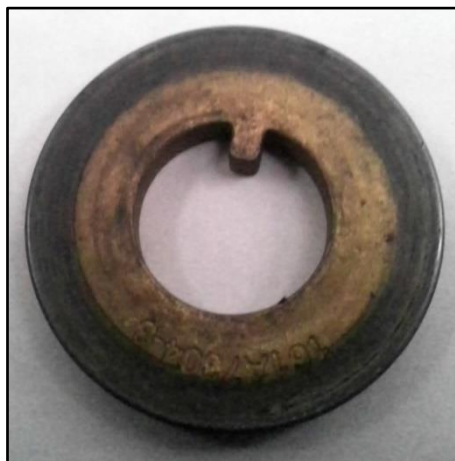
Photographs of the tang washer (**Photos No. 7 and 8**) provided to the Aircraft Manufacturer by the Operator appear to show that the surface treatment on one side of the tang washer had been removed due to contact with the adjacent bushing. However, the opposite side of the tang washer (i.e. the nut side), which should show similar wear to the surface treatment due to contact with the castellated nut does not appear to show any wear. The Aircraft Manufacturer believes that this may indicate that the castellated nut was not fully seated against the tang washer, and that the torque wrench may have registered the correct applied torque without the components being correctly seated.

Photo No. 7: Tang Washer showing evidence of surface in contact with adjacent bushing

4. The castellated nut and cotter pin intended to secure the pivot pin were not found.
5. Photographic evidence of the tang washer found with the pivot pin showed some evidence of damage to the surface of one side of the washer which may have been caused by contact with the adjacent bushing. The other side of the tang washer (which should have been in contact with the castellated nut) did not appear to show any damage

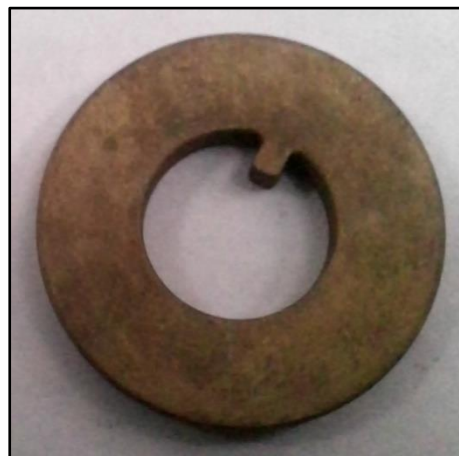
Photo No. 8: Tang Washer, no evidence of surface contact with adjacent castellated nut
