Air Accident Investigation Unit Ireland

SYNOPTIC REPORT

SERIOUS INCIDENT

ATR 72-212A, EI-FAW

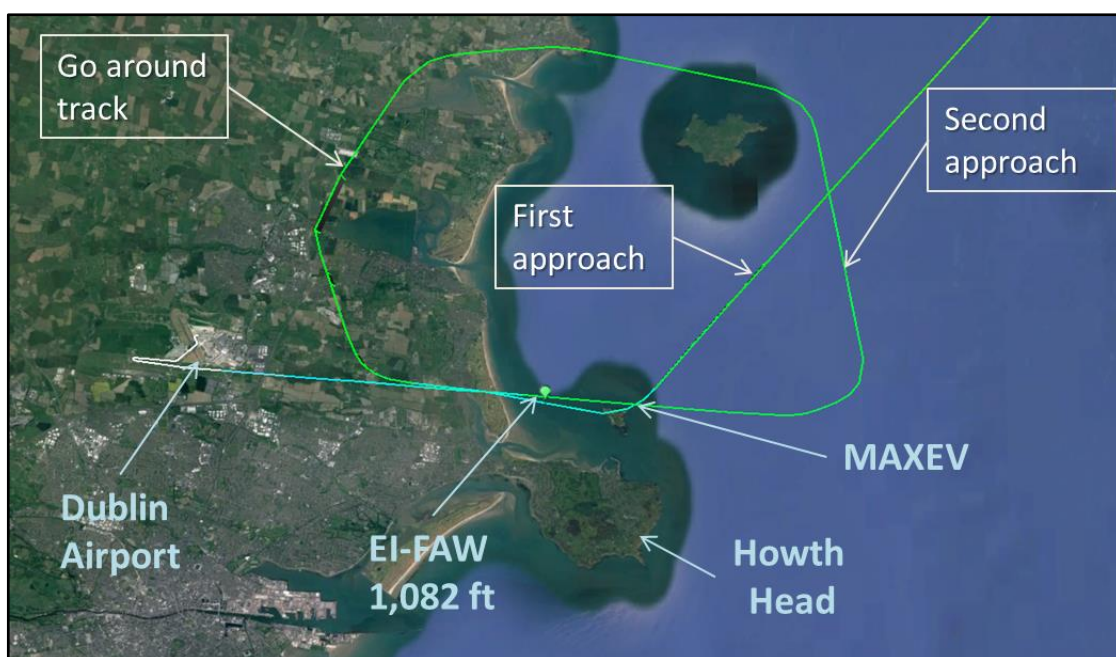
Figure No. 1: EI-FAW Flight Path overlay with the aircraft's position at 16.39 hrs

At 16.39:26 hrs, as the aircraft passed an altitude of 1,200 ft, an MSAW alert was triggered on the controller's ATC radar screen, causing the ATCO to request the aircraft to *"confirm established on the localiser¹¹ runway 28?"* The Aircraft Commander responded *"Em ye yes confirm we are now eh going eh going around eh [callsign]"*. The ATCO requested clarification of the intentions of the Aircraft Commander by asking *"eh [callsign] just confirm you are going around?"* to which the Commander replied *"Affirm"*. The ATCO acknowledged this transmission with *"Ok [callsign] roger"*. During this interaction, the aircraft continued descending until reaching an altitude of 1,082 ft and an IAS of 168 kts at a point 1.75 NM west of MAXEV. The altitude of an aircraft at this point on the ILS glideslope for RWY 28 should have been 1,975 ft.

During the first approach the aircraft flaps remained at zero degrees and the undercarriage remained in the 'UP' position. Following the MSAW alert and the controller's intervention, the aircraft executed a go-around and climbed to an assigned altitude of 3,000 ft.

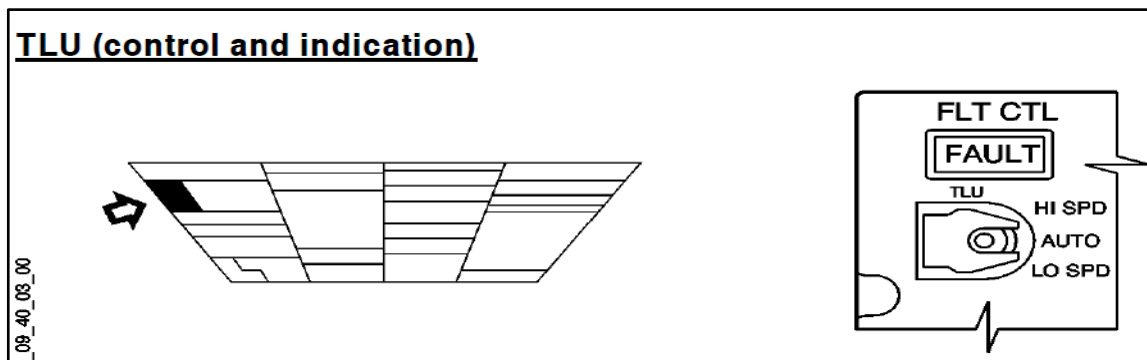
Figure No. 2: ATR 72-212A TLU Controls and Indication

The TLU is controlled from an overhead panel in the cockpit (**Figure No. 2**). The TLU switch is normally selected to AUTO. In the event of a failure of the system, an amber FAULT light in the TLU panel will illuminate and the TLU can be operated manually by the Commander by placing the switch in the ‘HI SPD’ (High Speed) or ‘LO SPD’ (Low speed) mode as the appropriate airspeed is reached. The operation of the TLU is the same for both the ‘-500’ and ‘-600’ versions of the ATR 72-212A.

On the day prior to the flight, the TLU System in EI-FAW was inoperative in AUTO mode and this was recorded in the Aircraft Technical Logbook (ATL). The '-600' version (the subject aircraft) includes an additional caution indication that illuminates on the central Engine and Warning Display (EWD) which states 'FLT CTL TLU'. There is no equivalent indication in the '-500' version.

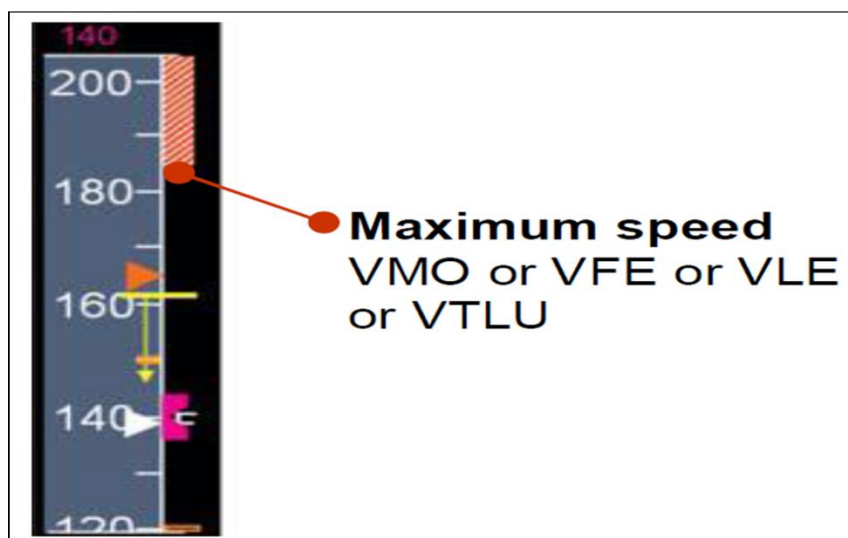
Figure No. 5: Context-dependent overspeed value on the ATR72 ‘-600’ cockpit speed tape

- On the ATR 72, a maximum speed indication of 185 kts is displayed on the speed tape when the TLU is manually selected on LO SPD (**Figure No. 5**). This is indicated through the striped red and white “Barber’s Pole” band on the speed scale [of the ‘-600’ version].

- When the TLU is manually selected to LO SPD while the IAS is above the max speed of 185kts (VTLU), there is no aural warning as there is for max speed due to VFE (max flap extension speed), VLE (max landing gear extension speed) or VMO (max operating speed).
- Whenever the AP function is disengaged manually without disengaging the Yaw Damper (YD) function, the AP green arrows turn off, AP DISENG is displayed on the Flight Mode Annunciator (FMA) as a white on red message reverse video, and the “cavalry charge” aural warning is generated. The disengagement is achieved by action on one of the following devices:

The Investigation established that the TLU deferral criteria and in-flight operational procedures in the MEL for both the '500' and '600' versions of the ATR 72 are the same, although the Commander's assessment of the cause of the occurrence was '*MEL of the TLU is different from ATR 600 and ATR 500.*' The Commander told the Investigation that he set the TLU to LO SPD at 3,500 ft and 185 kts. According to the FDM data, the aircraft passed 3,500 ft at 16.37:22 hrs while the aircraft was at an IAS of 202 kts. This speed is above the V_{TLU} indication on the Commander's cockpit speed tape, and would cause the '*Barber's Pole*' (of the '600' version) to move to 185 kts, indicating an overspeed situation to the Commander.

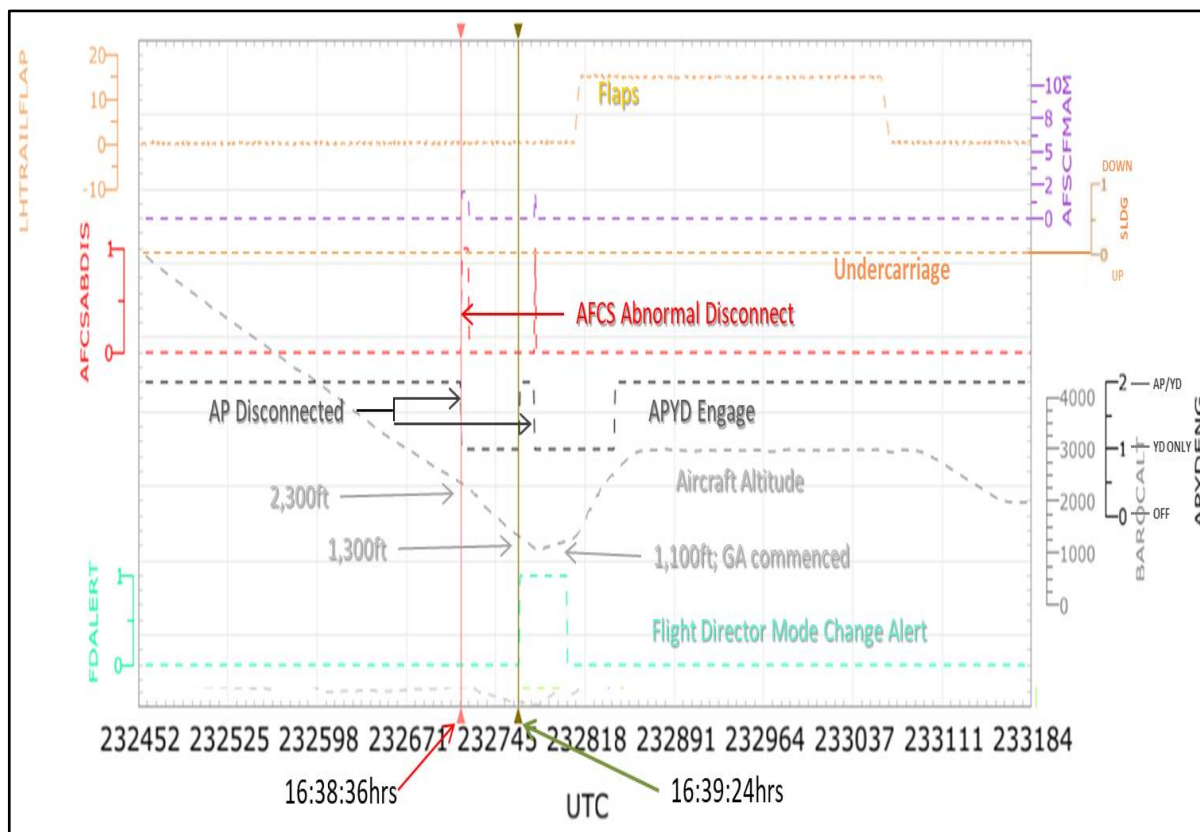
Figure No. 8: FDM Data showing moment of Autopilot disconnect during first approach

At 16:38:36 hrs, passing 2,300 ft at 186 kts, the FDM recorded an abnormal disconnect of the Automatic Flight Control System (AFCS) and autopilot (**AFCSABDIS** in **Figure No. 8**), and a Flight Mode Annunciator of 'AP DISENG' was activated in the cockpit.

At 16:38:43 hrs (seven seconds later), the armed vertical mode changed from ALT SEL GS to GS indicating that the selected altitude was being captured. The engaged vertical mode changed to ALT*, which is the capture mode for the pre-selected altitude of 2,000 ft. The autopilot remained disengaged. At 16:38:58 hrs, while at 1,800 ft and 184 kts on a heading of 224 degrees, the engaged lateral mode changed from HDG SEL to LOC*, which is the capture mode for the localiser. However, during LOC* the HDG SEL will still cause the aircraft heading to change until the localiser is captured. The aircraft commenced a right turn onto a heading of 283 degrees. This turn was conducted while the autopilot was disengaged (the Co-pilot recalled initiating the turning of the aircraft).

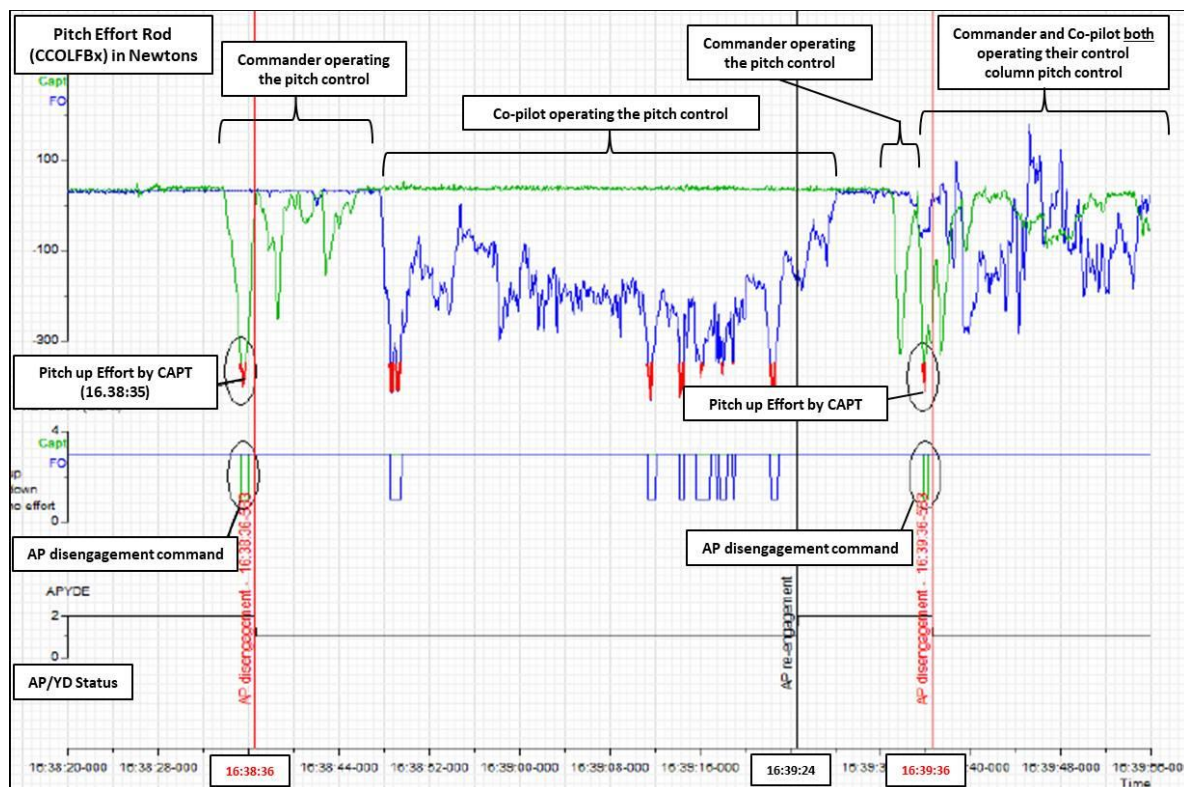
Figure No. 9: Extract of FDM Data provided by Aircraft Manufacturer.

Some root causes cannot be excluded from QAR²⁷ data (internal AFCS failure, AHRS vertical speed monitoring, AP push button or AP quick release) but as a pitch effort on the control column greater than 10daN²⁸ is noticed on QAR data just before AP disconnection, this root cause is the most probable explanation for AP disengagement.

This condition is triggered when the effort applied on the rod becomes greater than $\pm 35\text{daN}$ (parameter "Pitch Effort Rod": CCOLFBx [Figure No. 9]). At GMT 16:38:35, the effort applied by the captain on the Rod becomes lower [a greater negative force] than -35daN and reaches -39daN , the AP is disconnected 1s later due to AFCA and MFC confirmation time and refresh rate.

13. The autopilot disconnected at 16.38:36 hrs and at 16.39:36 hrs. Both disconnect events were caused by the inappropriate pitch up force of -39daN applied to the Commander's control column.

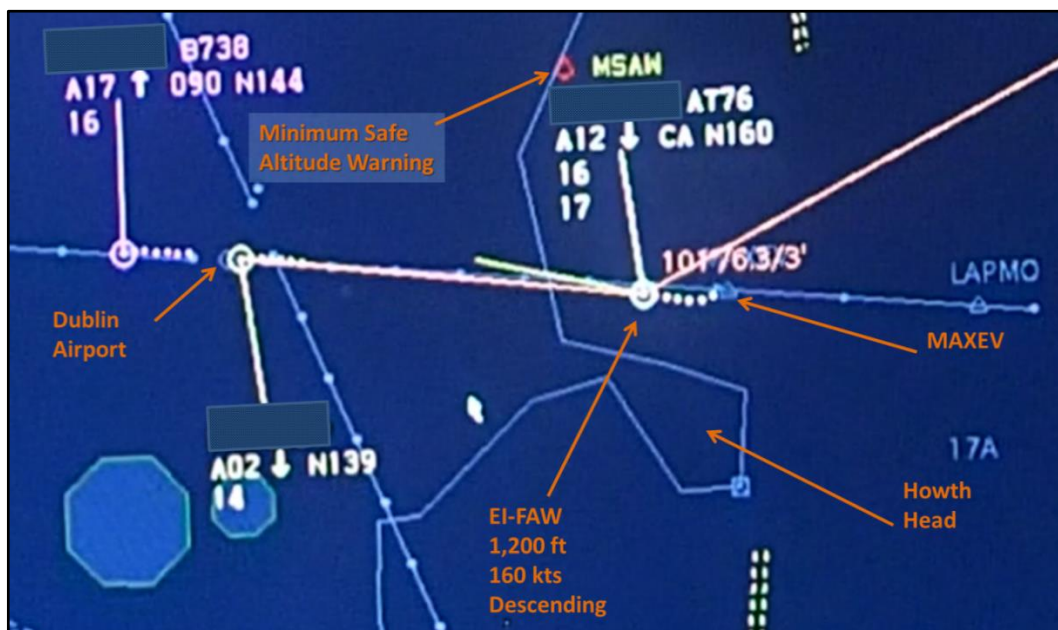
Figure No. 10: ATC Radar Screen showing the position of EI-FAW at the time of the MSAW

The ATC radar screen at 16.39:35 hrs is shown in **Figure No. 10**, and indicates the moment that the MSAW activated. The ATCO enquired whether the aircraft was established on the localiser. In response, the Commander stated that a go-around was being commenced.
