Air Accident Investigation Unit Ireland

SYNOPTIC REPORT

**Serious Incident
Stolp Starduster TOO SA-300, G-UINN
Ballyboy Airfield, Co. Meath**

1 June 2019

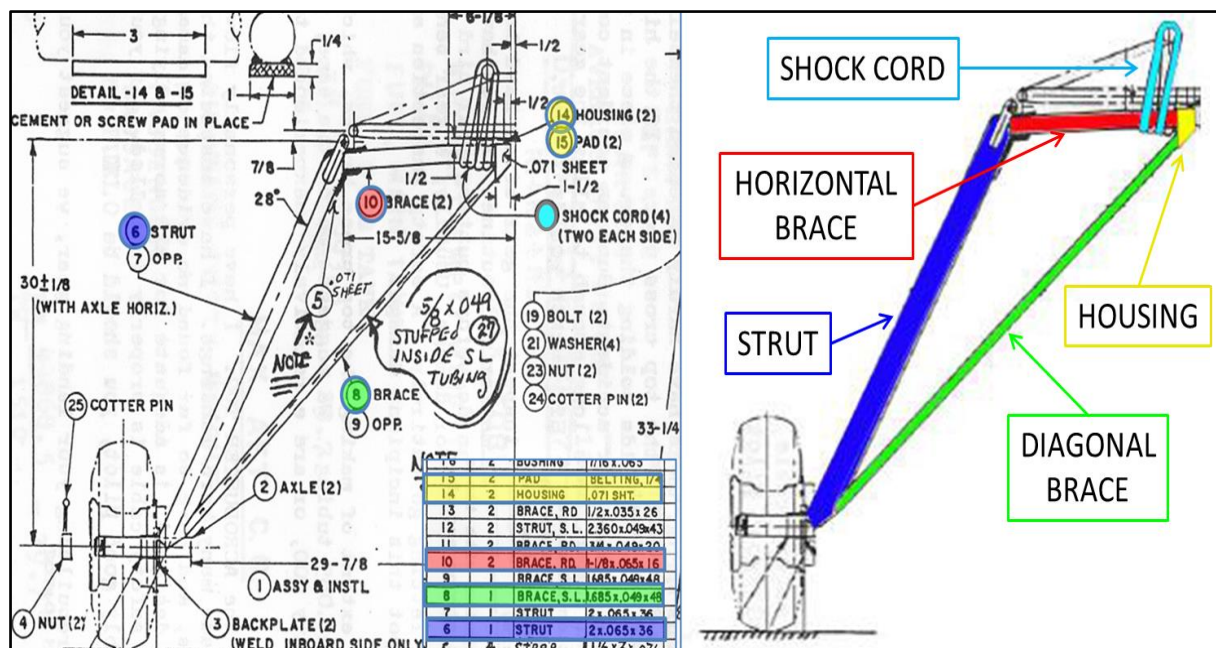
Figure No. 1: Left Main Undercarriage (looking forward), with simplified view (right).

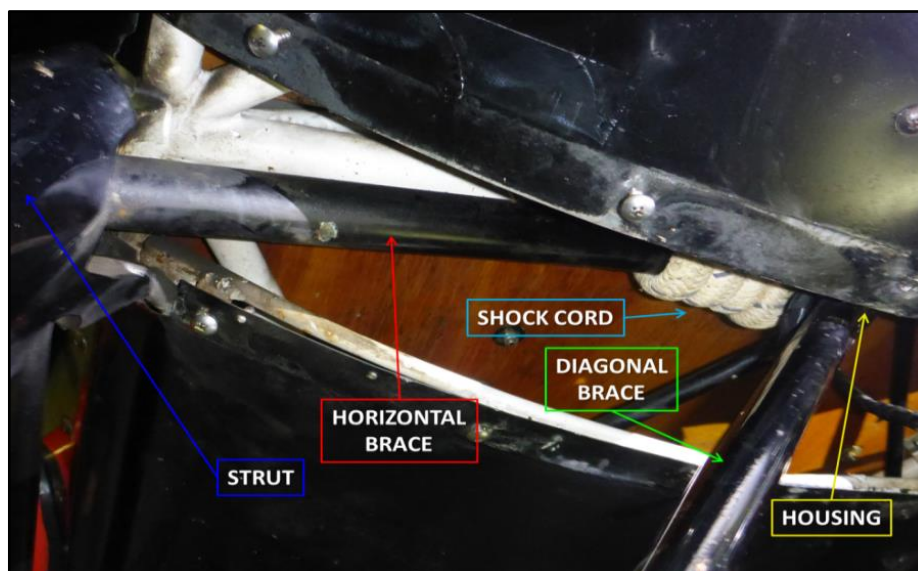
Photo No.1: Right main undercarriage assembly of G-UINN looking rearwards.

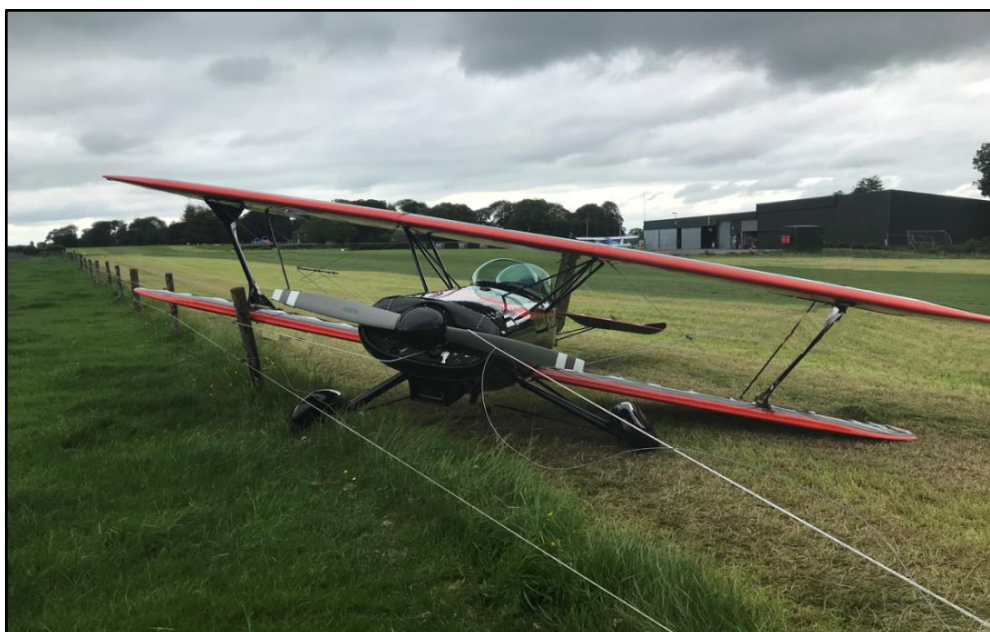
The aircraft was examined by an Inspector of Air Accidents shortly after the occurrence¹⁰. It was located approximately 390 metres (m) from the threshold of RWY 29 (**Photo No. 2**). It had come to rest against a wooden fencepost which was supporting the perimeter fence on the south side of the airfield. The fence ran parallel to the runway, approximately 12 m from the runway edge. The propeller blade was loosely entangled in the strands of the fence-wire, but the strands were not wrapped around the propeller hub.

Photo No. 2: The position of G-UINN following the runway excursion.

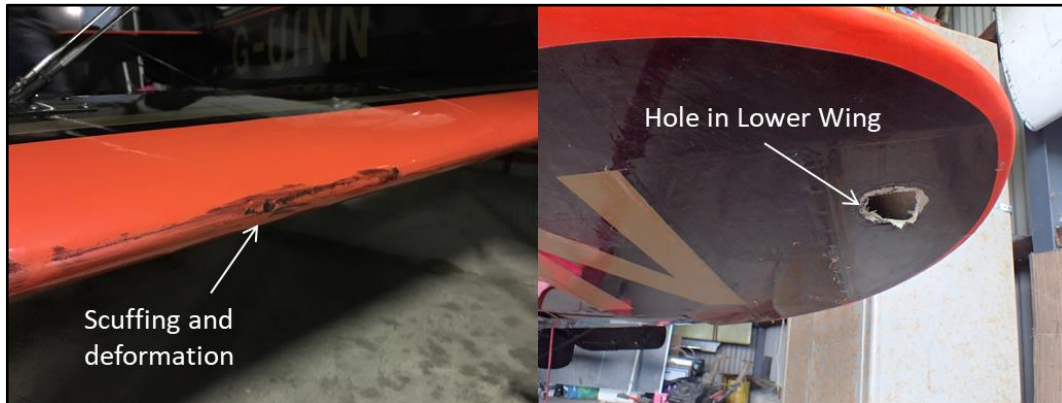
The leading edge of the lower right wing had contacted a fence post causing some scuffing and deformation of the leading edge (**Photo No. 3A**), and there was a hole in the underside of the lower left wing where it had contacted the grass during the excursion (**Photo No. 3B**).

Photo No. 3A: Lower right wing Leading Edge. **Photo No. 3B:** Underside of lower left wing.

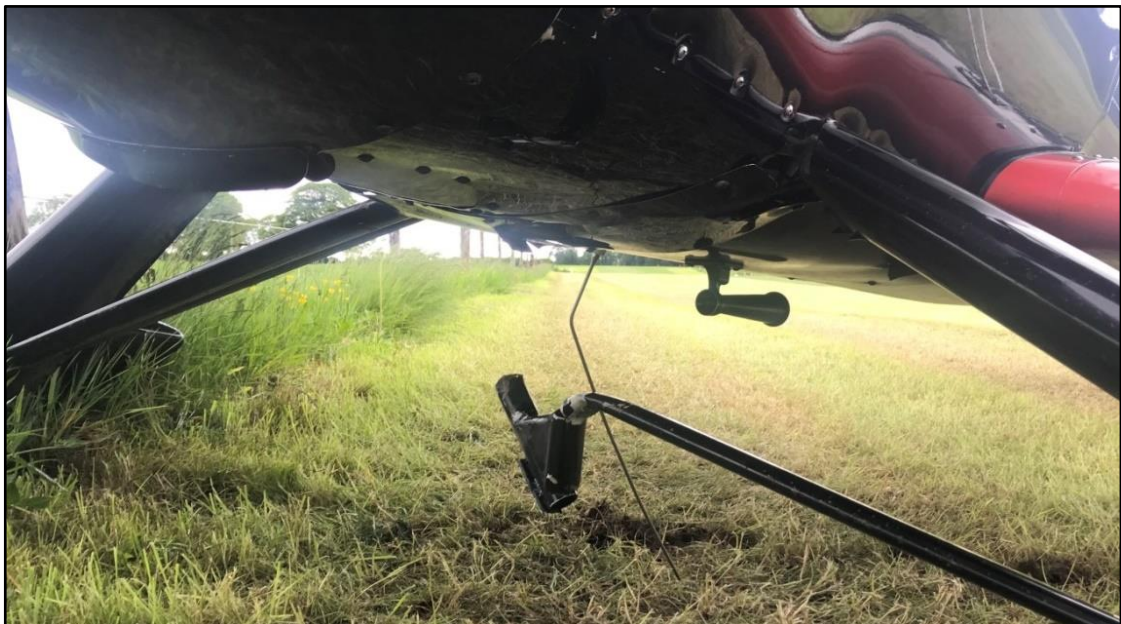
The housing from the left undercarriage assembly was visible below the aircraft fuselage, having detached from the horizontal brace. The housing had also fractured where it joined the diagonal brace, but was still partially attached. (**Photo No. 4**).

Photo No. 4: Housing partially attached to the diagonal brace

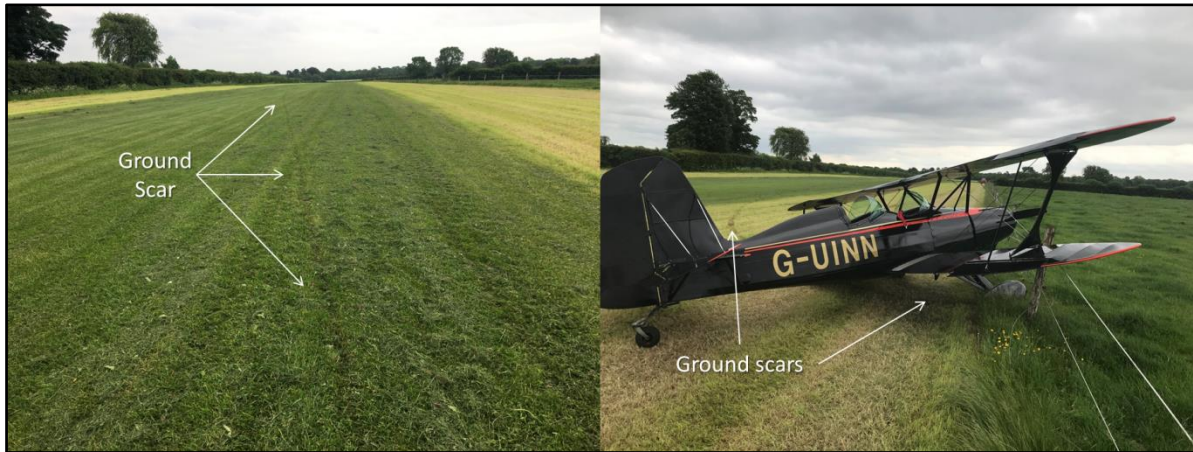
There were ground scars on the runway (**Photo No. 5A and 5B**) that extended from the point where the Pilot said that the aircraft touched down, to the aircraft's final position. These scars were made by the aircraft's right undercarriage leg. The scars originated near the centre of the runway and curved gradually to the left prior to exiting the runway. The final scars also showed where the left wingtip contacted the ground as the aircraft pivoted to its final position against the fence.

**Photo No. 5A:** Initial ground scar**Photo No. 5B:** Final ground scars

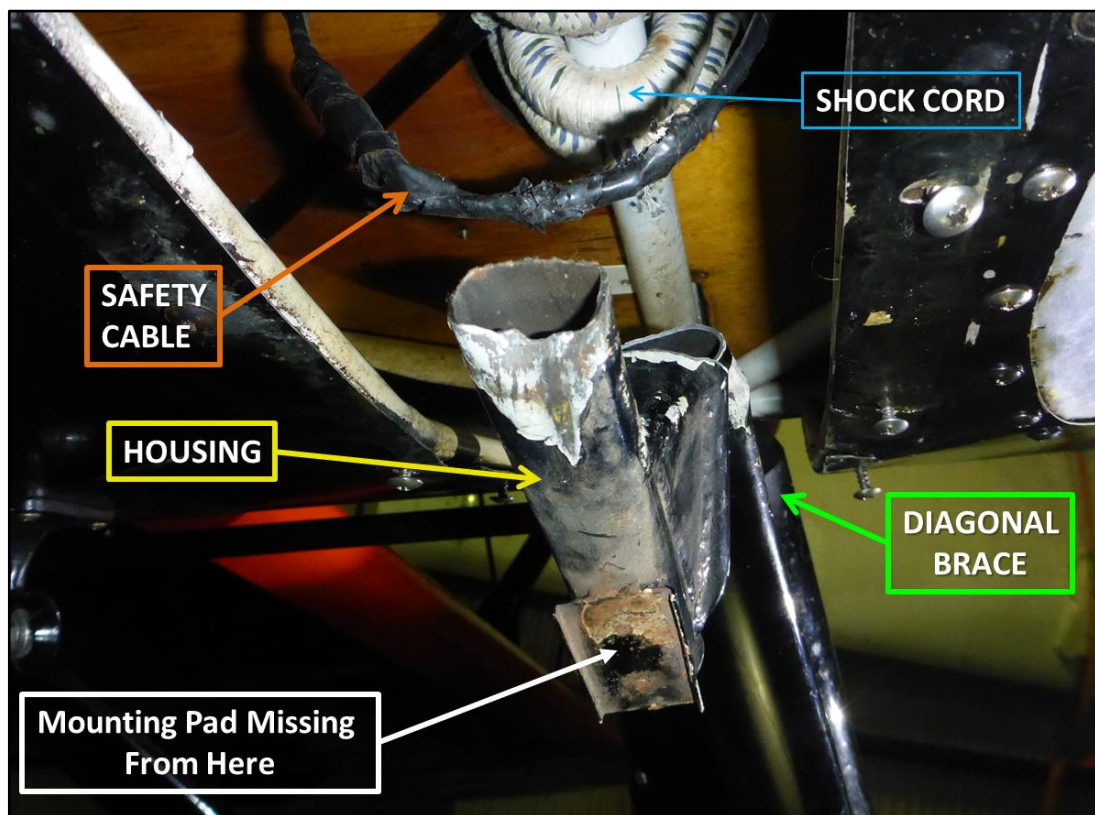
An examination of the left undercarriage assembly showed that the safety cable was present, and was not tightened to the point that would prevent the horizontal brace from moving freely as described in the *Starduster Magazine*. The rubber mounting pad (No.15 in **Figure No. 1**) was missing from the housing (**Photo No. 6**). The Pilot subsequently informed the Investigation that the respective rubber mounting pad from the right undercarriage housing was also missing, and may have been missing for a considerable period of time. The Investigation noted that the cockpit 'g' meter indicated that a maximum of +3.4 g, and a minimum of +0.6 g had been recorded¹¹.

**Photo No. 6:** View of the damaged left undercarriage assembly

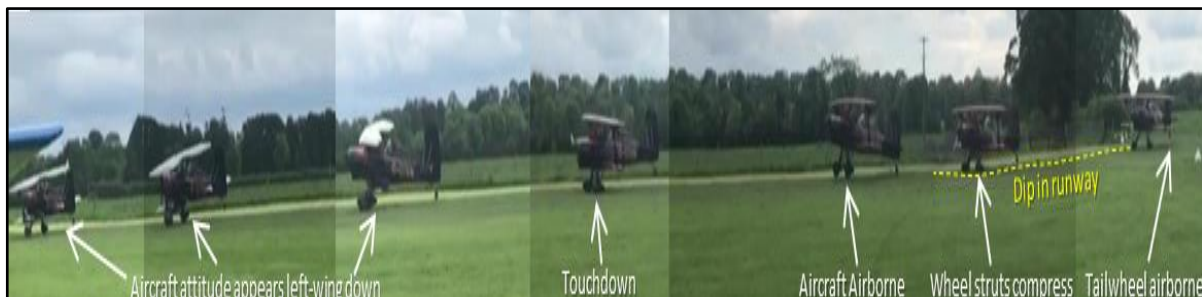
The Pilot provided the Investigation with a video which was recorded by an acquaintance. The video consisted of five seconds of recorded data consisting of a portion of the aircraft's take-off roll on RWY 11. The video was taken from in front of a hangar located to the north of the runway. The Investigation extracted seven still images from the video, and created a composite image of the take-off roll (**Photo No. 7**). As the aircraft comes into view on the right of the image, it is travelling at sufficient speed for the Pilot's control inputs to lift the tail-wheel off the ground. As the aircraft continues its initial take-off roll, it encounters a dip in the grass runway. As the aircraft exits the dip, the wheel struts can be seen to compress initially and then expand causing the aircraft to become airborne momentarily. The aircraft does not appear to have sufficient airspeed to remain airborne and it touches down again. There appears to be a small incline on the runway at this point, and the wheel struts can be seen to compress when the aircraft touches down. For the remainder of the take-off roll following this touchdown (the three aircraft images on the left side of **Photo No. 7**), the aircraft appears to be travelling consistently in a left wing low attitude. The aircraft disappeared from view behind another aircraft, and the video ended before the aircraft was seen again.

Photo No. 7: Composite image of the take-off roll extracted from recorded video

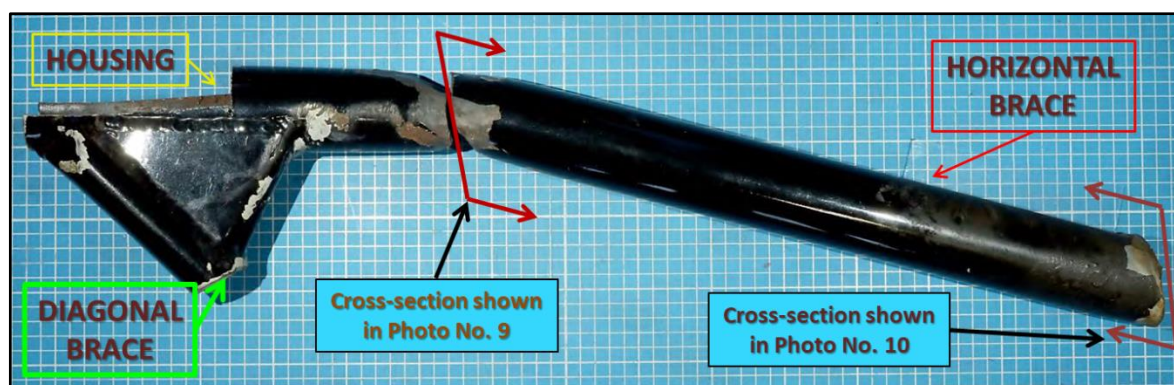
The Investigation sent the horizontal brace and the housing to a metallurgical expert to conduct an examination and failure analysis of the components. The horizontal brace had fractured at both ends, and the diagonal brace had fractured where it joined the housing.

Photo No. 8: Horizontal brace and housing

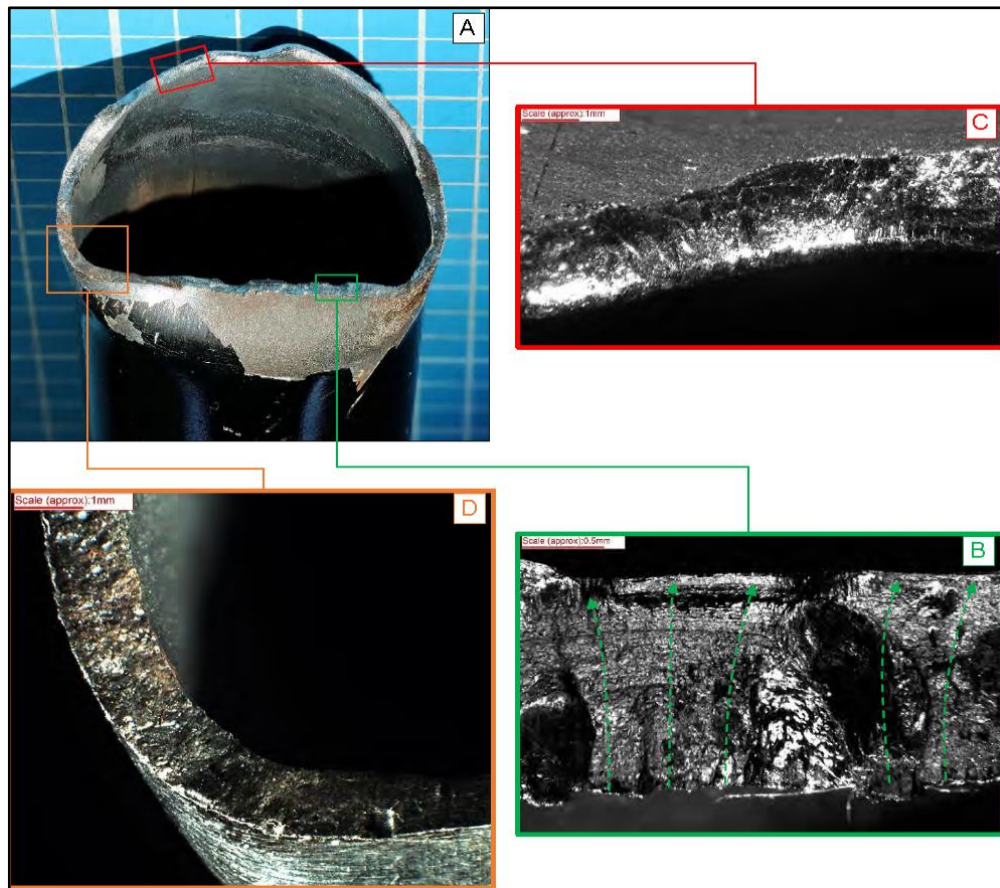
The inboard fracture surface of the horizontal brace is shown in **Figure No. 3**. Images labelled **B**, **C**, and **D**, are microscopic images of the respective areas highlighted in image **A**. Near its inboard end, the brace had fractured 50 millimetres (mm) from its joint with the housing.

There was significant buckling of both the topside and the underside of the tube, adjacent to the fracture plane. Bending of the tube in the downward direction had caused its underside to become buckled and flattened. Within this region, crack progression markings were evident on the fracture surface. They indicated that multiple, incipient fatigue cracks had initiated on the outer diameter of the tube and propagated through its wall thickness (**Image B**). As they did so, they coalesced to form a single fatigue crack front, which had reached approximately 25 mm in length. The remainder of the fracture surface was inclined on 45 degree shear planes. This was consistent with instantaneous overloading of the remaining cross-section, due to the advancing fatigue crack. Much of this region of final separation showed a shiny, burnished appearance, caused by rubbing against the mating fracture surface (**Image C**). Rusting was present on those regions of final separation (**Image D**), which had not been burnished by rubbing. The metallurgist stated that these characteristics indicated that, prior to the accident, there had been a period of operation of the aircraft after the tube had separated.

Figure No 3: Microscopic images of the inboard failure of the horizontal tube

The metallurgical expert noted that the buckling on the underside of the tube was consistent with bending of the brace in the downward direction. The magnitude of this downward bending load had exceeded the yield stress of the tube and, according to the metallurgical expert, had occurred at some time prior to the occurrence landing. The consequent buckling had provided a site of concentration for cyclic stresses arising from take-off, landing and taxiing loads, which acted in an upward direction. Over multiple flight cycles, this had caused the initiation and growth of fatigue cracks within the buckled region, until the remaining uncracked cross-section became overloaded. At this point, the horizontal brace separated at its inboard end. The metallurgical analysis could not specifically determine when this yield stress was exceeded.

The buckling on the topside of the tube was most evident on the section which had remained attached to the housing. It was considered by the metallurgical expert that this buckling most likely had occurred either during the act of final separation or by contact between the opposing fracture surfaces, after separation.

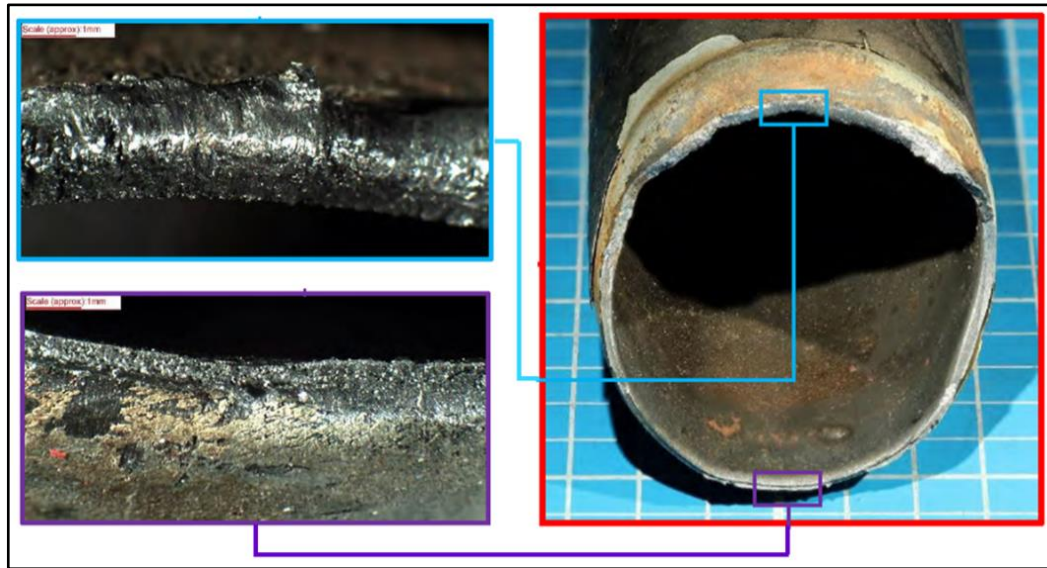
At its outboard end, the brace had fractured at its joint with the strut (**Figure No. 4**). Buckling was evident on the topside of the tube, adjacent to the fracture plane. It was consistent with a bending load, which had exceeded the yield stress of the tube. The entire fracture surface area was clean and free from rusting. This indicated that there had been no significant period of aircraft operation, post-fracture. The characteristics of the fracture surfaces indicated that an instantaneous overload failure had initiated at the bottom of the tube and spread around its circumference, with final separation occurring at the top.

Figure No. 4: Microscopic images of the outboard failure of the horizontal tube

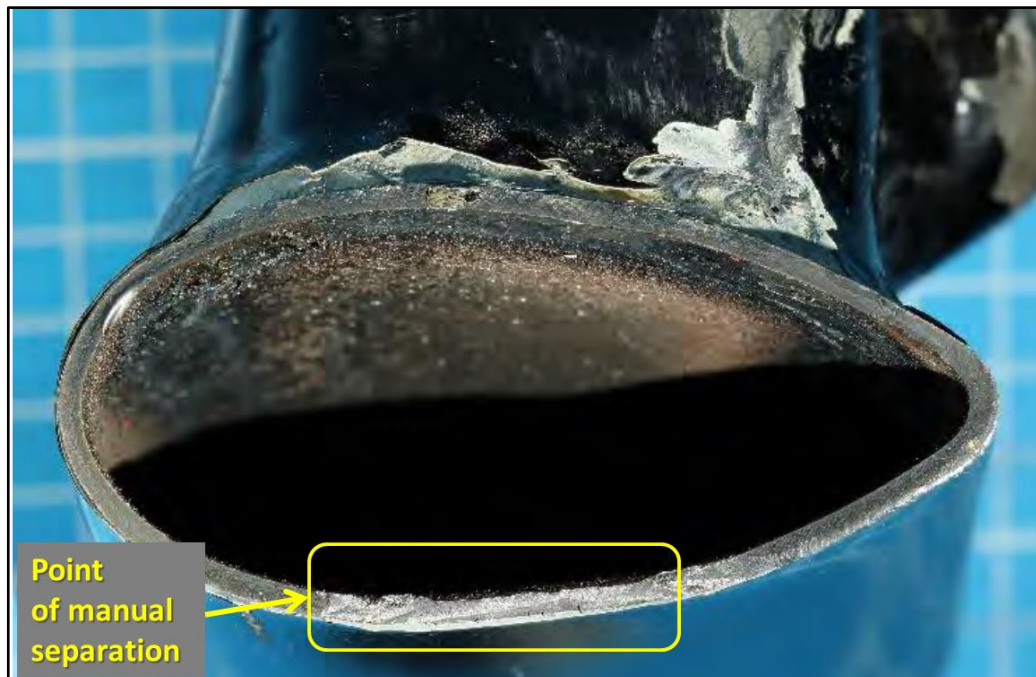
The diagonal brace had fractured at its junction with the housing (**Photo No. 9**). The fracture plane was predominantly aligned on 45 degree shear planes, consistent with an instantaneous overload failure. The entire fracture surface area was clean and free from rusting. This indicated that there had been no significant period of aircraft operation post-fracture. The lighter coloured fracture surface on the diagonal brace, shown in the lower portion of **Photo No. 9**, occurred when the diagonal brace was manually separated from the housing by an Inspector of Air Accidents for the metallurgical analysis to be conducted.

Photo No. 9: Fracture point of the diagonal brace with the housing

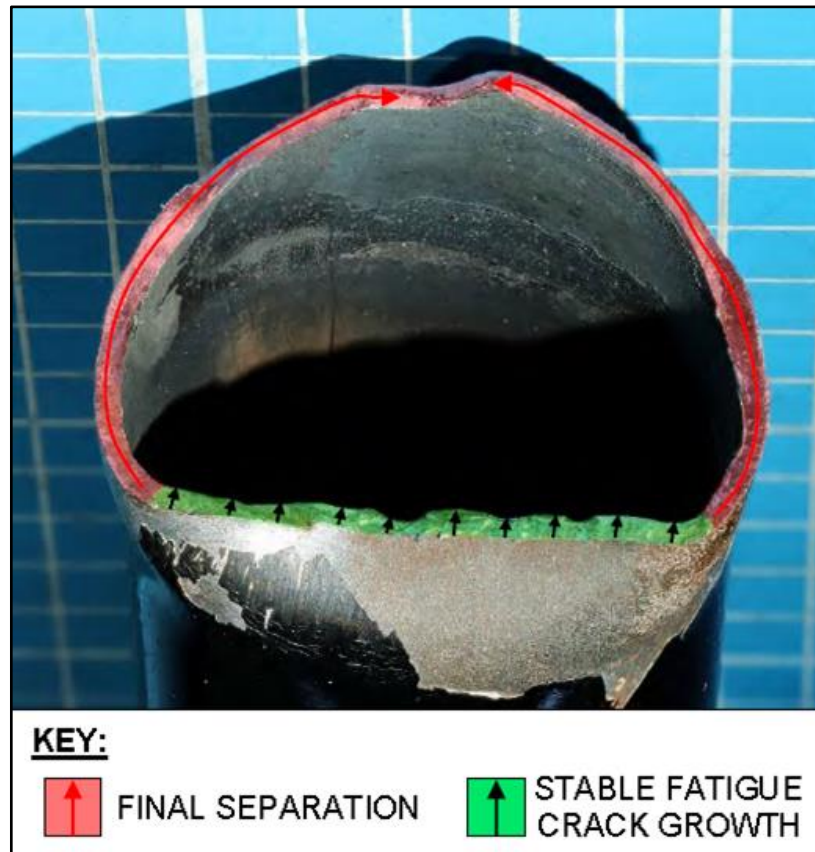
The metallurgical expert stated that the mating fracture surfaces at the inboard end of the horizontal brace had rubbed against each other after the tube had separated, as indicated by the burnished appearance of the surfaces. This indicated that there had been a period of aircraft operation, after the brace had separated at its inboard end. The Pilot provided the Investigation with a video which showed the aircraft settling abnormally low on the left landing gear leg during the take-off roll that had immediately preceded the accident landing. The Investigation considered the possibility that this may have coincided with the separation of the horizontal brace at its inboard end. However, rusting was present on those regions of final separation which had not been burnished by rubbing. This would indicate that the inboard final separation probably occurred at an earlier time.

Photo No. 10: Failure sequence of the inboard horizontal tube
