Air Accident Investigation Unit Ireland

SYNOPTIC REPORT

**Comco Ikarus C42B, EI-ERM
Bartragh Island, Co. Mayo**

3 January 2021

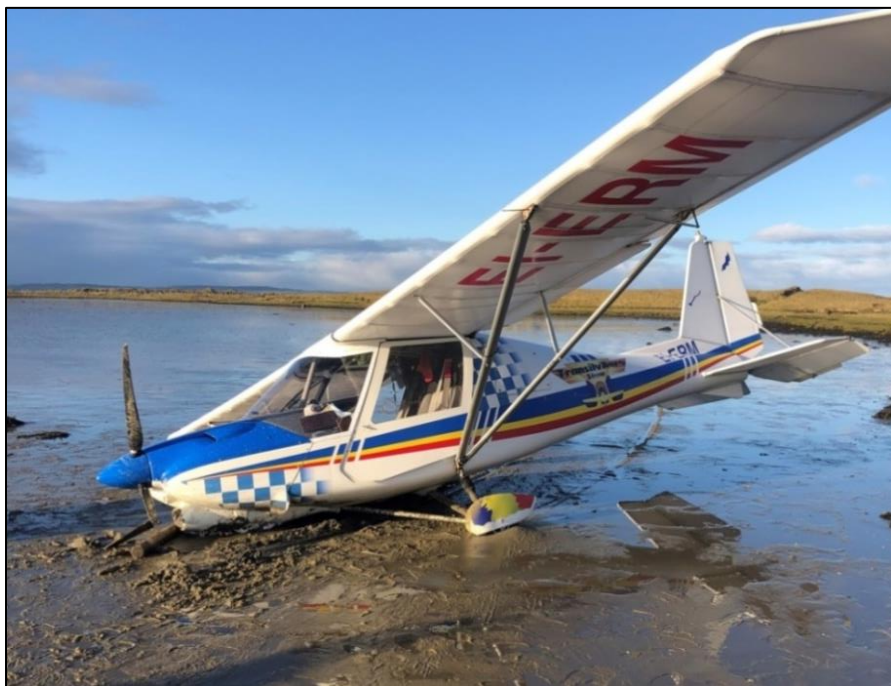
The aircraft landed on a sandy beach on the south-western side of Bartragh Island. The nose landing gear and right main landing gear collapsed during the landing and detached before the aircraft came to rest in wet sand (**Photo No. 1**). The Pilot and passenger were uninjured and exited the aircraft unaided. There was no fire.

Photo No. 1: Final resting position of aircraft (*photograph provided by the Pilot*)

The right main landing gear and the nose landing gear detached from the aircraft during the landing. One of the propeller's three blades was broken, and another was damaged. A tubular member within the fuselage that actuated the right-hand trailing edge flap was broken. The lower fuselage, inboard of the right main landing gear, sustained minor impact damage. There was evidence of rippling in the covering of the right wing, at its outboard upper surface. There was a hole in the lower surface of the right aileron. In addition, significant salt/sand contamination of the airframe and the exterior surface of the engine was evident.

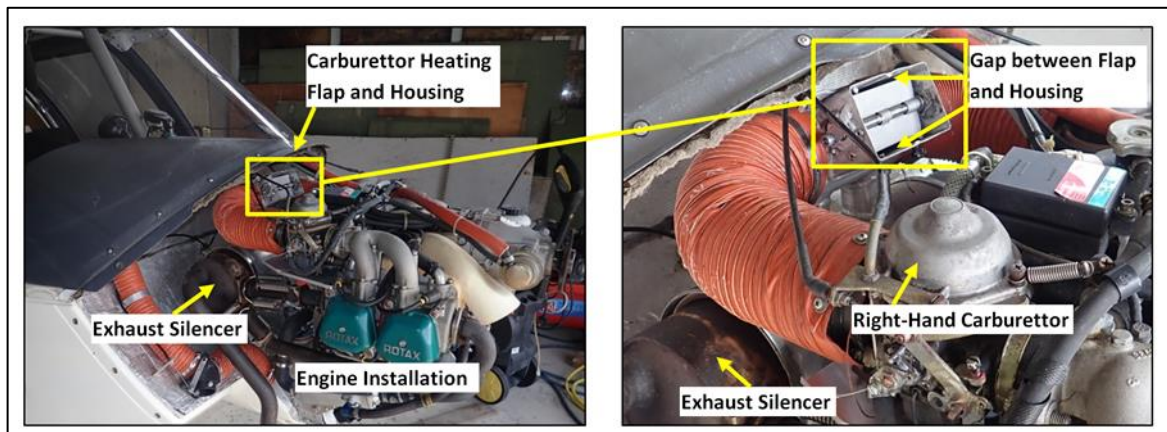
Figure No. 1: Location of carburettor heat flap (pictured in the closed (ON) position)

The Maintenance Manual for the aircraft type highlights that the flap '*does not close completely*'. This can be seen in the right-hand image in **Figure No. 1**, which shows that when the flap is in the closed position, there is a gap present between the edges of the flap and its housing.

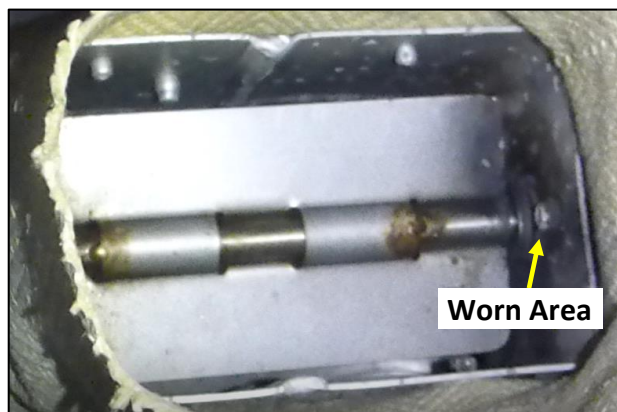
On 11 January 2021, the Investigation examined the aircraft at the location to which it had been recovered. During the examination, it was noted that the carburettor heat flap housing was worn in the area of the flap spindle (**Photo No. 2**). The flap was found to move freely to the open and closed positions when the cockpit-mounted selector was operated and the wear did not appear to adversely affect the operation of the flap.

Photo No. 2: Carburettor heat flap housing worn in area of flap spindle

During examination of the aircraft, the Investigation noted that the carburettor heat flap housing was worn in the area of the flap spindle. However, the flap was found to move freely to the open and closed positions when the cockpit-mounted selector was operated. The design of the system is such that when carburettor heat is selected to ON, the flap does not close completely, resulting in a gap between the edges of the flap and its housing. Furthermore, as outlined above, the Pilot reported that the carburettor heating had been selected to OFF approximately five minutes before the engine-cut. Therefore, the wear in the area of the spindle, while not desirable, was not considered to have been a factor in the accident.

10. The carburettor heat flap housing was worn in the area of the flap spindle. This wear, while not desirable, was considered not to have been a factor in the accident.

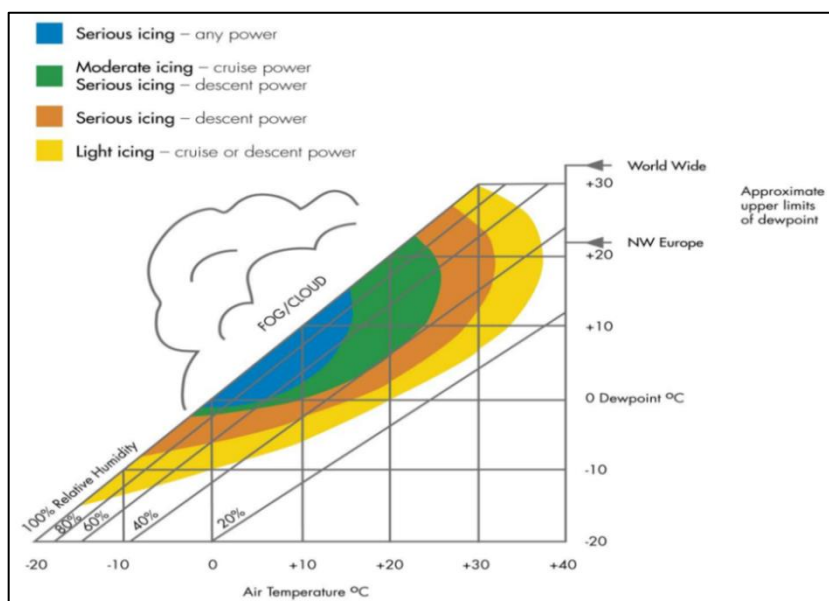
Figure No. 2: Carburettor icing chart, as published by the UK CAA

'[The] chart is not valid when operating on MOGAS. Due to its higher volatility, MOGAS is more susceptible to the formation of carburettor icing. In severe cases, ice may form at OATs up to 20° C higher than with AVGAS'.

The meteorological aftercast provided to the Investigation by *Met Éireann* for Bartragh Island at the time of the accident estimated that the temperature at 600-700 ft was between 2°C and 3°C, and the dew point was -1°C. According to the carburettor icing charts produced by the UK CAA and Transport Canada, these conditions were conducive to 'Serious Icing' at any power setting. A warning contained on the chart produced by Transport Canada states that it is 'not valid when operating on Mogas', which is 'more susceptible to the formation of carburettor icing'. Therefore, when MOGAS is used, carburettor icing could occur at conditions other than that indicated by the charts.

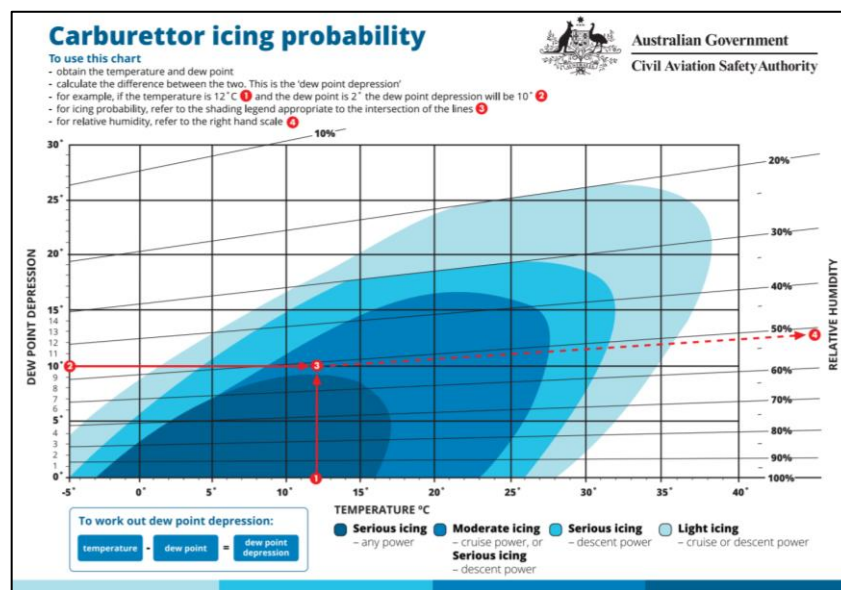
Figure No. 3: Carburettor Icing probability chart, as published by CASA

The carburettor icing probability chart produced by the CASA includes a 'dew point depression' parameter. In the case of this accident, the dew point depression was between 3°C and 4°C at 600-700 ft in the Bartragh Island area. When this information is applied to this chart, it also indicates that the meteorological conditions were conducive to 'Serious Icing' at any power setting.
