FINAL REPORT

AAIU Synoptic Report No: 2008-006

Aircraft Type and Registration:	EHI Merlin HC Mk 3, ZJ 137
No. and Type of Engines:	3 x Rolls Royce Turbomeca RTM322 turbines
Aircraft Serial Number:	50195
Year of Manufacture:	2002
Date and Time (UTC):	24 June 2007 @ 18.06 hrs approx
Location:	Salthill, Co. Galway
Type of Flight:	Military
Persons on Board:	Crew - 3 Passengers - Nil
Injuries:	Crew - Nil Others - 2 (Minor)
Nature of Damage:	Minor, to Emergency Egress Hatch
Commander's Licence:	Military
Commander's Details:	Male, aged 35 years
Commander's Flying Experience:	Military
Notification Source:	Salthill Gardaí
Information Source:	AAIU Field Investigation AAIU Report Form submitted by Pilot

On departure from the static display park at the Salthill Airshow 2007, an emergency egress hatch separated from the right-hand side cargo sliding door of a Merlin helicopter and fell to earth. The Investigation found that the locking mechanism of the egress hatch had been interfered with by an unknown member of the viewing public during the course of the day. This unlocked condition, remained undetected during the pre-flight inspection by the aircrew. Two spectators reported receiving mino

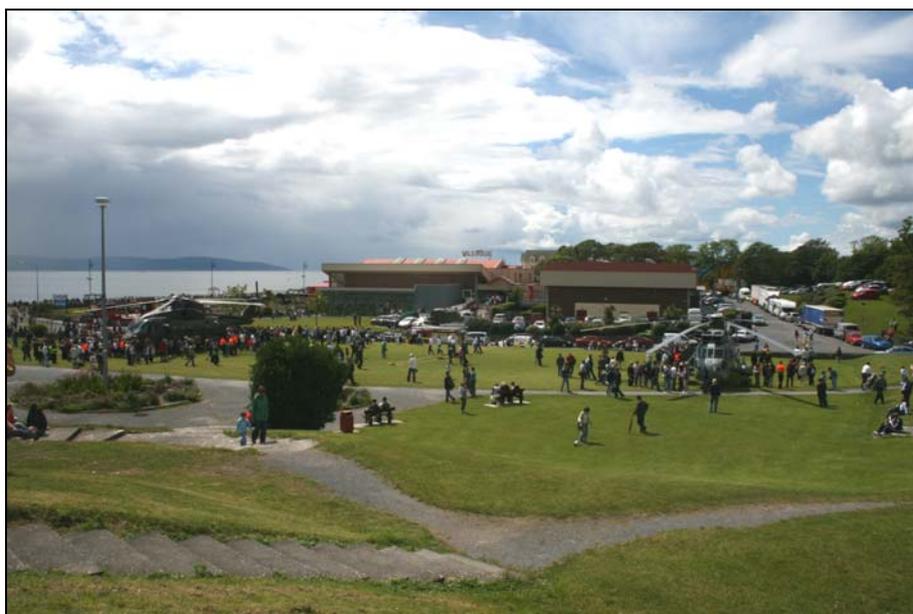
The Static Display Park (**Photo No. 1**) was located in the public park at Salthill close to the promenade. A member of the Airshow Organising Committee met with the flightcrew of the Royal Navy Sea King on its arrival on the 22 June 2007 and it was determined that the helicopter would not be open to the public, but the crew would be available to speak to the public as per previous years. On the morning of the 24 June 2007, the Merlin arrived into the static park and was met by a member of the Airshow Organising Committee, who was accompanied by a senior member of the Civil Defence (Officer-in-charge of Static Park). It was determined that the Merlin would be open to the public.

Photo No. 1: View of static display park - Merlin on left side - Sea King right side
(Photo: Mark Dwyer)

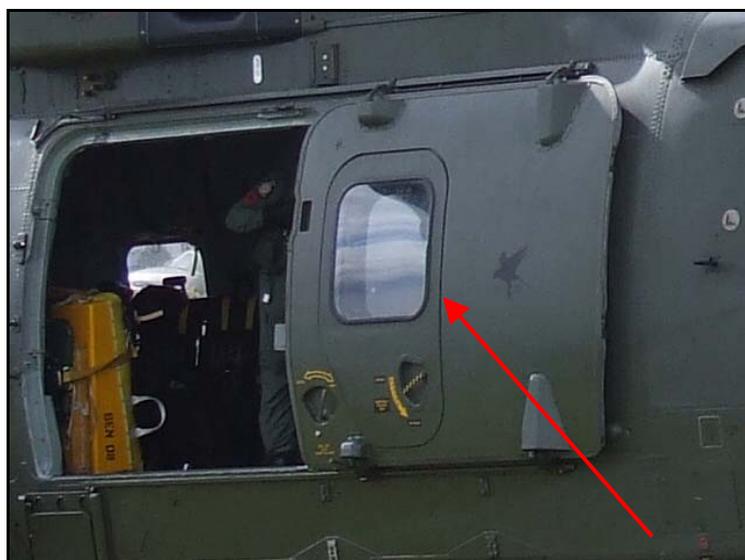
The emergency egress hatch (**Photo No. 2**) is contained within the main cargo sliding door. The hatch is made of light aluminium/composite and weighs approximately 7 kg. The main purpose of this egress hatch is for use in an emergency evacuation where the main cargo sliding door functionality is compromised following an accident.

Photo No. 2: Emergency egress hatch contained within main cargo sliding door.
(Photo: David Reddington)

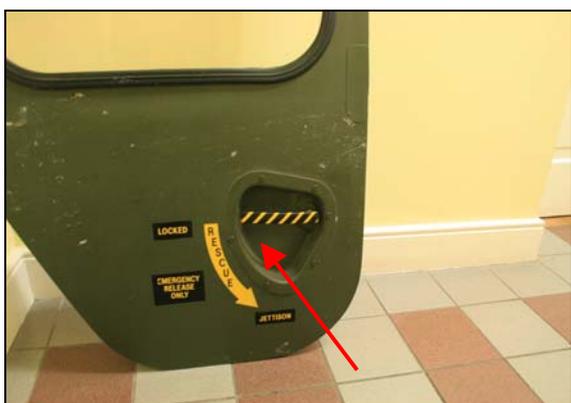
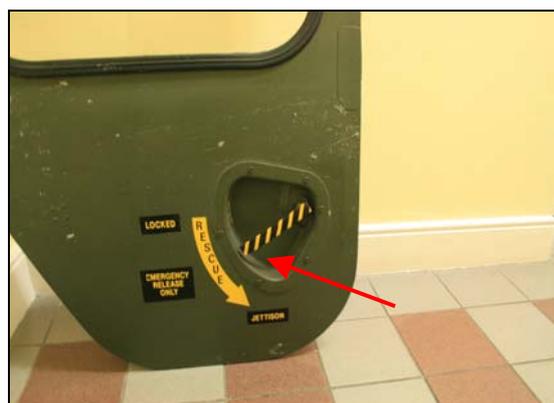
Photo No. 3: External view of egress hatch

The hatch is designed so that it can be opened from the inside and the outside (**Photo No. 3 & 4**). The hatch is not hinged, but is secured by a locking mechanism comprising of 2 fixed spigots (protruding studs) on the top section of the hatch and 2 lower mechanical spigots located on the lower left and right side of the hatch. In the sealed/locked position, the 2 fixed spigots slot into the top of the hatch frame contained within the main door. The lower left and right side spigots extend mechanically into the main door/hatch frame and secures the hatch within the main door. If the locking mechanism is selected to the open/jettison position, the lower spigots mechanically retract back into the hatch and the hatch itself falls away from the main cargo door.

Hatch handle in closed/locked position

Hatch handle in open/jettison position

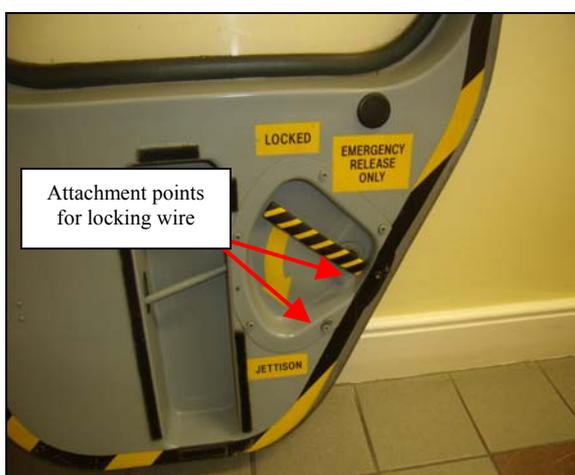
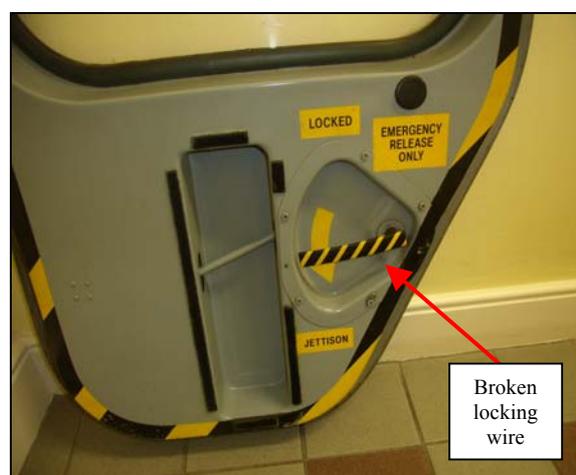
Photo No. 4: Internal view of egress hatch

On the internal cabin side of the hatch, the locking mechanism contains a “tell-tale” wire lock (**Photo No. 4**). This wire lock is basically a length of light copper wire, which is stretched between the locking handle and a hard point on the hatch. When the hatch locking handle is in the closed/locked position, the wire lock is near tight. If the handle is moved away from the locked position the wire comes under tension and snaps.

Hatch handle in closed/locked position

Hatch handle in open/jettison position

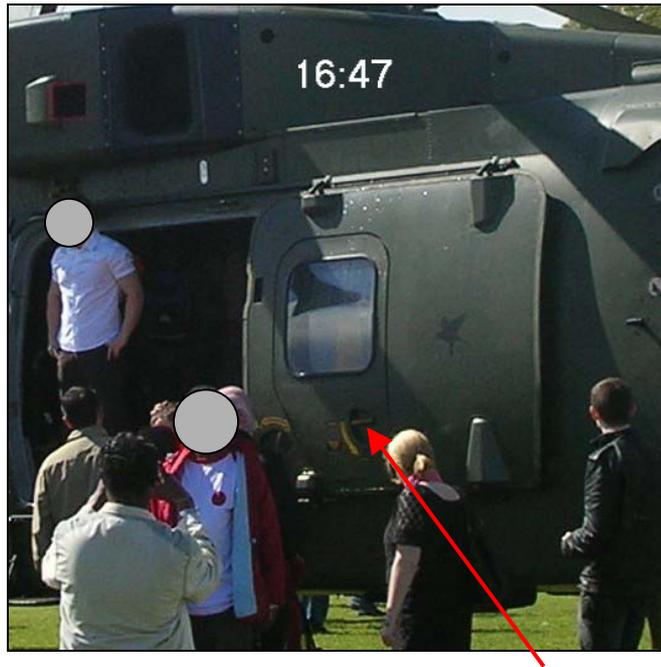
- There was a general presence of Gardaí, Civil Defence and military personnel around both helicopters throughout the day.
- At 16.47 hrs the egress jettison handle was photographed in the closed/locked position (**Photo No. 5**).

Photo No. 5: Emergency egress hatch handle in closed position
(Photo: Alan Hennessy)

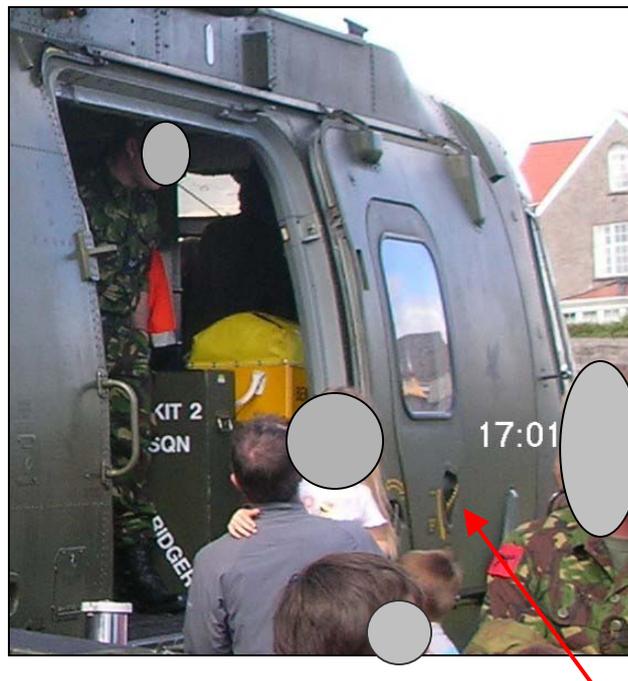
- At 17.01 hrs the egress jettison handle was photographed in the open/jettison position (**Photo No. 6**).
- On lift-off/departure (18.05 hrs approximately) for its return flight to Galway Airport the helicopters emergency egress jettison handle of the main cargo sliding door is photographed in the open/jettison position (**Photo No. 7**).

Photo No 6: Emergency egress hatch handle in open/jettison position
(Photo: Alan Hennessy)

5. Between 16.47 hrs and 17.01 hrs the locking handle for the emergency egress hatch was moved from its locked/closed position to the open/jettison position by an unknown member of the public.

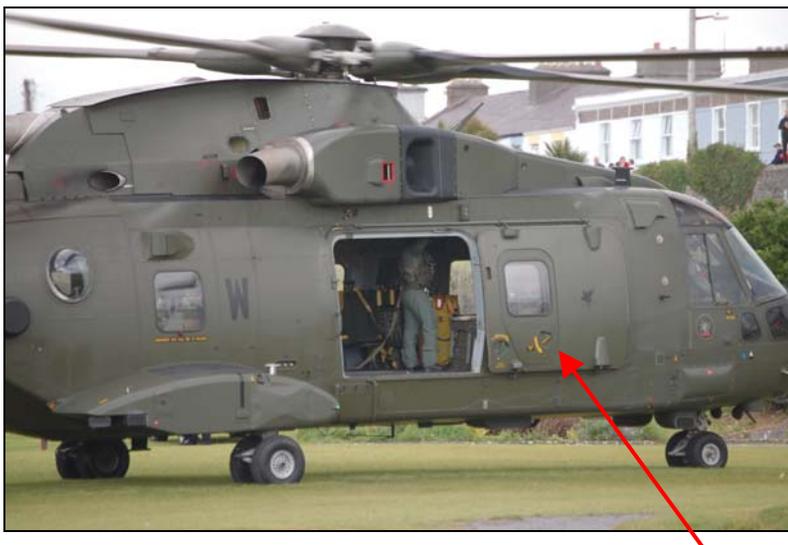
Photo No. 7: Emergency egress hatch handle in open/jettison position just prior to lift-off
(Photo: Leo Daly)

6. The open/jettison condition of the hatch handle was not observed by the flightcrew during their pre-flight “walk-around” inspection.
7. During the transition away from an out of ground effect (OGE) hover, as the main cargo sliding door was being “closed-up”, the unsecured hatch “detached” from its stowed position and fell to earth.
