# FINAL REPORT

**AAIU Synoptic Report No: 2008-015**

<b>Aircraft Type and Registration:</b>	Sud SE.313B Alouette II, N577AG
<b>No. and Type of Engines:</b>	1 x Turbomeca Artouste II C6
<b>Aircraft Serial Number:</b>	1666
<b>Year of Manufacture:</b>	1961
<b>Date and Time (UTC):</b>	24 October 2007 @ 15.40 hrs
<b>Location:</b>	Castlewarden, Co Kildare
<b>Type of Flight:</b>	Private
<b>Persons on Board:</b>	Crew – 2
<b>Injuries:</b>	Crew – 1 (Serious)
<b>Nature of Damage:</b>	Substantial
<b>Commander's Licence:</b>	FAA Private Pilot's Licence (Helicopter)
<b>Commander's Details:</b>	Male, aged 47 years
<b>Commander's Flying Experience:</b>	(See Section 1.4)
<b>Notification Source:</b>	Watch Manager, ATC Shannon
<b>Information Source:</b>	AAIU Field Investigation

## **SYNOPSIS**

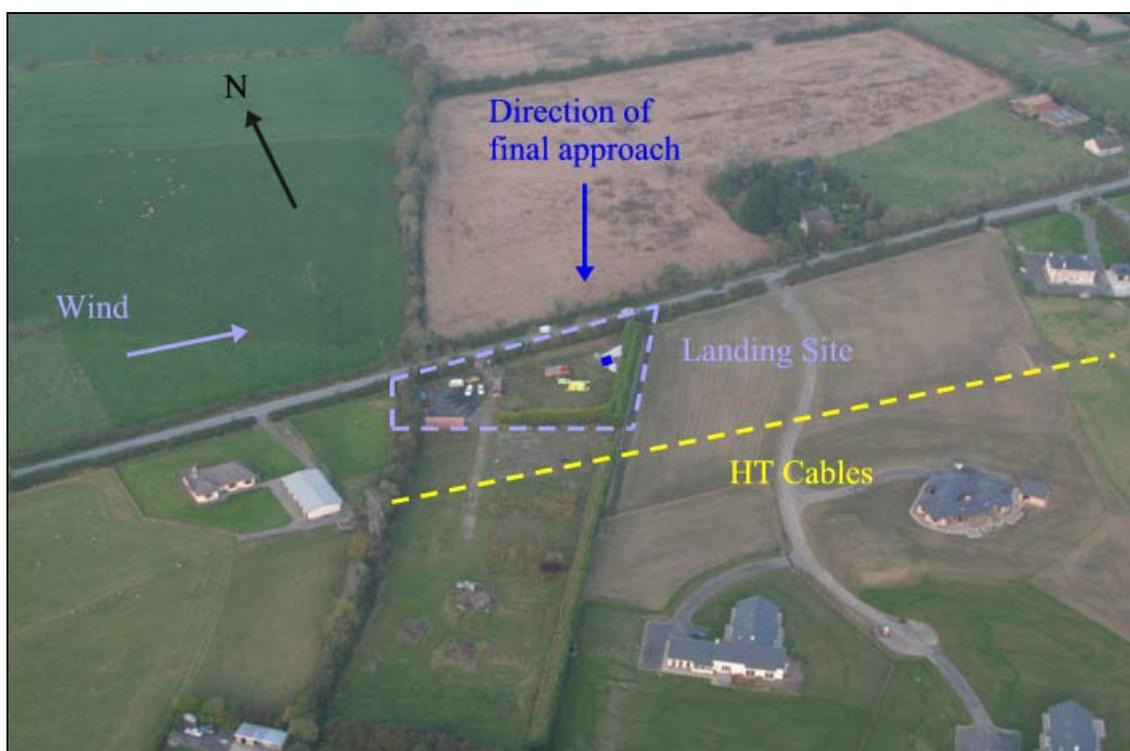
**Photo No. 1:** General view of Landing Site

The landing site consisted of a level grass field, with a hard-core road access area to the western side (**Photo No. 1**).

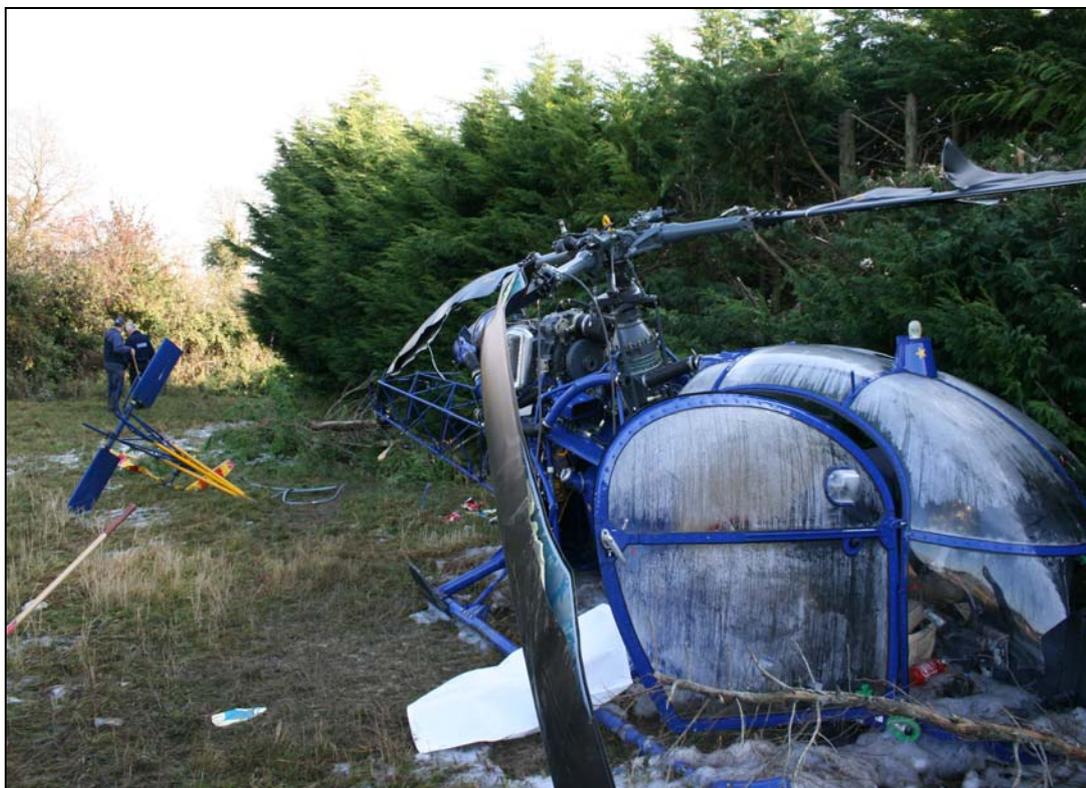
**Photo No. 2:** Main wreckage and severed tail boom

The entire structural framework of the helicopter was found distorted and fractured. This is indicative of large vertical deceleration forces on impact. Almost all the main tubing structure was distorted, the landing skids and shock struts all showed evidence of high impact forces. A section of airframe tubing ruptured the fuel tank on the right side allowing the contents to spill. The entire lower section of the fuel tank was crushed by impact.
