FINAL REPORT

AAIU Synoptic Report No: 2008-016

Aircraft Type and Registration:	Piper PA12, EI-CMN
No. and Type of Engines:	1 x Avco Lycoming 0-235-C1
Aircraft Serial Number:	12 -1617
Year of Manufacture:	1946
Date and Time (UTC):	27 April 2008 @ 1305 hrs
Location:	Birr Airfield, Co Offaly
Type of Flight:	Private
Persons on Board:	Pilot - One
Injuries:	Pilot - None
Nature of Damage:	Substantial
Commander's Licence:	Private Pilot's Licence
Commander's Details:	Male, aged 62 years
Commander's Flying Experience:	277 hours, of which 77 were on type
Notification Source:	Manager, Birr Airfield.
Information Source:	AAIU Pilot Report Form submitted by Pilot, AAIU Field Investigation.

SYNOPSIS

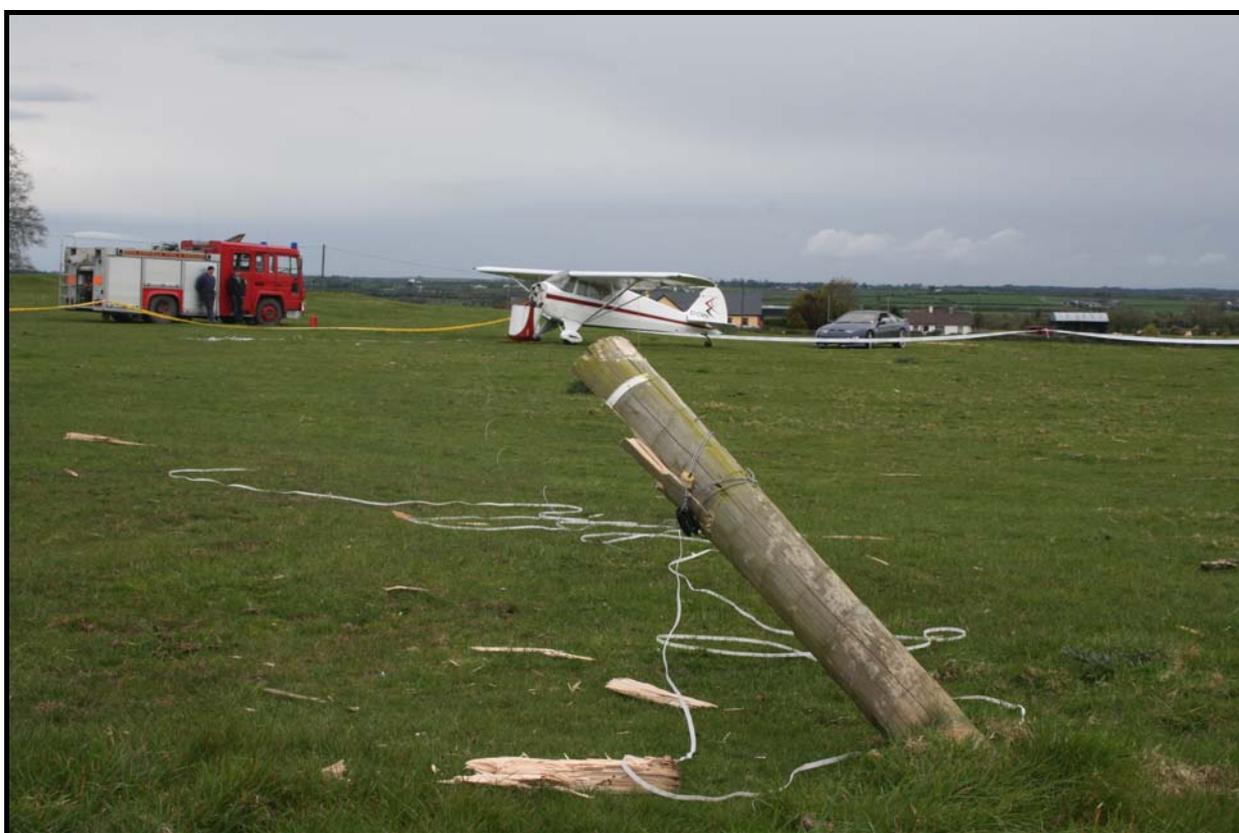
The aircraft struck a stout wooden pole during an attempted overshoot, leading to a shattered propeller and the almost total severance of the engine from the airframe.

The Pilot's own assessment of the cause of the accident was his failure to correct the right drift on landing, which led to the impact with the post and the subsequent serious engine damage. A contributing factor was the Pilot's low annual hours and flight experience on type.

Photo No. 1: Accident scene showing impacted post and engine resting on ground
