FINAL REPORT

AAIU Synoptic Report No: 2008-017

Aircraft Type and Registration:	Enstrom F-28 C, G-WSEC
No. And Type of Engines:	1 x Lycoming H10-360-E1AD
Aircraft Serial Number:	398
Year of Manufacture:	1977
Date and Time (UTC):	02 August 2007 @ 18.40 hrs
Location:	Near Newtownmountkennedy, Co. Wicklow
Type of Flight:	Private
Persons on Board:	Crew - 1 Passengers - 1
Injuries:	Crew - None Passengers - None
Nature of Damage:	Aircraft destroyed
Commander's Licence:	See Paragraph 1.2
Commander's Details:	Male, aged 65 years
Commander's Flying Experience:	2,000 hours (of which approximately 200 were on type)
Notification Source:	AAIU advised by Gardaí from Wicklow Garda Station
Information Source:	AAIU Field Investigation

SYNOPSIS

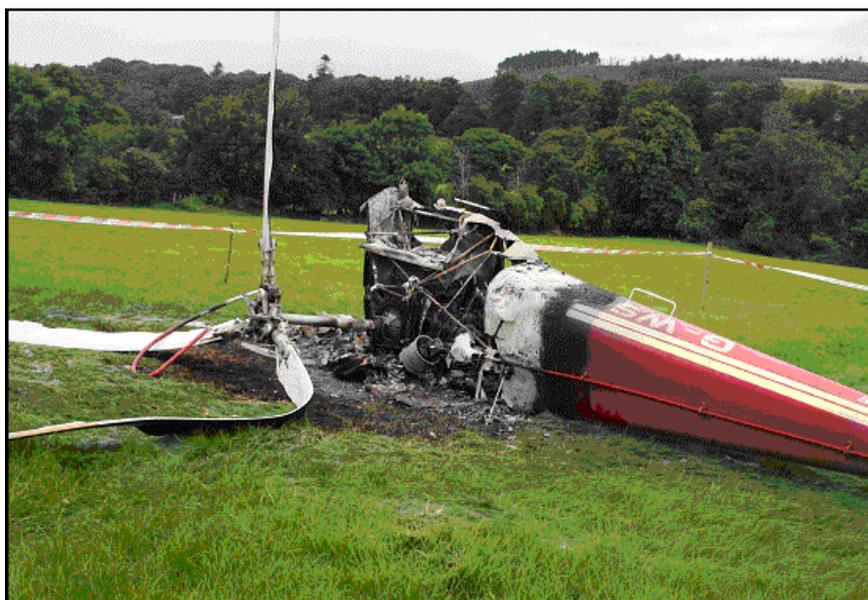
The Pilot attempted a run on landing on an up sloping grass field. Here, on the approach to land, the helicopter cut through some ESB domestic power lines, just before the first touch on. It continued uphill at least another 50 metres before coming to rest on its side, directly under ESB high-tension lines. The Pilot and passenger released their 4-point harnesses and exited the helicopter within 10 seconds. Almost immediately the helicopter was engulfed in flames, which destroyed the cabin, engine and gearbox area (**Photo No. 1**). Only the rear section of the tail boom remained recognisable and intact. Both the Pilot and Passenger were shocked by their experience but otherwise unhurt. The Fire Services were quickly on the scene and contained the fire from destroying the rear of the tail boom and tail rotor section. The Gardaí secured the accident site until AAIU Inspectors arrived. Later ESB technicians switched off the power supply in the area for a number of hours as a precautionary measure.

Photo No. 1: Accident Site and burnt remains of G-WSEC

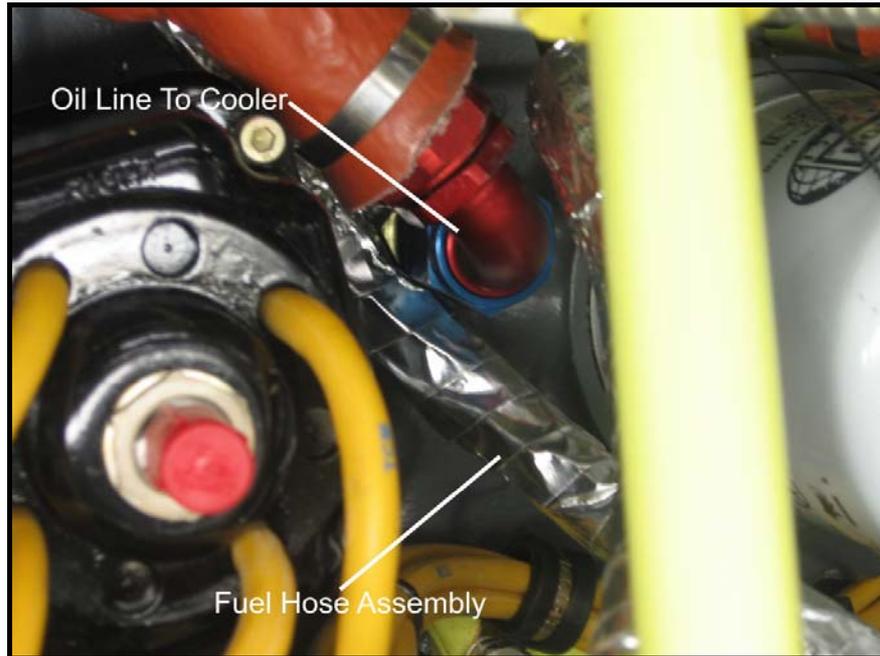
- It was a Lycoming Part Number LW-12878-4S260, which has one end wrapped in foil by the helicopter manufacturer, which turns the part into Enstrom part Number 28-12463-1. **Photo Nos. 2 and 3** show this hose as found on an undamaged Enstrom helicopter. **Figure 1** shows the schematic location of the hose.
- It carried a tag that gave a manufacturing date of 1989.
- The hose connected the fuel control unit (fuel servo) that is located under the engine with the fuel distributor/divider that is located on top of the engine.

Consultation with the helicopter's manufacturer indicated that at a point approximately 7 inches from the fuel control unit (fuel servo) end of the hose, the hose is routed between the oil outlet line and the magneto. At a point 7 inches further along the hose, it is normally secured by a clamp to prevent contact with the adjacent oil line or the magneto. The damaged section of this hose is shown in **Photo No. 4**.

**Photo No. 2: A view of the Fuel Hose showing the relative location of the Oil Pipe.
(Photo taken from an in-production Enstrom F28F)**

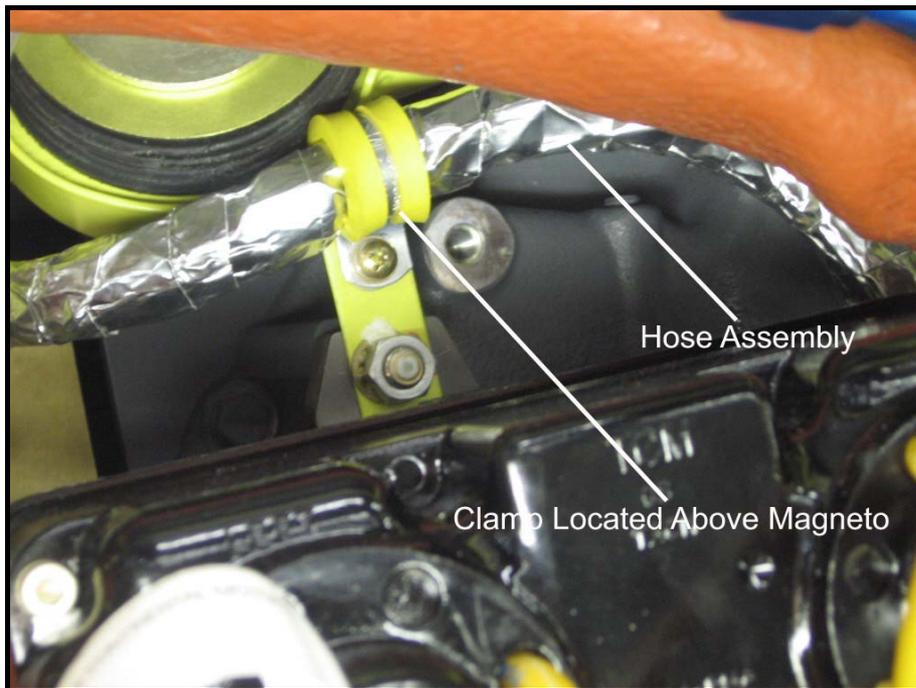
The fuel hose damage is consistent with wear or fretting damage over an extended period of time. The contact with either the magneto or the oil pipe was probably caused by the absence of the securing clamp, the mispositioning of the clamp, or distortion of the clamp in subsequent maintenance. The result was that contact between the hose and the oil pipe or magneto was not prevented. Due to the extensive melting in this area, it is impossible to make a definite determination regarding these alternative possibilities. The mechanism of such fretting failure in this type of hose is that an external item (such as the oil pipe or magneto in this case) wears through the outer protective layers of the hose and then starts to wear through the metal braid.

**Photo No. 3: A view of the Fuel Hose showing the relative position of the
Magneto and the securing clamp.
(Photo taken from an in-production Enstrom F28F)**

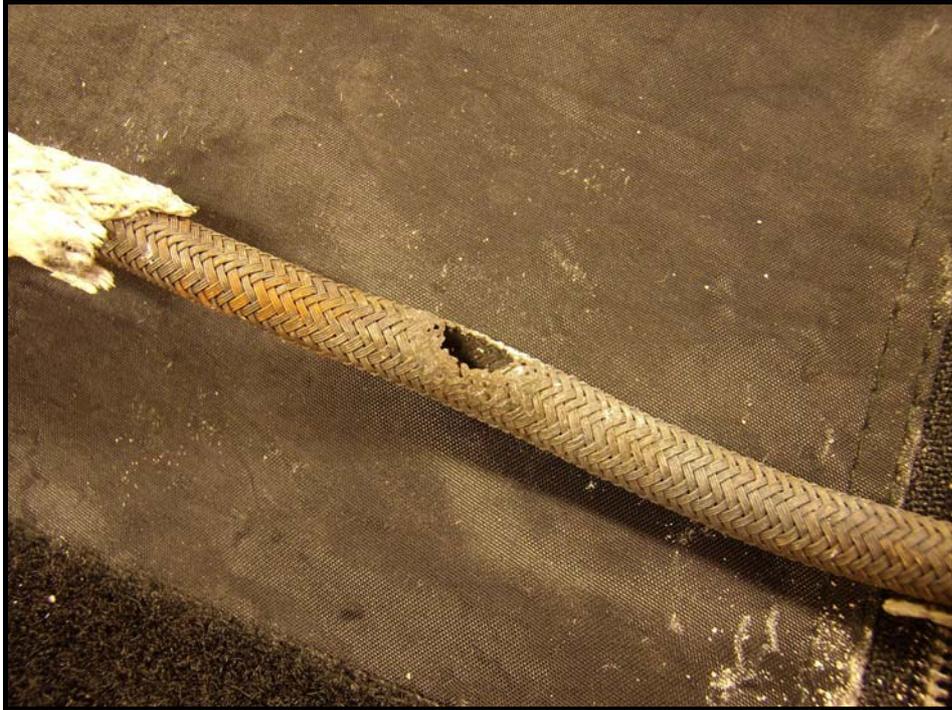
On further examination of the helicopter, a length of fuel hosing was discovered. This hose was found loose in the engine bay. Examination of this hose showed that a hole had been worn through the side of the hose. Further investigation of the hose showed:

- The purpose of the hose is to carry fuel from the fuel control unit (fuel servo) to fuel distributor/divider, with a nominal working pressure of 24 PSI.
- Both ends of the hose were normally screwed into aluminium fittings. These had melted, which accounted for the hose being found loose in the engine compartment.
- The hole was worn approximately 7 inches from the fuel control unit (fuel servo) end of the hose.

When the circular continuity of the braid is destroyed (i.e. it has completely worn through at one section of the circumference) the fretted ends of the braid turn inwards and pierce the inner wall of the hose, producing tiny pinholes. In this case, the Avgas fuel in the hose, under a pressure of 24 PSI, then exited through these small holes in a very fine spray. Because the fine spray had a very large surface area, and was sprayed into a hot engine bay, it vaporised readily and quickly.

4. The fuel hose from the fuel servo to the fuel distributor came into contact with the adjacent structure, due to a missing or misaligned securing clamp.

A missing or misplaced clamp that secured the fuel hose probably caused the initiating failure. As a result, this hose fretted against the adjacent structure and ultimately developed a fuel leak. The ignition of the leaking fuel led to the loss of the helicopter.

Photo No. 4: Damaged Fuel Hose of G-WSEC showing the hole, worn through the metal braid as a result of the contact and fretting action. (The rubber material of the hose has been burned away.)

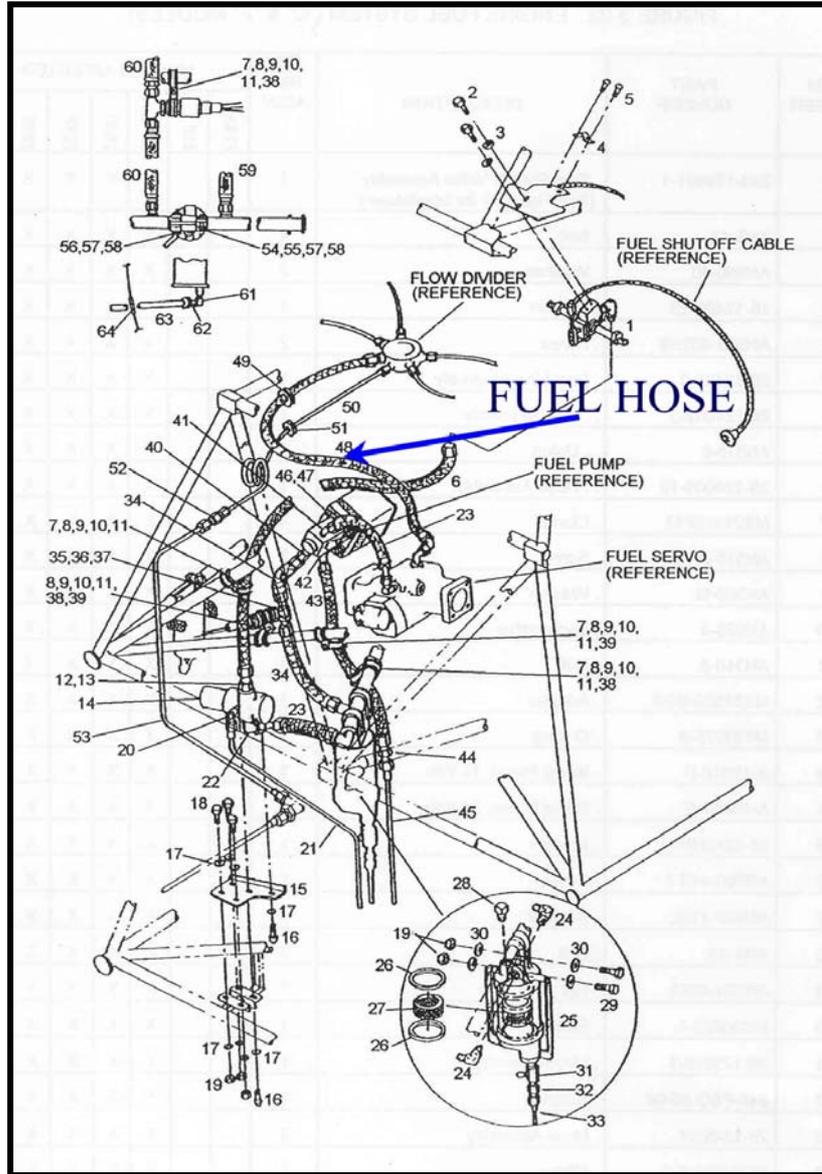
Figure 1: This shows the schematic location of the fuel hose.
