FINAL REPORT

AAIU Synoptic Report No: 2009-008

Aircraft Type and Registration:	DC-8-63F, N865F
No. and Type of Engines:	4 Pratt and Whitney JT3D-7
Aircraft Serial Number:	46088
Year of Manufacture:	1969
Date and Time (UTC):	28 March 2008 @ 22.40 hrs
Location:	Shannon Airport (EINN), Ireland
Type of Flight:	Commercial Air Transport Non-scheduled - International Cargo
Persons on Board:	Crew - 4 Passengers - 0
Injuries:	Crew - Nil Passengers - Nil
Commander's Flying Experience:	9,581 hours, of which 2,834 were on type
Notification Source:	Station Manager, Shannon ATC
Information Source:	Pilot Report Form submitted by Pilot, AAIU Investigation

SYNOPSIS

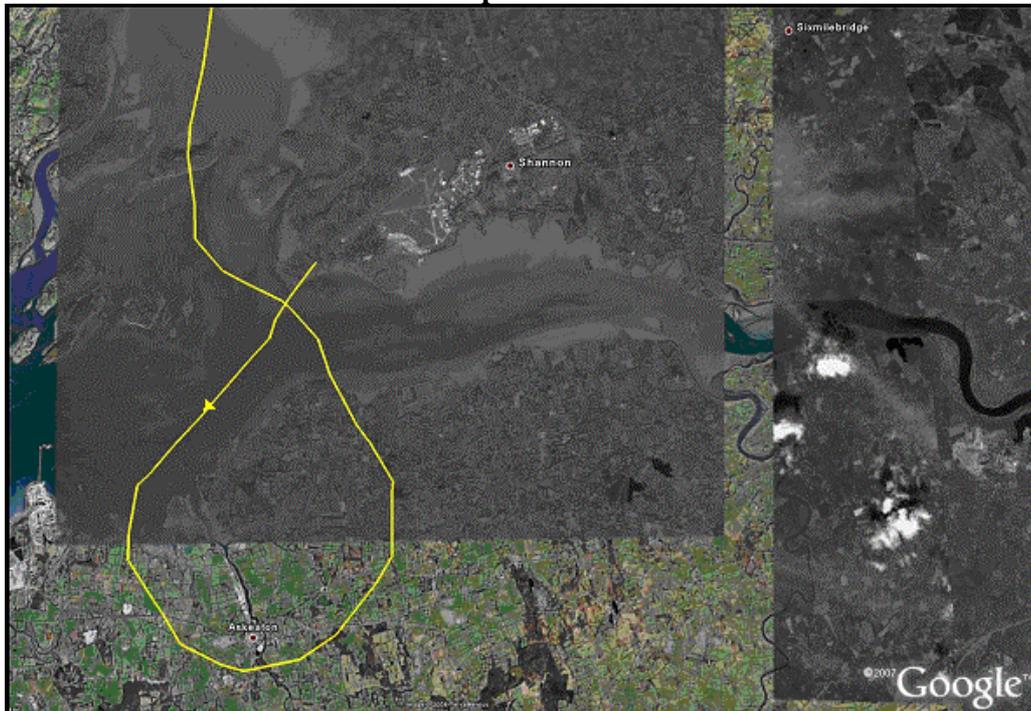
Graphic No. 1

Shannon ATC provided ATC recordings, which included a copy of radar data, to the Investigation. **Graphic No. 1** shows the track of the aircraft during the occurrence, as derived from the radar track. The radar position, speed and altitude of the aircraft is recorded every 5 seconds.

Track of N865F over ground

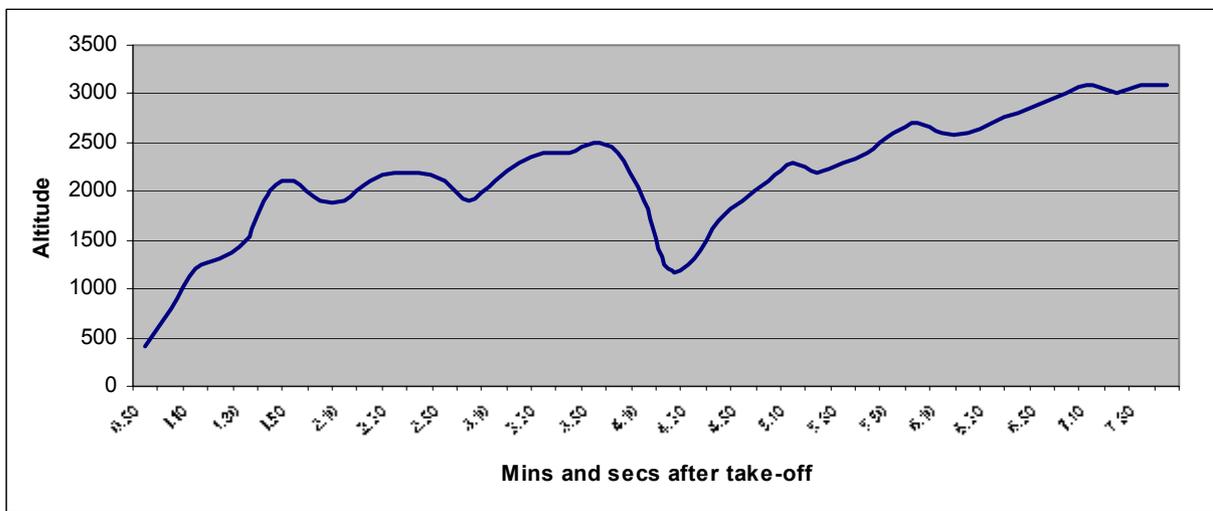
Graphic No. 2

The aircraft then passed by the village of Askeaton (located inside the lowest point of the track in **Graphic No. 2**) at 2,400 ft in a descending left turn. At 4 minutes and 15 seconds after take-off the recording shows that the radar Minimum Safe Altitude Warning (MSAW) system activated to warn the Controller of an unsafe condition. The MSAW activated as the aircraft descended through 1,700 ft to a minimum altitude of 1,100 ft during the occurrence. The MSAW then stayed active for 20 seconds until the aircraft climbed back through 1,500 ft, at which point it was established on a northeasterly heading. The following graph shows the height of the aircraft during the occurrence, as recorded by ATC radar.

Radar Recording

The aircraft descended from 2,400 ft to 1,100 ft in 30 seconds, or a descent rate of 2,600 ft/min. ATC voice recordings show that the ATC controllers were monitoring the aircraft and were extremely concerned about the unusual descent, its rate and the developing situation, as evidenced by the internal communications between the Approach Controller and the Tower Controller on their mutual telephone line.
