PRELIMINARY REPORT

AAIU Report No: 2010-007
State File No: IRL00910048
Published: 08/07/2010

On the afternoon of 27 June 2010, a Boeing 737-800 parked on stand 109R at Dublin Airport, following a flight from Krakow. During disembarkation from the rear door the first three passengers emerged from the aircraft onto the mobile air stairs unit. The stairs then partially collapsed trapping and causing serious injury to a passenger's leg.

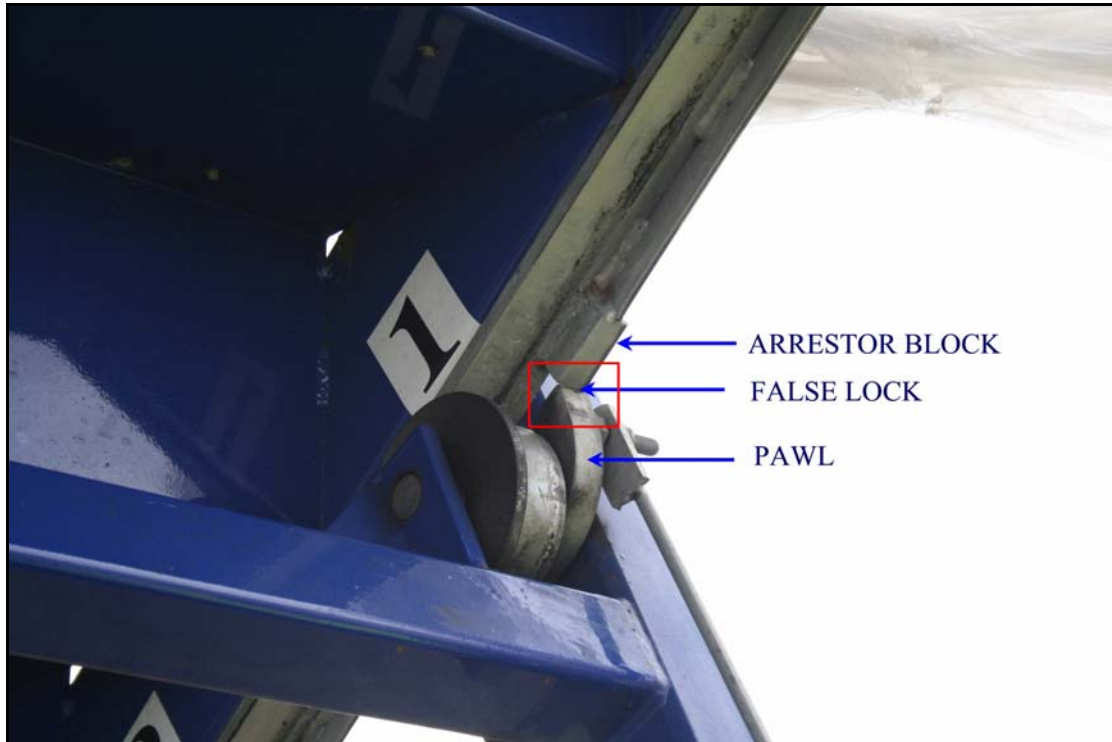
During testing by the Investigation a number of issues relating to the occurrence stairs unit were identified. In particular, one of the locking pawls was found to be unserviceable and incapable of engaging with the arrestor blocks. The stairs unit manufacturer informed the Investigation that previous testing had shown that one serviceable pawl, correctly engaged, was sufficient to maintain the sliding unit lock. However, the stairs unit manufacturer also observed that, in this case, the unserviceable pawl mechanism on one side was "*working against*" the mechanism for articulating the serviceable pawl on the other side.

The Investigation's testing revealed that it was possible for the fixed section upper platform and a sliding section step tread to align properly even though the locking mechanism was not fully engaged. This occurred when the arrestor block rested on the upper, leading edge of the serviceable pawl, thereby providing a "*false*" locking of the sliding stair. **Photo No. 1** shows this "*false*" lock condition where the pawl is not correctly engaged.

Photo No. 1: False lock configuration

It was found that this "*false*" lock was sufficient to allow one person to stand on the sliding section without adverse consequence. However, when three people stood on the sliding section the "*false*" lock suddenly gave way and the section slid rapidly downwards until the pawl engaged in the next detent. This was accompanied by a loud noise. During this downward slide, the tread that had been level with the fixed top platform dropped rapidly whilst, instantaneously, the next step slid downwards closing the gap. The result was that anything resting on the tread that had been level with the platform was trapped between the edge of the platform and the edge of the descending (next higher) step.

Following examination of a serviceable air stairs unit of the same part number the Investigation found that it was possible for both pawls to simultaneously engage in a "*false*" lock condition.

1. Ryanair Ltd. should ensure that personnel involved in the use of mobile air stairs units visually confirm and crosscheck the correct engagement of both pawls immediately prior to each use. ([IRLD2010007](#))

2. Ryanair Ltd. should ensure that personnel involved in the use of stairs units are trained to recognise when pawl mechanisms are correctly engaged. ([IRLD2010008](#))

4. TB Davies (UK) Limited should advise operators of the Owen Holland Engineering Ltd. LTPS 2636 air stairs units of the potential problem of “false” lock occurrence. ([IRLD2010010](#))

5. TB Davies (UK) Limited should review the design of the LTPS 2636 air stairs units and assess whether modifications and/or additional control measures are required to obviate the possibility of “false” lock occurrence. ([IRLD2010011](#))
