FINAL REPORT

AAIU Report No: 2010-006
State File No: IRL00909070
Published: 09/07/2010

Aircraft Type and Registration:	Stampe SV4A, EI-CJR
No. and Type of Engines:	1 x Renault 4PO5
Aircraft Serial Number:	318
Year of Manufacture:	1953
Date and Time (UTC):	09 August 2009 @ 16.00 hrs
Location:	Craughwell, Co. Galway
Type of Flight:	Private
Persons on Board:	Crew - 1 Passengers - 1
Injuries:	Crew - 0 Passengers - 0
Nature of Damage:	Substantial
Commander's Licence:	Private Pilot Licence (Aircraft)
Commander's Details:	Male, aged 65 years
Commander's Flying Experience:	720 hours of which 150 hours were on type
Notification Source:	Passenger
Information Source:	AAIU Pilot Report Form submitted by Pilot, AAIU Field Inspection

On climb out, at between 100 ft and 150 ft above the ground, the engine stopped. The aircraft made a forced landing into an agricultural field adjacent to the airfield. There were no injuries. The aircraft suffered substantial damage. The Investigation found that the accident was probably due to carburettor icing. The Report makes three safety recommendations.

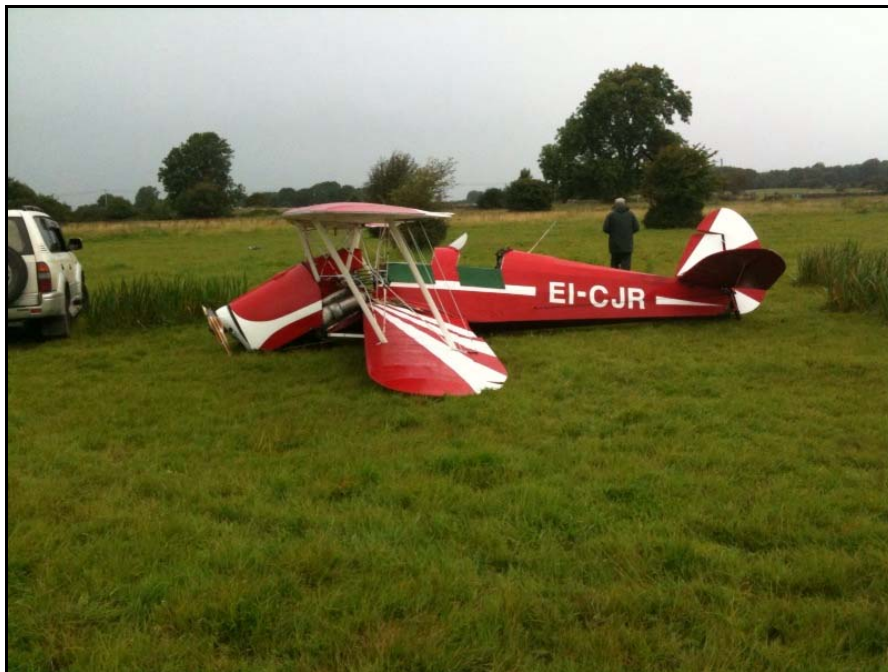
Photo No. 1: Aircraft as it came to rest

The Investigation determined that the aircraft had adequate fuel on board. Control continuity was verified except for impact related damage. The Investigation found that the aircraft was well maintained and there were no significant problems previously noted with the aircraft. All aircraft damage was consistent with impact damage and no evidence of pre-existing failure or damage was observed. An examination of the engine revealed no evidence of mechanical failure. The Pilot informed the Investigation that he was not aware of the exact temperature and dew point for the time of the accident flight. He also informed the Investigation that the aircraft was operated on a 50/50 mix of Avgas and Mogas¹. The aircraft is not fitted with a carburettor heating system. The Pilot advised the Investigation that he believed the cause of the accident was carburettor icing.

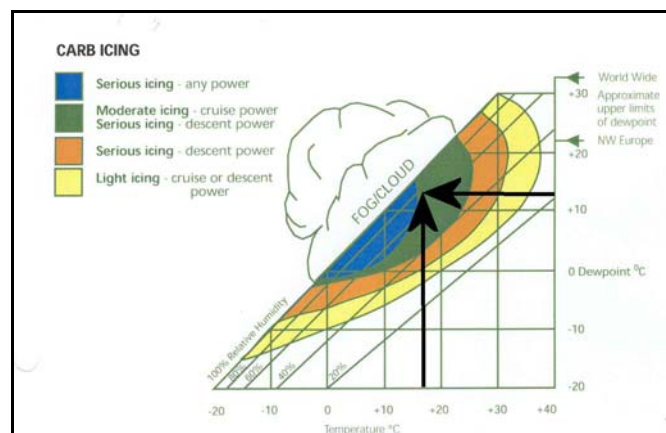
Transport Canada produced an indicative chart (*“TP 2700 – Carburettor Icing Conditions”*) that provides guidance to pilots. The chart plots carburettor icing risk and power setting against air temperature and dew point. The chart is widely known and referred to in General Aviation. Transport Canada describes the chart as a, *“rough guide to conditions conducive to carburettor icing”*. The chart is based on Avgas, and TC says that for Mogas, *“the risk areas would be larger”*. It is impossible to be more specific due to the variability of Mogas volatility. However, TC notes, *“In severe cases, ice may form at OATs² up to 20° C higher than with Avgas”*. **Figure No. 1** shows a version of this (Avgas) chart, with the temperature and dew point for the accident flight plotted.

Figure No. 1: AVGAS carburettor icing chart for accident flight

Although the aircraft was operating on 50/50 Avgas/Mogas mixture, in accordance with AN A16 the aircraft is considered to have been operating on Mogas. For an Avgas-operated aircraft the prevailing conditions (temperature and dew point) were conducive to the formation of moderate carburettor icing at cruise power and serious carburettor icing at descent power. Allowing for the use of Mogas the chart suggests that, on the day of the accident, there was a serious risk of carburettor icing at any power setting. Evidence of carburettor icing is perishable and carburettor icing is usually diagnosed by exclusion i.e. by ruling out other potential causes such as mechanical failure. In this case the prevailing temperature and dew point (**Figure No. 1**), suggests a strong possibility of carburettor icing, particularly when cognisance is taken of Transport Canada's warning in relation to the (Avgas) chart, that, "*the risk areas would be larger*", for Mogas.

The complications of operating on Mogas, and the precautions and tests required to do so safely, are not widely appreciated/understood in the General Aviation community. In this regard the widely used carburettor icing chart is invalid for Mogas, and may be giving false comfort/readings to General Aviation operators. In extreme cases it may be incorrect by as much as 20° C.

The IAA should consider revising AN A16 to include relevant scientific and operational information such as that made available by Transport Canada and the UK's CAA and LAA. [\(IRLD2010004\)](#)
