FINAL REPORT

Formal Report No: 2010-009

Manufacturer: Schweizer Aircraft Corporation

Model: Model 269C-1

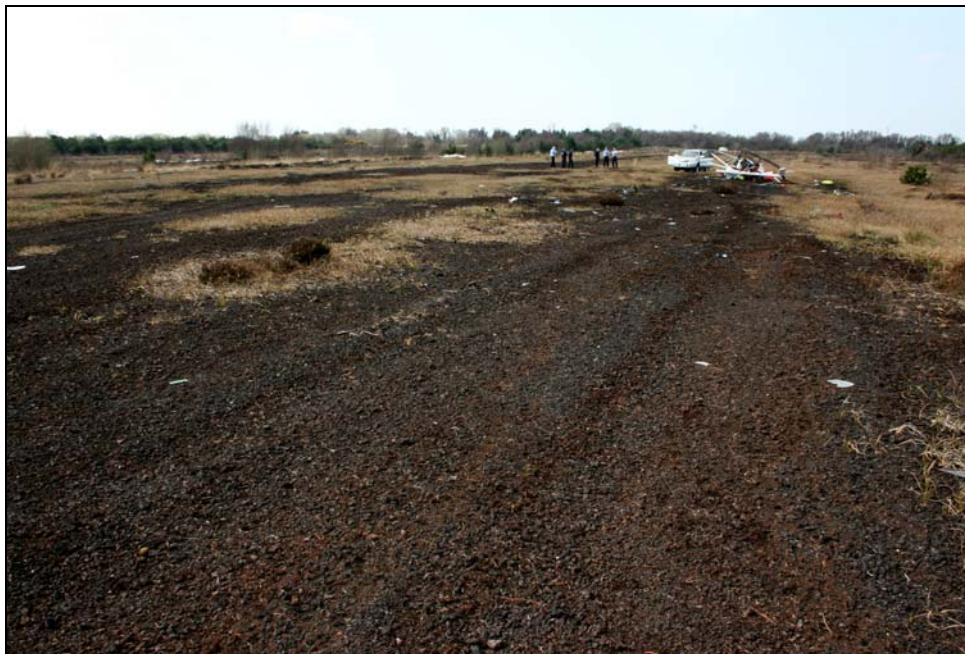
The impact occurred in an area of machined bog 2.5 km southeast of the village of Kilshanchoe. The bog was machined into level strips approximately 80 metres wide running in a north-westerly direction bounded on either side by raised banks (**Photo No. 1**).

Photo No. 1: General view of accident site facing direction of flight.

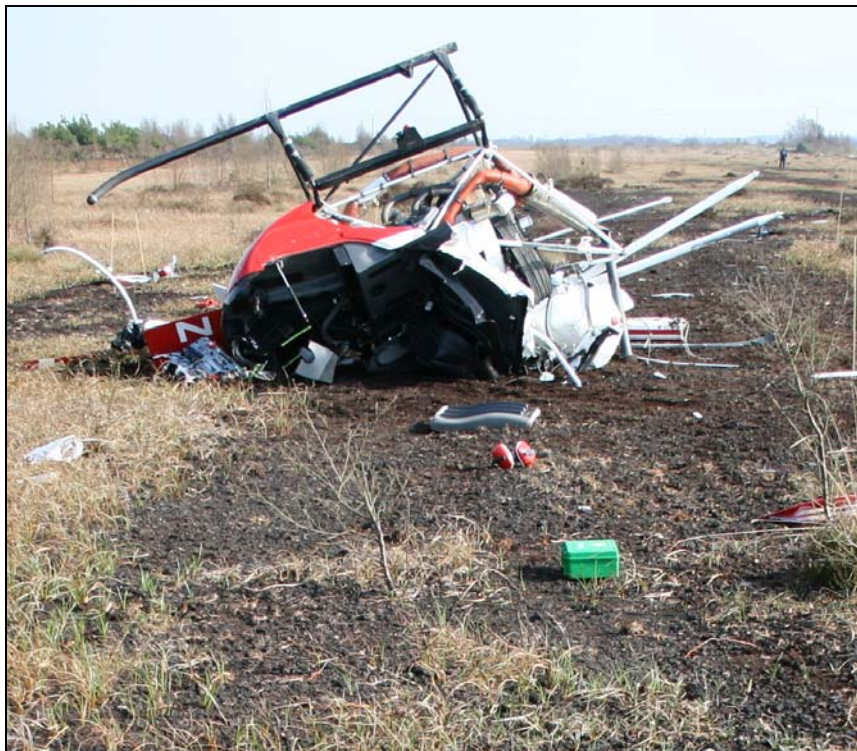
The main wreckage of the helicopter came to rest in an inverted position 16.5 metres beyond the position of the main rotor, and 53.5 metres from the transmission line on a heading of 320° M. The entire canopy was shattered into small pieces and spread around the main wreckage. The tailboom was severed at the attachment points, and swung clockwise to lie parallel to the body (**Photo No. 2**).

Photo No. 2: General view of main wreckage facing direction of approach

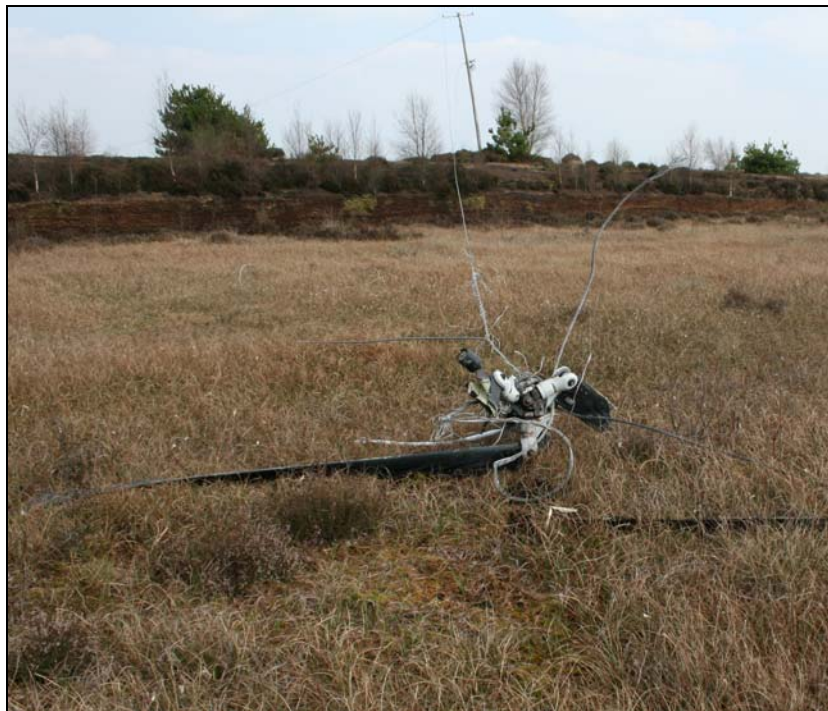
The main rotor head, attached to a portion of the helicopter's magnesium mast housing, had separated from the fuselage and was found with two power cables wrapped tightly around the head, on the right hand side of the wreckage trail at a distance of 42 metres from the initial impact point. A cable remained attached to each of the poles either side of the flight path. The main rotor drive shaft was complete and was also still attached to the head, with its upper end located inside the mast. The power lines and main rotor head are illustrated in **Photo No. 3**.

Photo No. 3: Detached Main Rotor, transmission pole is visible in the background

The damage pattern indicates that a cable made contact with the top of the rotor disc severing a blade from top to bottom and then two cables made direct contact with the rotor head. The fact that the two cables were wrapped completely around the head indicates that the head was rotating rapidly at impact. As the cables were wound between once and twice around the head, this suggests that the blade rotation was stopped between one and two revolutions after impact. As the cables became taut, the fuselage of the helicopter pitched up rapidly, at which point the rotor head and drive shaft detached allowing the fuselage of the helicopter to continue forwards, impacting the ground in an inverted position. The landing skids were completely undamaged by the impact confirming the wreckage impacted in an inverted attitude and did not tumble. It is likely that, as the helicopter pitched severely upwards following the cable strike, the loading of the two cables wrapped around the head caused the mast to fracture in overload near the aft cabin lateral bulkhead. The mast structure fractured through heavy tensile load. The aft support strut of the mast failed at its attachment point to the fuselage due to a lateral bending overload. The direction of bending at the fracture is consistent with right yaw of the fuselage as a result of rotor stoppage. The main rotor drive shaft housed inside the mast was pulled completely clear of the main gearbox.

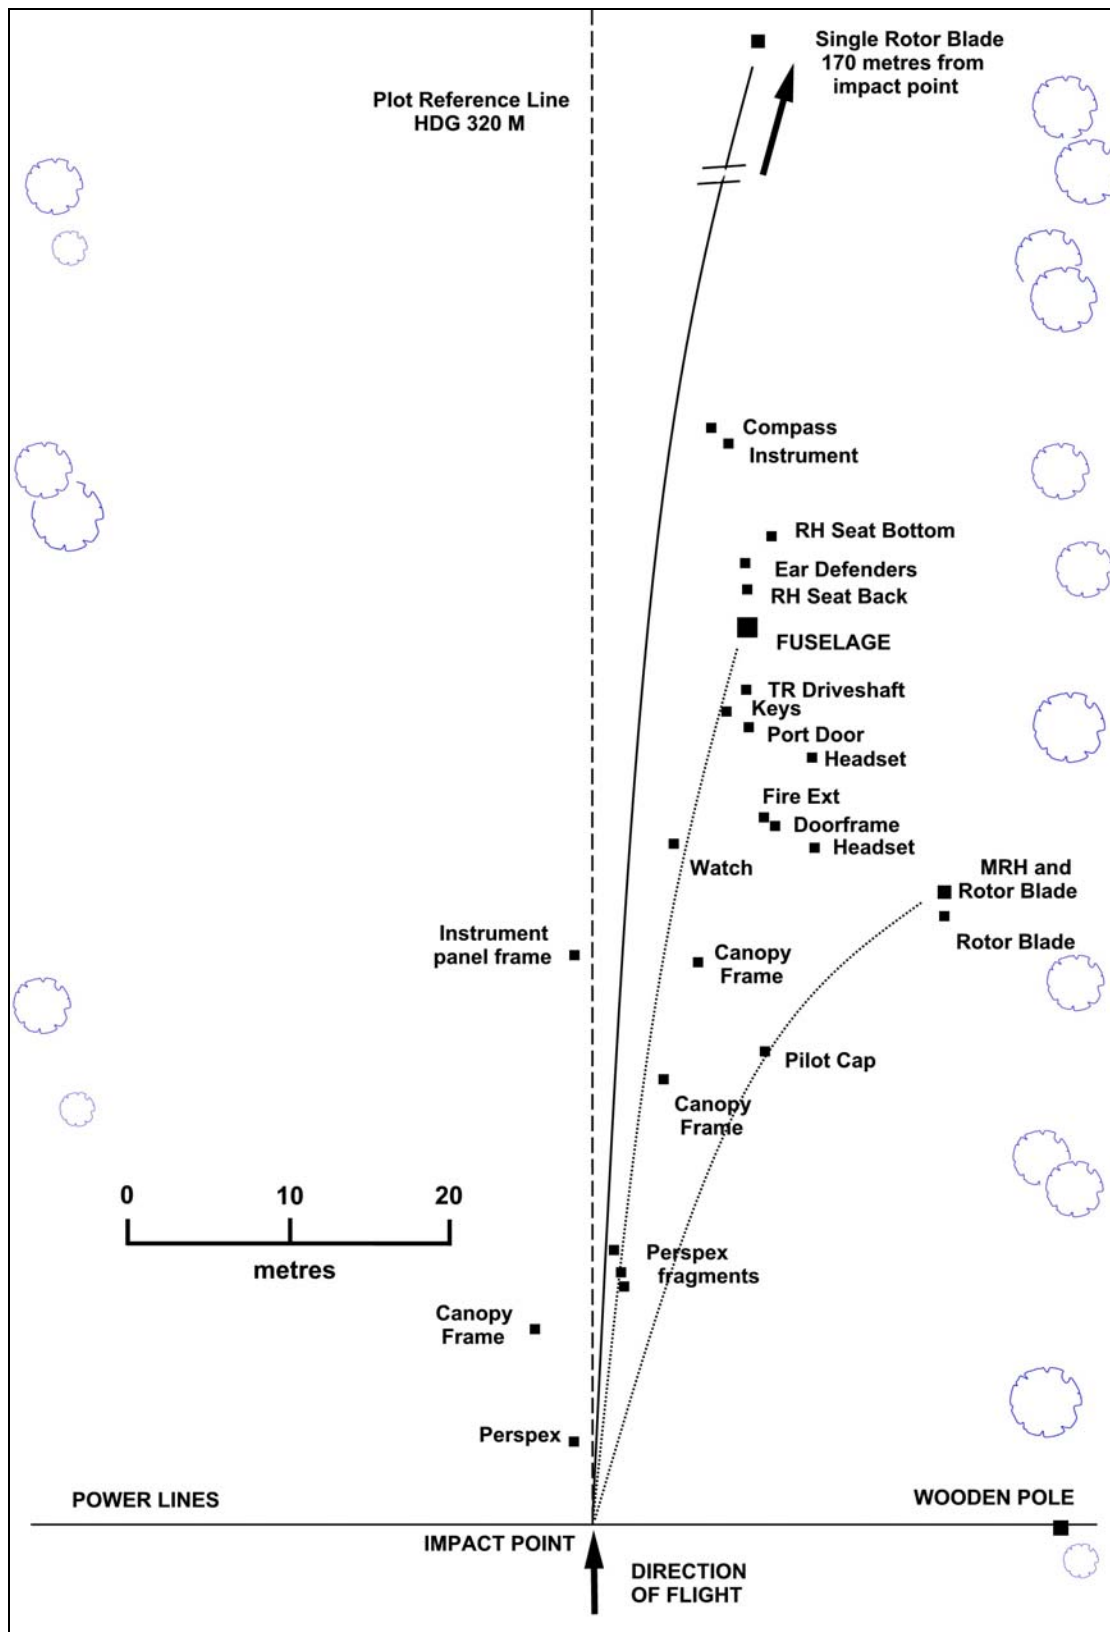
Wreckage distribution and debris field of EI-CZL

Commencing at a line between the two wooden poles that had supported the cables, the first piece of wreckage was a section of perspex from one of the doors including a round clear vision panel. This was found 5 metres forward of the line between the poles. Over the next 35 metres the ground was strewn with pieces of broken perspex and parts of the canopy frame. At a distance of 36.5 metres forward of the initial impact point, a transmission line cable was lying across the wreckage trail. The distribution of the debris field relative to the impact with the power lines is illustrated in **Appendix C**.
