# FINAL REPORT

AAIU Report No: 2010-017  
State File No: IRL00910022  
Published: 19/10/2010

<b>Aircraft Type and Registration:</b>	Auster 5, Series J1, EI-AUM	
<b>No. and Type of Engines:</b>	1 x Cirrus Minor II	
<b>Aircraft Serial Number:</b>	2612	
<b>Year of Manufacture:</b>	1947	
<b>Date and Time (UTC):</b>	21 March 2010 @ 16.30 hrs	
<b>Location:</b>	Seven Parks Farm, Co. Dublin	
<b>Type of Flight:</b>	Private	
<b>Persons on Board:</b>	Crew - 1	Passengers - 1
<b>Injuries:</b>	Crew - Nil	Passengers - Nil
<b>Nature of Damage:</b>	Substantial	
<b>Commander's Licence:</b>	Commercial Pilot Licence, issued by the Irish Aviation Authority (IAA)	
<b>Commander's Details:</b>	Male, aged 68 years	
<b>Commander's Flying Experience:</b>	9,255 hours, of which 122 were on type	
<b>Notification Source:</b>	Pilot	
<b>Information Source:</b>	AAIU Pilot Report Form submitted by Pilot, AAIU Field Investigation

On landing, the aircraft veered to the right, ground-looped and impacted a boundary fence.

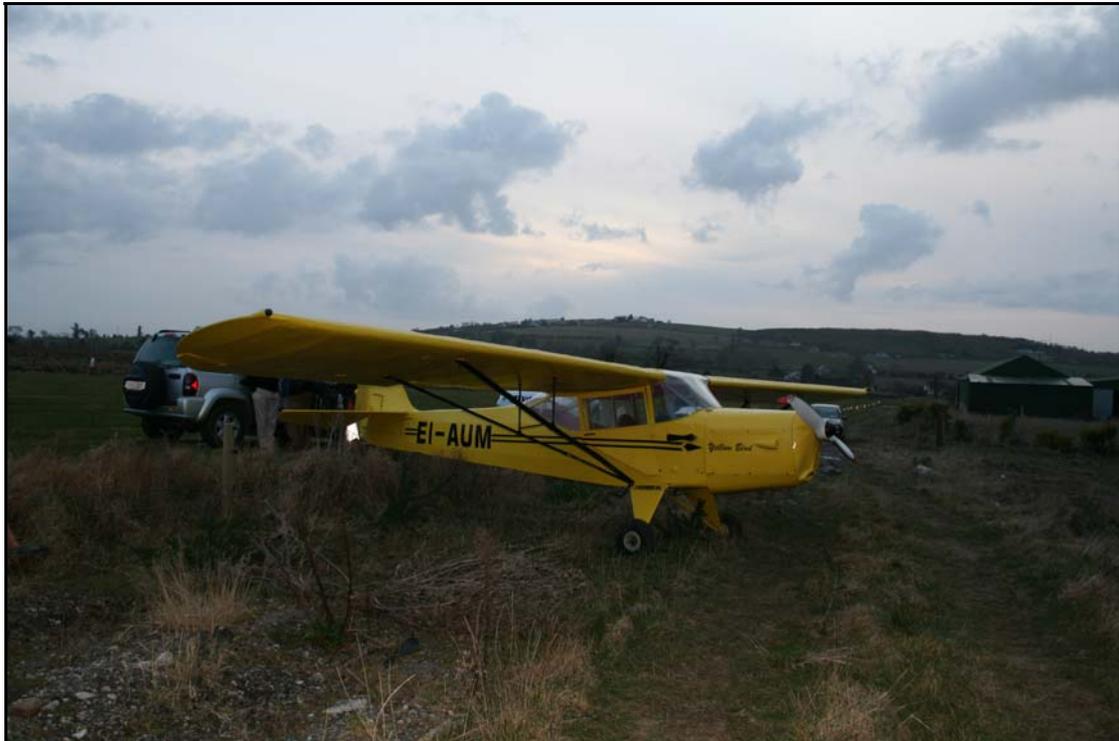
The aircraft was flying a circuit detail on Runway (RWY) 27 at Seven Parks Farm. The first circuit was uneventful. While landing from the second circuit, directional control was lost, and the aircraft veered to the right striking a wire boundary fence. The aircraft came to rest with the tail still on the higher/runway side of the fence and the tail plane against a fence post (**Photo No. 1**).

**Photo No. 1: Aircraft as it came to rest**

Beyond the boundary fence the ground level fell away by approximately 0.6 m into an adjacent field. The aircraft's main wheels dropped into an adjacent field causing the propeller and engine bottom cowling to impact the ground at low speed. The aircraft suffered substantial damage including a broken propeller tip, crushed bottom engine cowling, damaged right wing struts and tearing of the fabric on the bottom of the fuselage. On-site inspection by the Investigation verified the continuity of all control runs.
