FINAL REPORT

AAIU Report No: 2010-021
State File No: IRL00909123
Published: 18/11/2010

Aircraft Type and Registration:	Mainair Blade 912S, EI-EHR (Microlight)
No. and Type of Engines:	1 x Rotax 912S
Aircraft Serial Number:	1296-0801
Year of Manufacture:	2001
Date and Time (UTC¹):	27 December 2009 @ 16.20 hrs approximately
Location:	Near Shinrone, Co. Offaly, Ireland
Type of Flight:	Private
Persons on Board:	Crew - 1 Passengers - 1
Injuries:	Crew - 1 Passengers - 1
Nature of Damage:	Aircraft destroyed
Commander's Licence:	U.K. Civil Aviation Authority (CAA) National Private Pilot's Licence (Aeroplanes) (NPPL(A)) with microlight rating
Commander's Details:	Male, aged 41 years
Commander's Flying Experience:	35 hours, of which 19 were on type
Notification Source:	Shannon Air Traffic Services
Information Source:	AAIU Pilot Report Form, AAIU Field Investigation

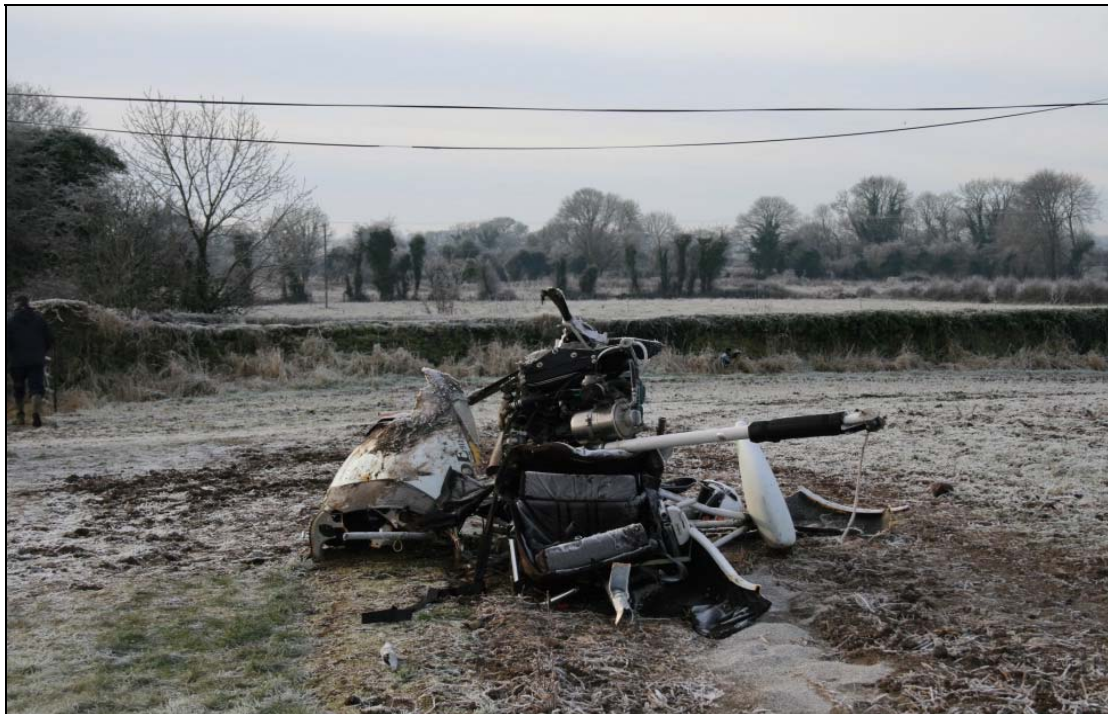
The aircraft impacted the airstrip field approximately 20m inside the boundary wall, which ran alongside and parallel to the telephone cables and road. Two telephone cables were supported on poles at a height of approximately 6m (20ft) from the ground. The cable, which had been supported at the upper position on the adjacent poles, displayed a significant droop along with some damage to its insulation. The cable supported at the lower position on the poles remained approximately parallel to the ground. The aircraft appeared to have continued on its approach track until impact and it came to rest in close proximity to the runway threshold.

Photo No. 1 shows the wreckage of EI-EHR looking back along its approach path towards RWY 04. The telephone cables are visible, with what had been the upper cable drooping considerably, and showing evidence of impact damage.

Photo No. 1: General view of wreckage and telephone cables

As the Mainair Blade flies its approach to land in a nose-up attitude and since the rear wheels are the lowest part of the aircraft in that configuration, it is probable that one or both of the rear wheels made contact with the upper of the two parallel telephone cables, approximately 6 m above the ground. The cable was stretched by the contact but did not break. The sudden deceleration of the aircraft caused by the cable snagging the wheel(s) caused the Pilot to lose control of the aircraft, which impacted into the field in a nose-down attitude.
